Investigation of a Damaged High-rise Building near Ground Zero

The building studied is a 39-story office building at 130 Liberty Street in lower Manhattan. It was located to the immediate south of tower 2. Figure 1 shows the building's location with respect to the Trade Center complex.

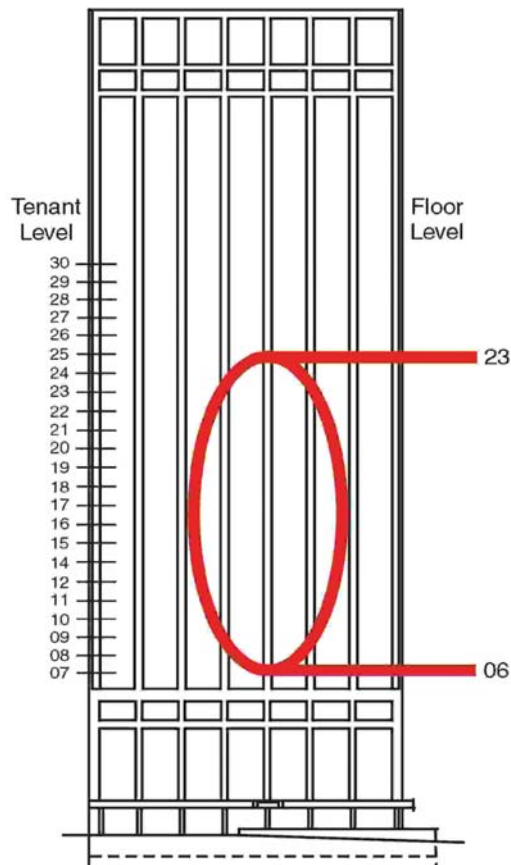
The façade of the building consists of windows and a lightweight cladding system. A sketch of the northern façade badly damaged by falling debris is presented in Figure 3. The elliptical line in the figure identifies the zone of damage to the façade of the building, where TL denotes “tenant level.”

Figure 3. Sketch of northern façade showing the zone of damage.

on both of these faces of the building but the damage on the western face was confined to a one-bay width between lines 7 and 8. The cladding to corner column A8 was lost between the ground and tenant level 5 and between tenant level 9 and 12.

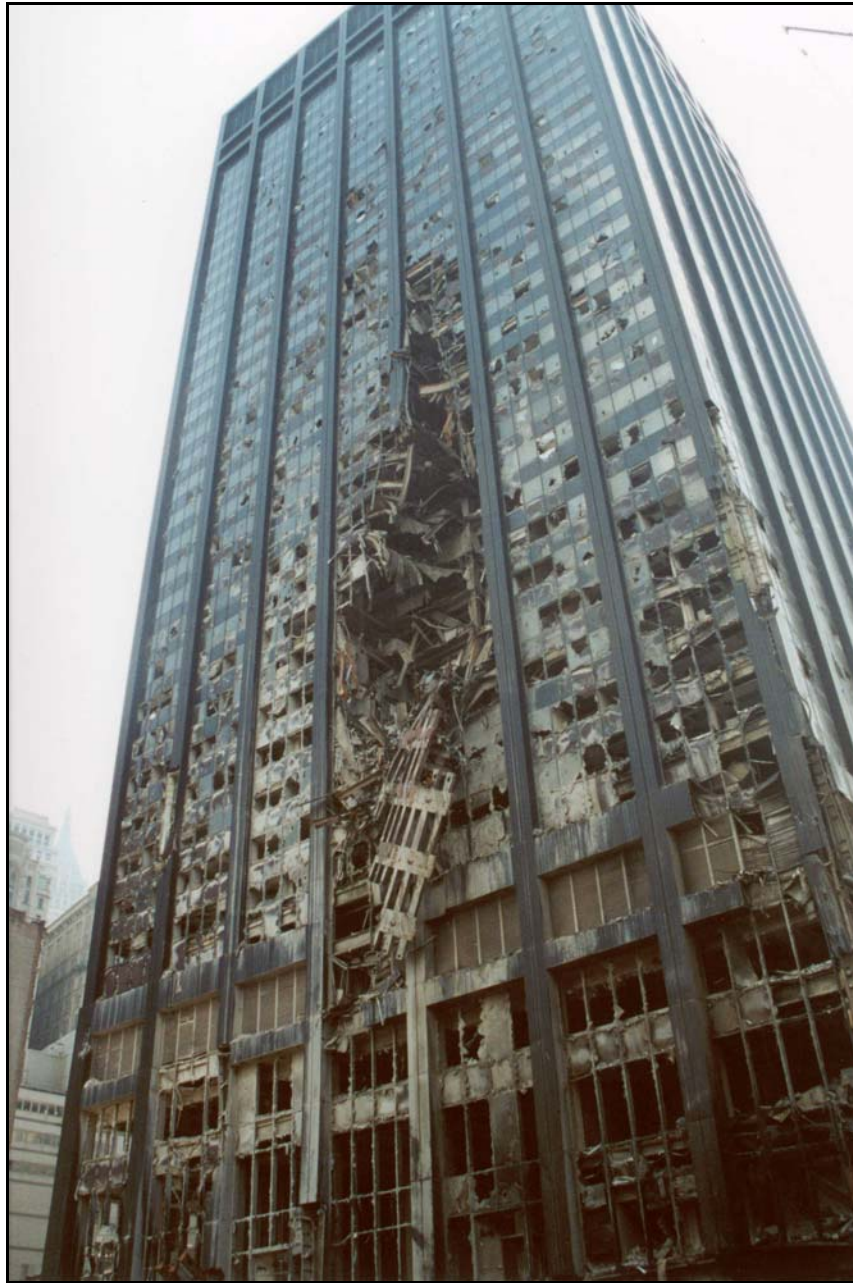
The visit of September 21 involved an exterior inspection of the building from ground level as part of a broader survey reported elsewhere (Bruneau et al., 2002). Figure 4 presents four photographs of the building taken on September 21, 2001. Part a. is a view of the northern façade showing the large gash in the exterior wall caused by falling debris that was ejected from tower 2 as it collapsed. One large piece of the façade of tower 2 can be seen in this figure at approximately the 9th floor level. It is highly likely that this three-story-high piece of debris caused much of the damage that is evident above the 9th floor. Clearly seen in this figure is the loss of a column on line D (see Figure 2) between tenant level 7 and tenant level 25.

Figure 4a. *Damage to the 130 Liberty Plaza building from the exterior—view of northern façade.*

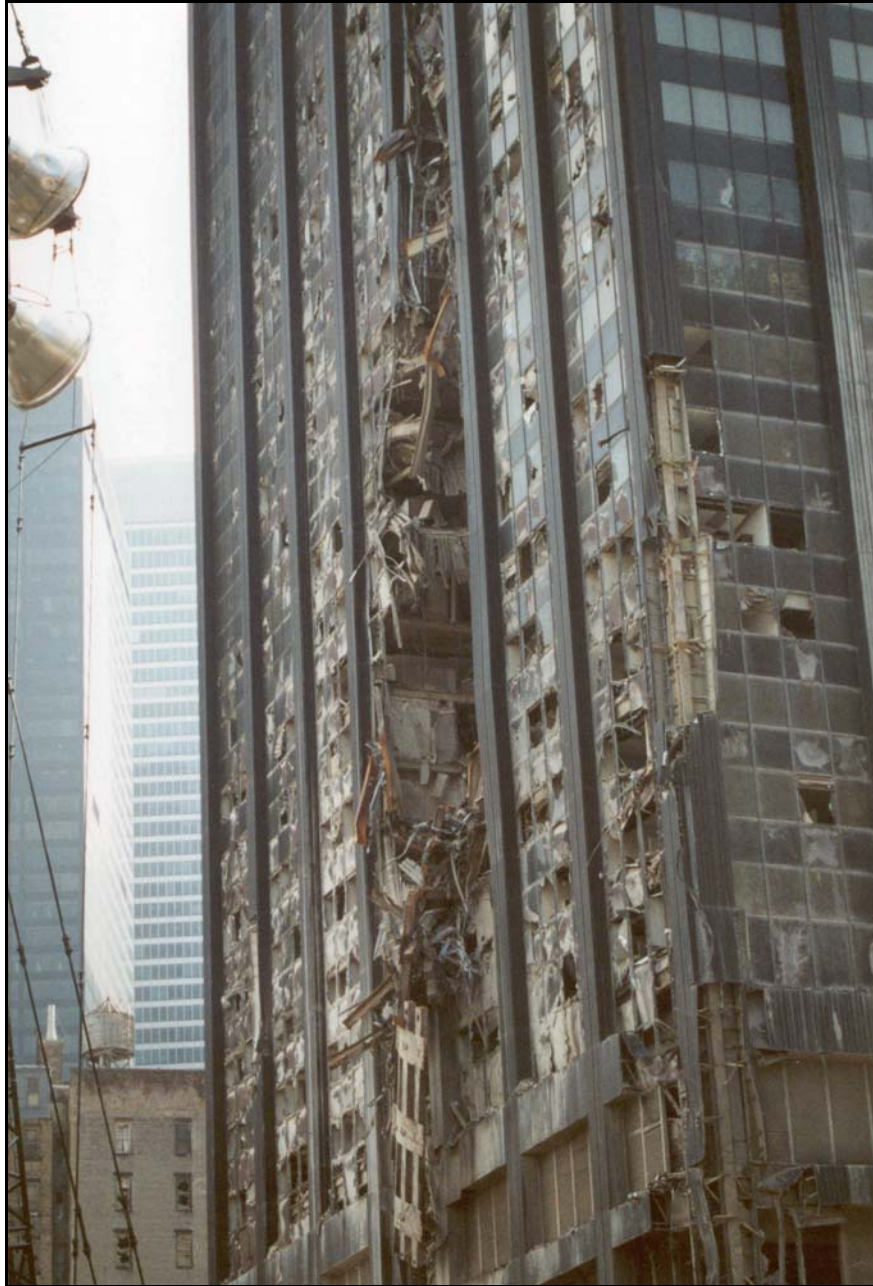
Part b of Figure 4 shows damage to the northern and western faces of the building. Windows were broken

Figure 4b. Damage to the 130 Liberty Plaza building from the exterior—view of northern and western facades.

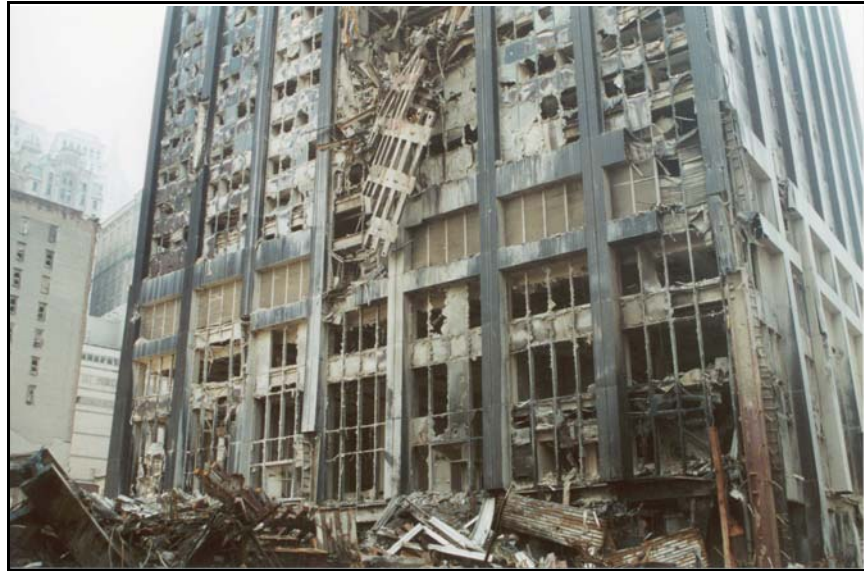
Parts c and d of Figure 4 show damage to the lower levels of the building on its north face. Burning debris ignited small fires in the lower levels of the building but these fires appear to have been confined to the perimeter of the building. Most of the windows in the lower levels, especially below the mechanical plant room at the 5th floor, were broken but it is not known how many of these windows were broken deliberately by the rescue teams to eliminate falling glazing hazards to the rescue workers operating to

Figure 4c. Damage to the 130 Liberty Plaza building from the exterior—view of lower 10 stories of northern façade.

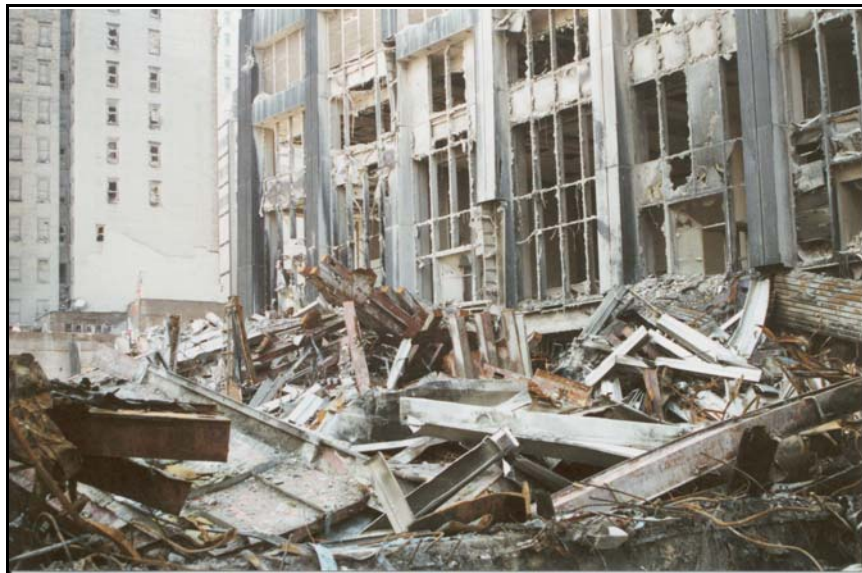
Figure 4d. Damage to the 130 Liberty Plaza building from the exterior—damage to northern façade at the entry level.

the immediate south of tower 2. Part d shows the debris pile just north of the building, 10 days after the attacks. Much of the debris was from tower 2.

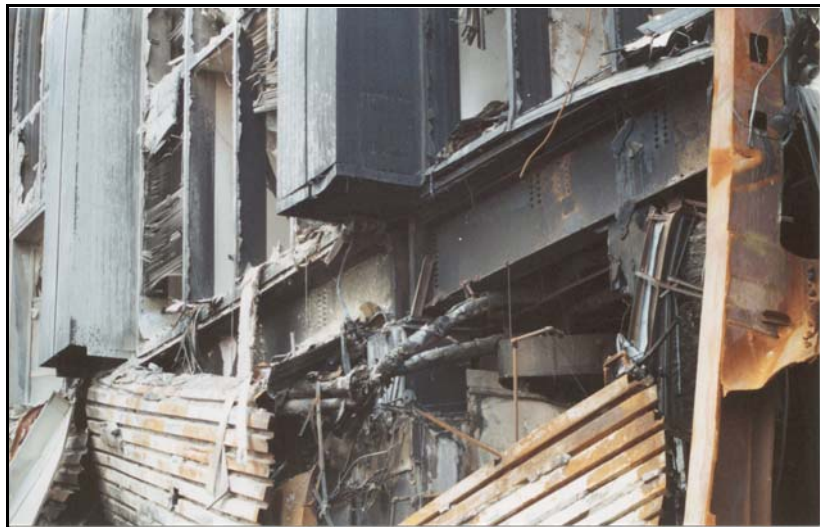
Figure 5 presents information on the moment-resisting connections used in the building. Part a of the figure shows fire damage to the lower framing, a cover-plated moment connection of the beam to the column, and the connections used to join the steel floor beams to the perimeter girders. No spray-on fireproofing is evident on the side or bottom of the perimeter beam although it may have been knocked off upon impact. Façade construction details can be clearly seen in this figure. Part b of the figure shows a typical beam-column moment connection on the western face of the building. Cover plates are clearly visible in this connection and damaged (or incomplete) fireproofing can be seen on the exterior face (web) of the perimeter beam.

Figure 5a. Exposed steel moment framing in the first story of the building—first story of northern face.

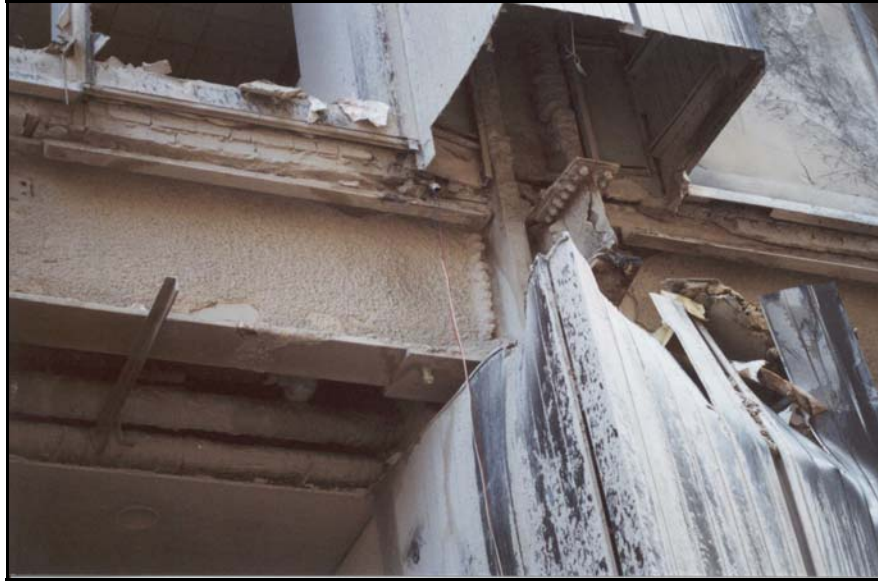
Figure 5b. Exposed steel moment framing in the first story of the building—first story of the western face.

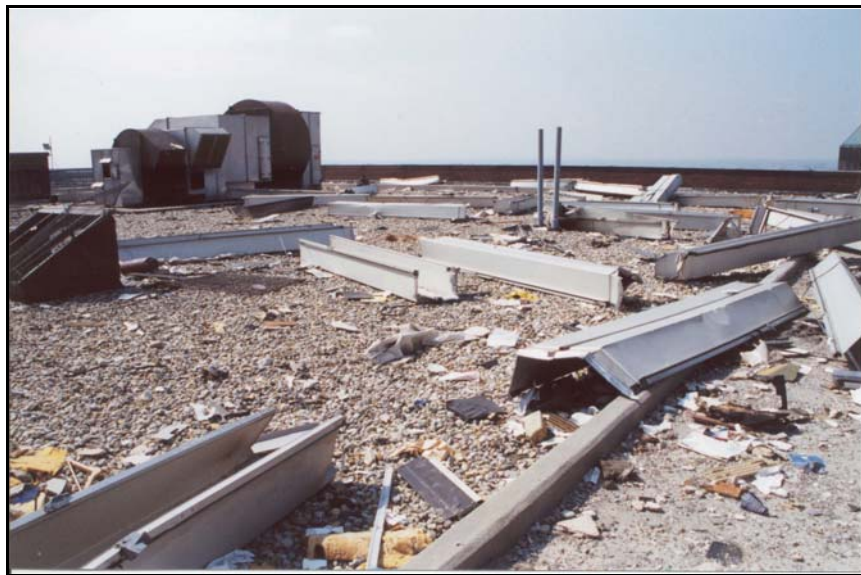
Figure 6b. Debris at the roof level of 130 Liberty Plaza—
photograph looking west.

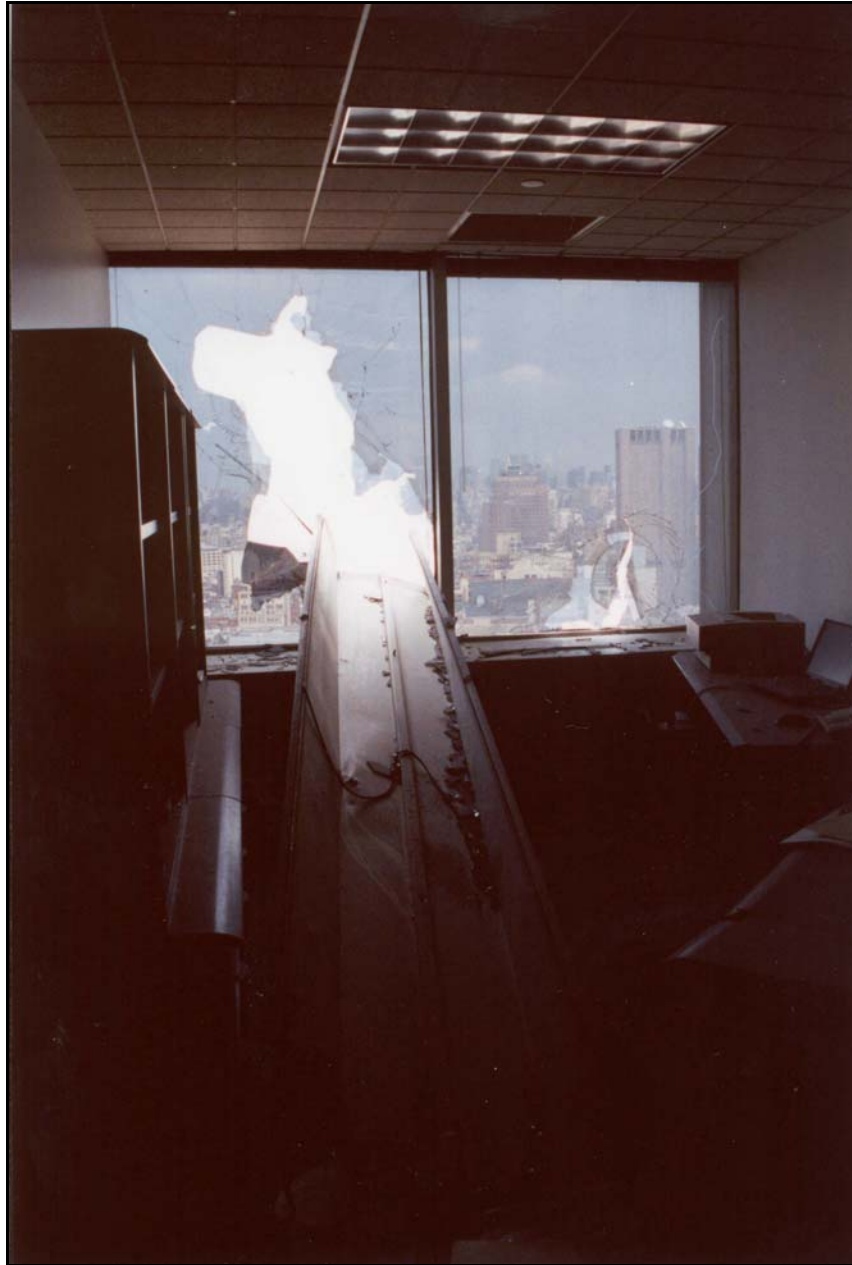
Figure 7a. Office space damage above tenant level 29 — penetration of tower 2 fascia piece.

Damage to the building above tenant level 29 was modest (relative to the damage below tenant level 25) and was limited to broken glass (caused by debris ejected from tower 2 as it collapsed). Figure 7 shows sample non-structural damage above tenant level 29. Part a of the figure shows damage caused by a section of fascia that was ejected from tower 2 and penetrated a window on the northern face of the building. Part b shows debris in a corner office at grid A8. The angle section lying atop the overturned chair in this figure penetrated the north-facing window of the building. (The hard hat and flashlight in the photograph belonged to the photographer.)

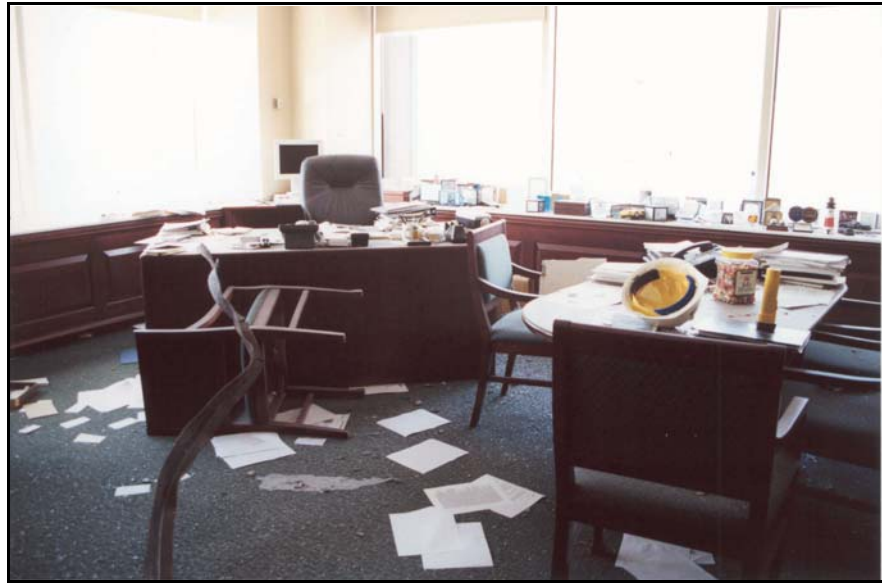
**Figure 7b. Office space damage above tenant level 29—
typical damage in office space.**

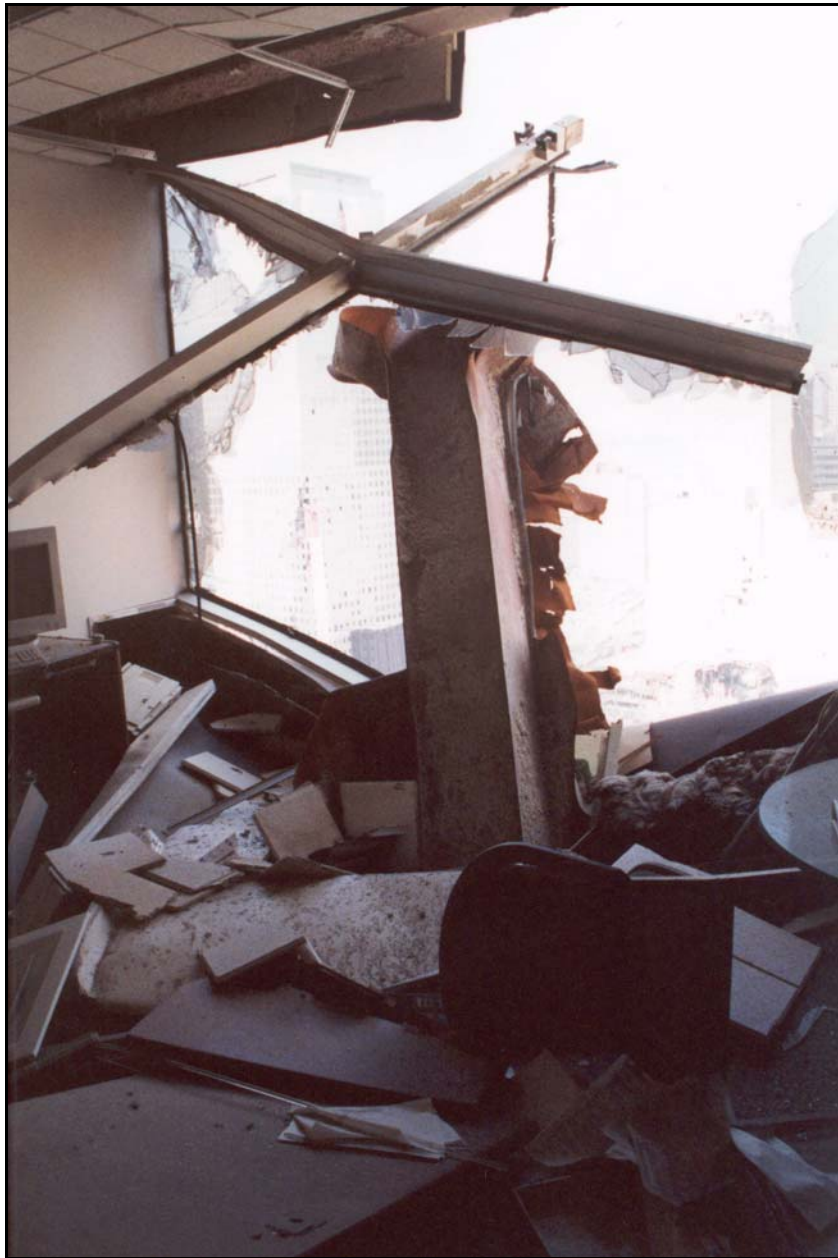
The first major structural damage was observed at tenant level 29 and was due to the impact of one single-story-tall structural steel column from tower 2. (As described in Bruneau et al. (2002), this column was one of three in a typical spandrel module, so the two steel beams linking the three columns were destroyed before the single column hit the 130 Liberty Plaza building.) Figure 8a is a sketch of a typical three-column module. Figure 8b shows the upper end of the column above Level 29. Figure 8c is a photograph of the underside of the column and the damage it caused to the ceiling system. It is noteworthy that the unreinforced slab on metal deck arrested the fall of this substantial steel member.

Figure 8b. Damage due to column-missile ejected from tower 2—upper end of column-missile above level 29.

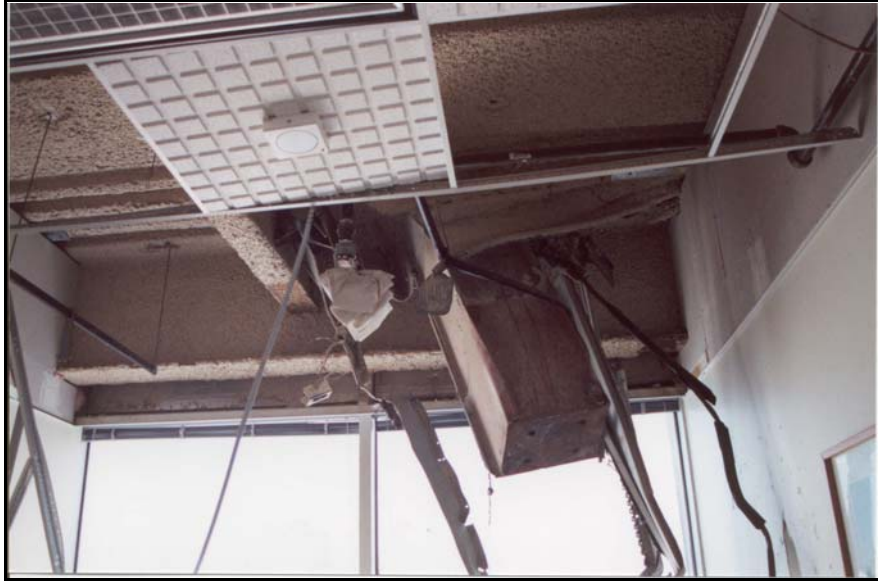
**Figure 8c. Damage due to column-missile ejected from tower 2—
Lower end of column-missile below level 29.**

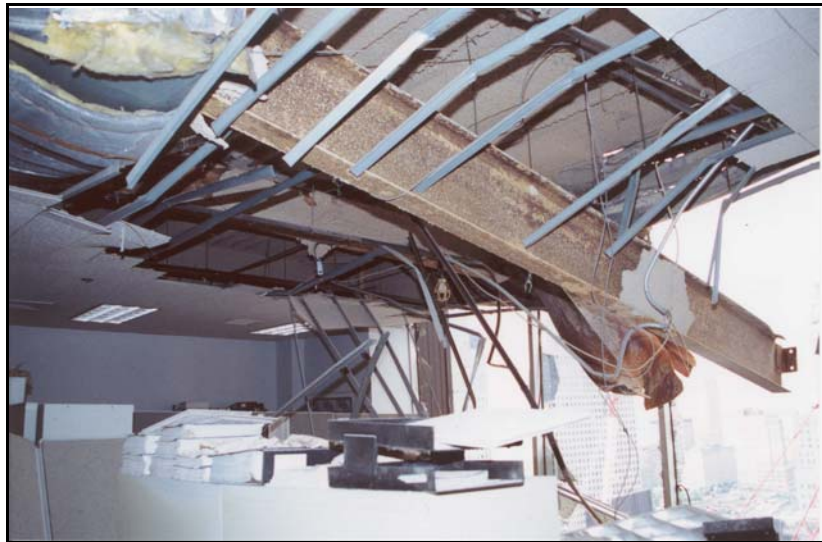
The degree of damage to the structural framing increased substantially below tenant level 26. Figure 9a shows a north-south spanning floor beam at the underside of tenant level 23 that has lost its support on line 8 due to the failure (loss) of the spandrel beam between lines D and E. Note the clean separation of the metal deck from the beam (made possible by the lack of studs joining the beam to the slab). Part b of the figure shows the underside of the floor slab at tenant level 22. At this level both north-south spanning floor beams were lost; the locations of these beams are marked by dark stripes on the underside of the metal decking. Of importance to the integrity of the floor system is the fact that the tenant level 22 slab at this location was able to span three times the distance assumed in design, namely, 26 feet, albeit with large deflections in the slab system. Part c of the figure shows a view of the slab of part b looking north-east. Part d of the figure is a view looking northeast of the underside of the slab at tenant level 21: a photograph taken from

Figure 9a. Interior damage at tenant levels 22 and 21—underside of level 23 slab looking northwest.

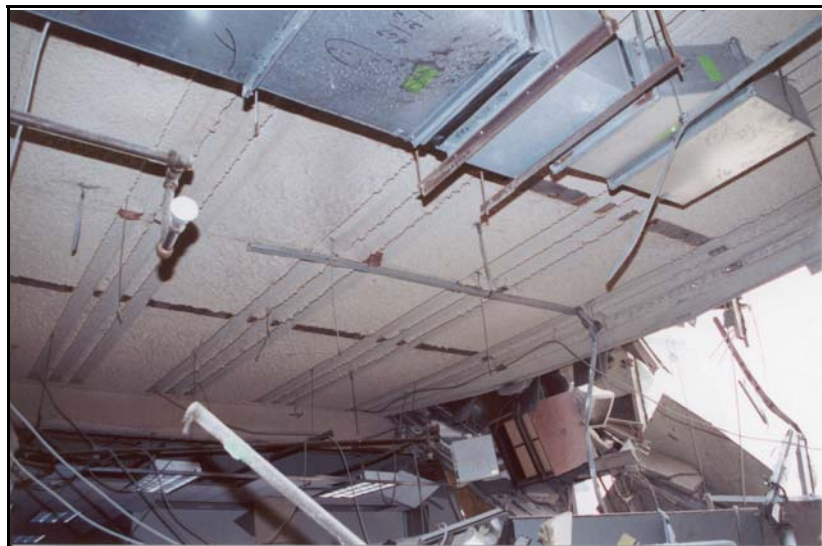
Figure 9b. Interior damage at tenant levels 22 and 21—underside of level 22 slab looking northwest.

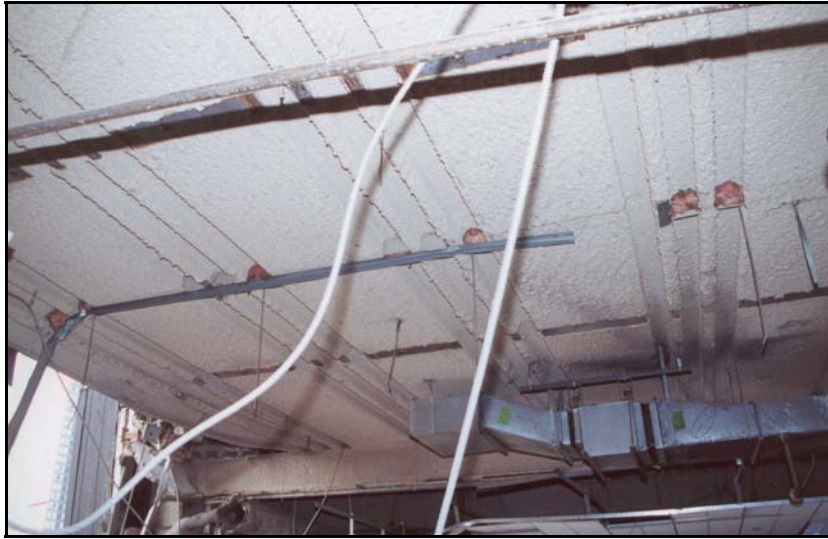
Figure 9c. Interior damage at tenant levels 22 and 21—underside of level 22 slab looking northeast.

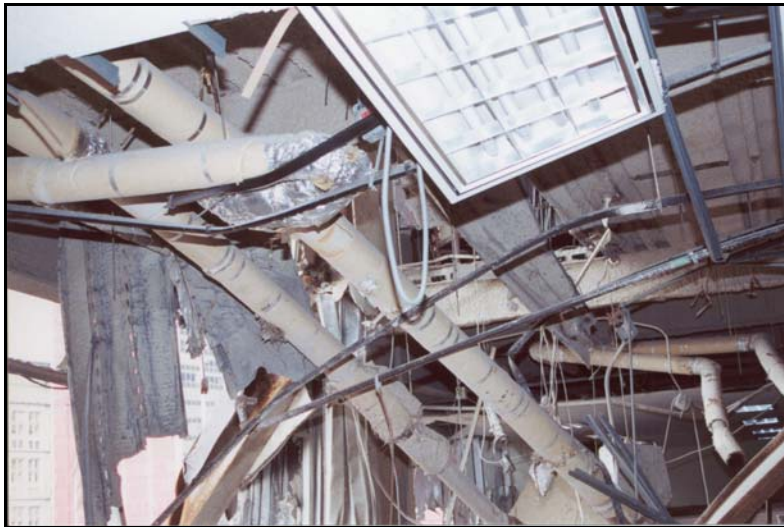
Figure 9d. Interior damage at tenant levels 22 and 21—underside of level 21 slab looking northeast.

approximately the same location as Figure 9c but one floor lower in the building. Fracture of the metal deck floor system at the line of the girder spanning north-south on line E can be seen in part d of the figure together with gross distortion of two steel floor beams spanning north-south to the (lost) spandrel.

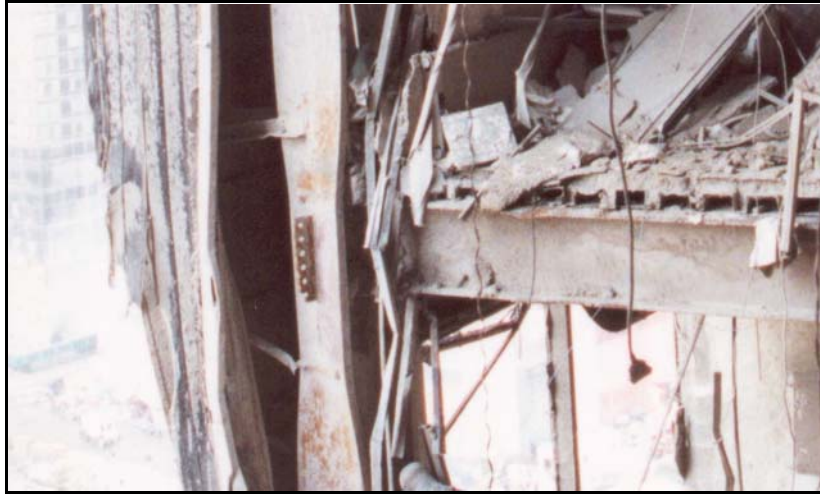
Figure 10 shows the remnants of a moment-resisting connection as photographed from tenant level 19 in the building. The fractured flange connections and the welded web tab are clearly visible. Part b of the figure is a photograph taken from the same location as the photograph of part a but looking towards the north-south spanning girder on line C. The World Financial Center and Winter Garden can be seen in the background of this photograph. Figure 10c is a view of two stories of framing along line D. Note the distortion in the column flanges at the level of the beam-to-column connection and that the metal decking fractured cleanly along a butt (noncontinuous) joint atop the girder on line D. Large deflections in the floor framing are not seen in this figure. Part d of the figure shows the fractured column on line D at approximately three feet above tenant level 18, immediately below the bottom of the framing shown in part c of the figure. The rubble pile at the base of tower 2 can be seen in the bottom of the Figure 10d.

Figure 10a. Interior damage photographs from tenant level 19—
failed moment connection at grid D8.

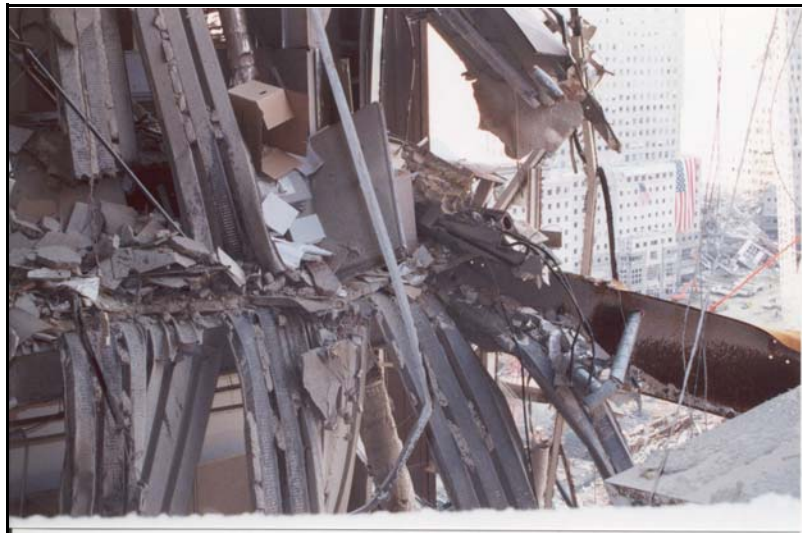
Figure 10b. Interior damage photographs from tenant level 19—
floor framing on line 8 between lines C and D.

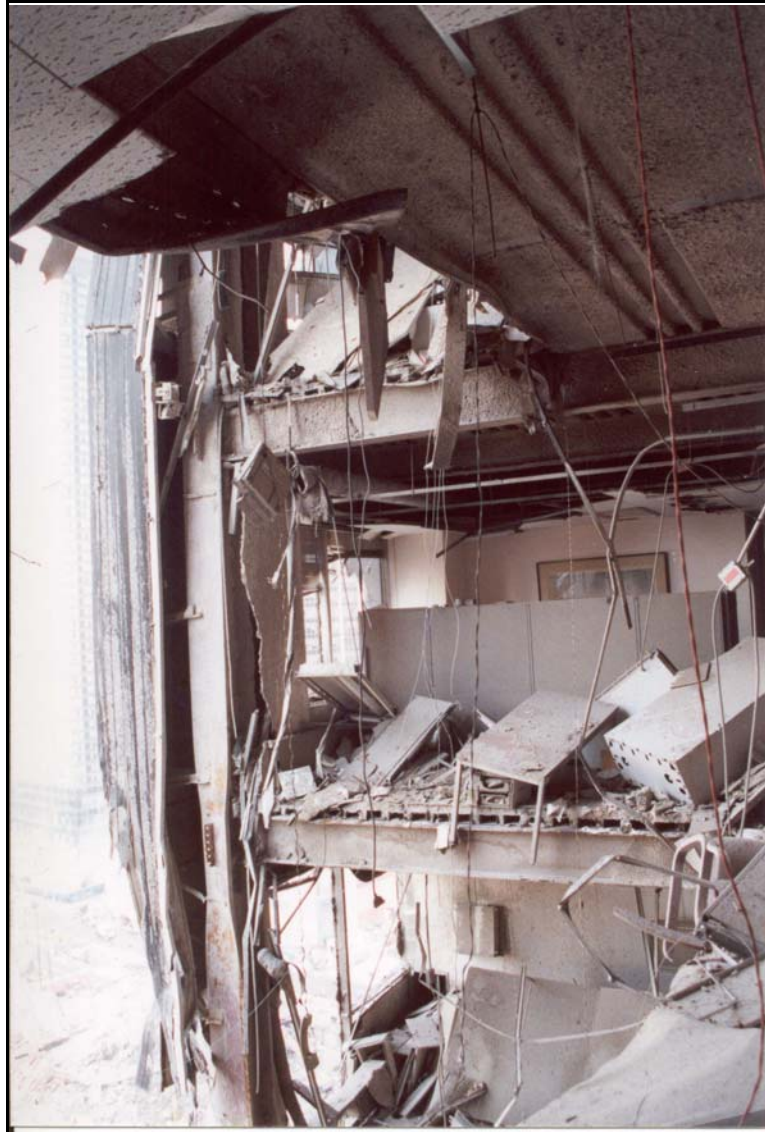
***Figure 10c. Interior damage photographs from tenant level 19—
damaged framing at levels 19 and 20.***

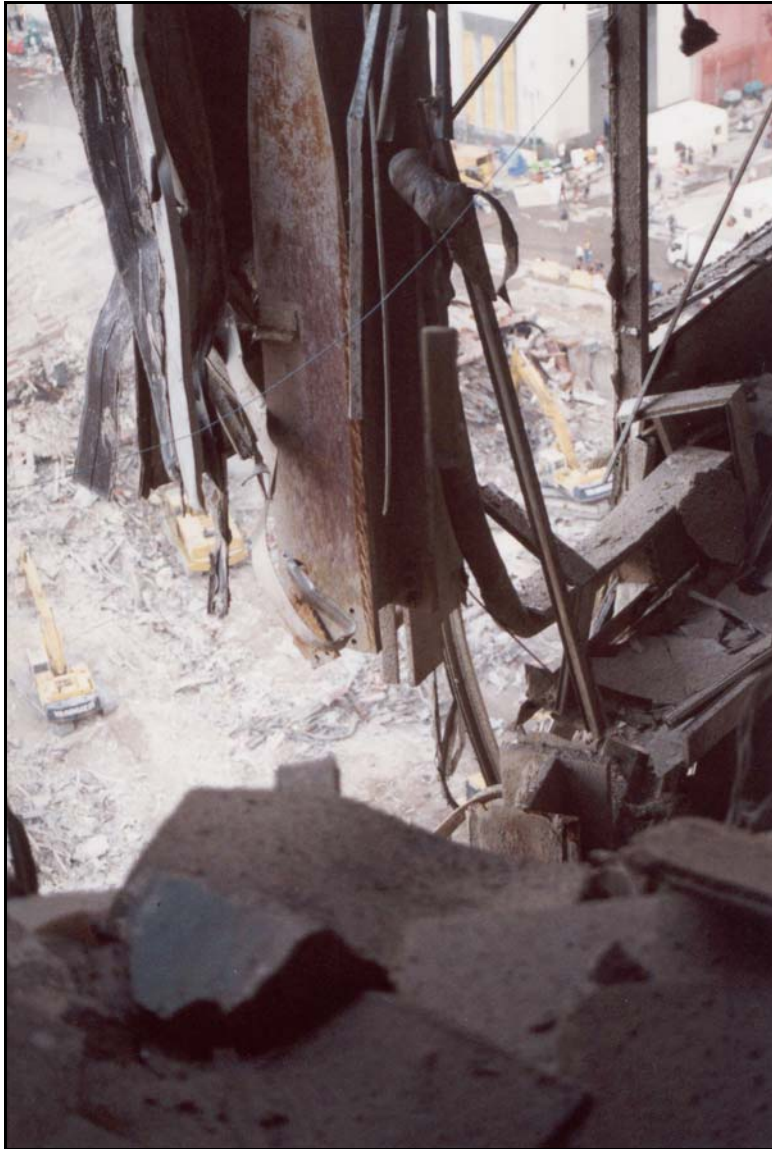
*Figure 10d. Interior damage photographs from tenant level 19—
failed column immediately above level 18.*

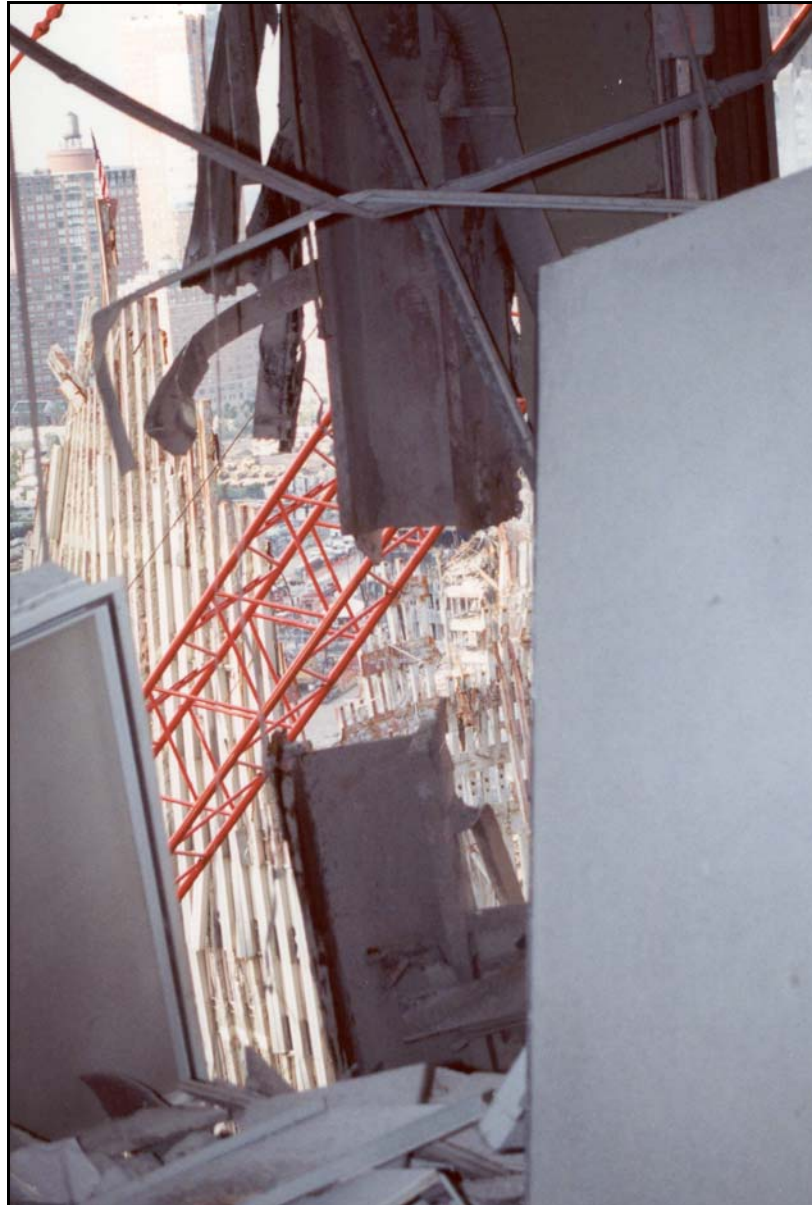
Figures 11a and 11b are photographs of the fractured column on line D taken from tenant levels 18 and 17, respectively. The façade of tower 2 can be seen in the background of part a of the figure and World Trade Center 4 can be seen in the background of part b of the figure.

Figure 11a. *Fractured column on line D from tenant levels 18 and 17—view at level 18.*

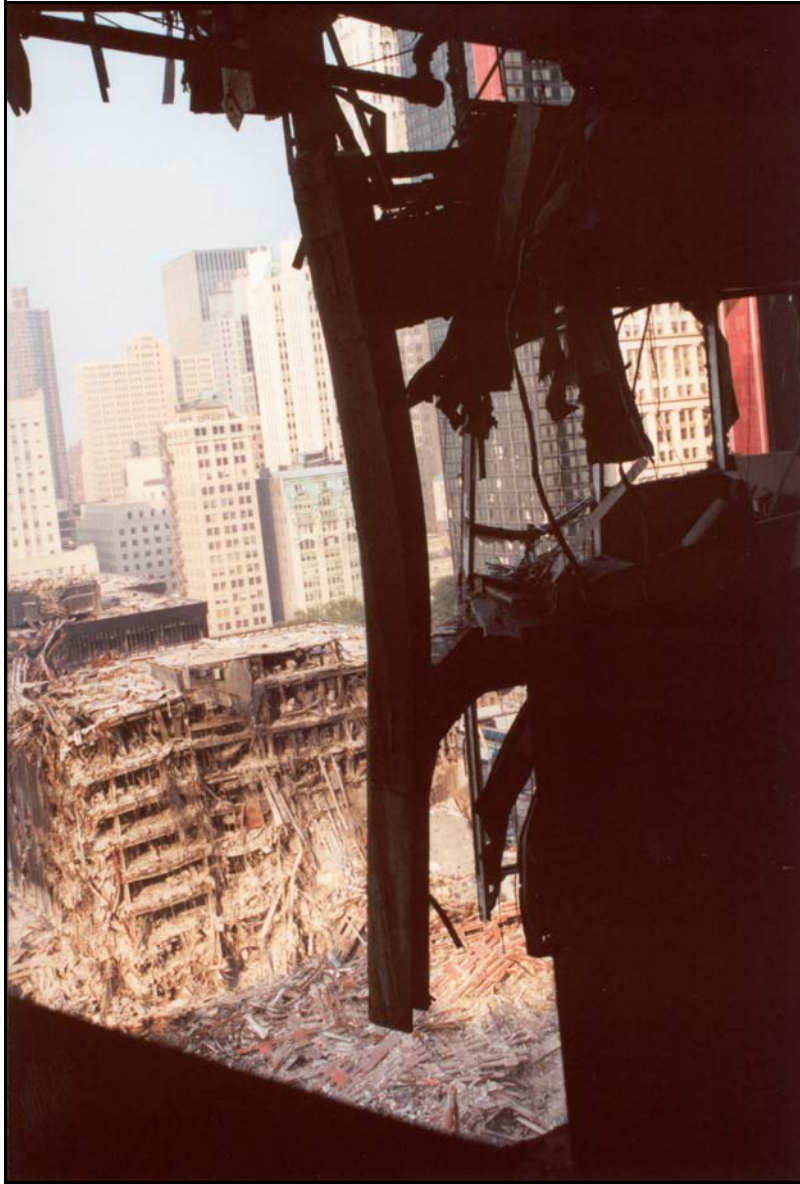
Figure 11b. Fractured column on line D from tenant levels 18 and 17—view at level 17.

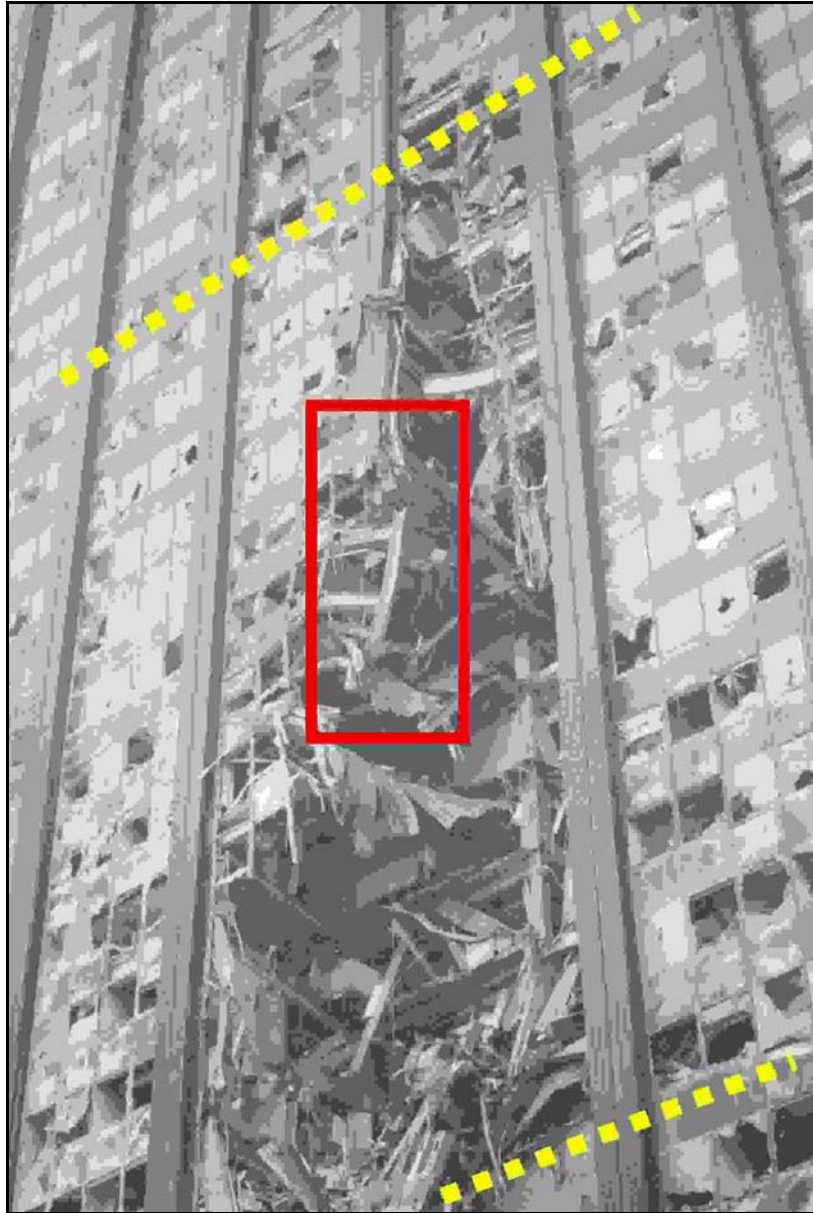
Figure 12 presents two photographs taken from outside the building looking toward the damage zone described in the previous pages. The box superimposed on Figure 12a shows the column of Figure 11. The fracture evident in Figure 11a is located at the top of the box. The distorted but intact two-story section of column seen in Figure 11b is located in the center of the box. In Figure 12a, the upper dashed line is at tenant level 25 and the lower dashed line is at tenant level 7. The dashed line in Figure 12b corresponds to the lower dashed line of Figure 12a. The large piece of debris that likely caused most of the damage above tenant level 10 is seen in Figure 12b precariously attached to the façade of the building.

Figure 12a. Damage to the northern face of the building between tenant levels 23 and 10—view of damage zone between levels 23 and 10.

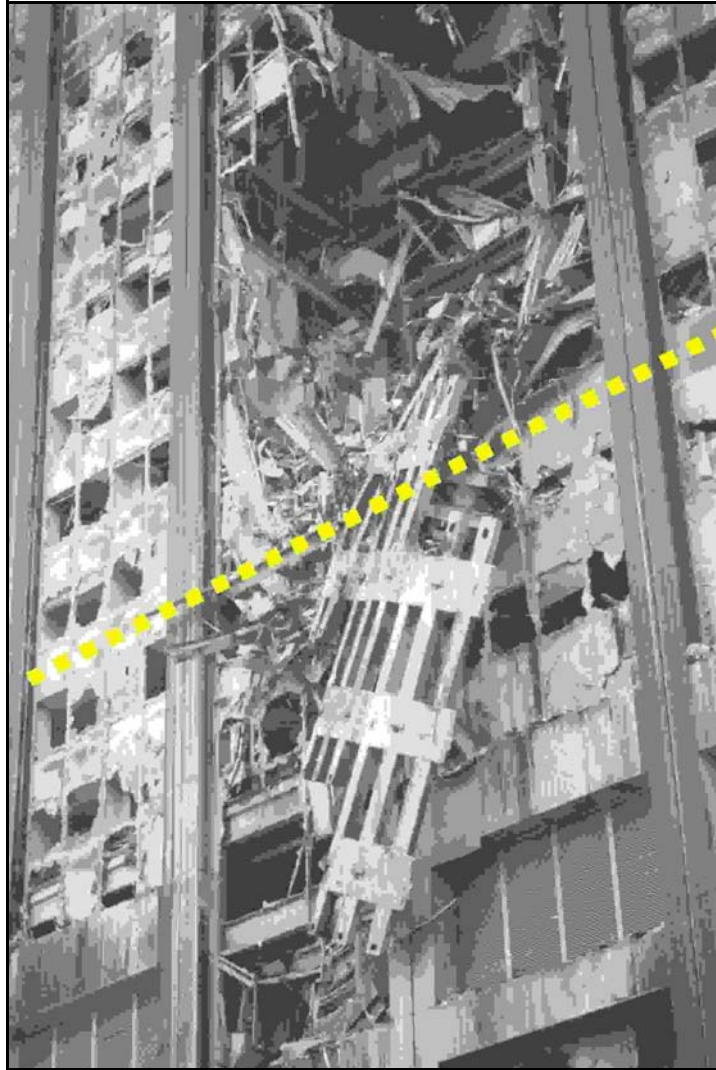
Figure 12b. Damage to the northern face of the building between tenant levels 23 and 10—view of damage zone adjacent to level 10.

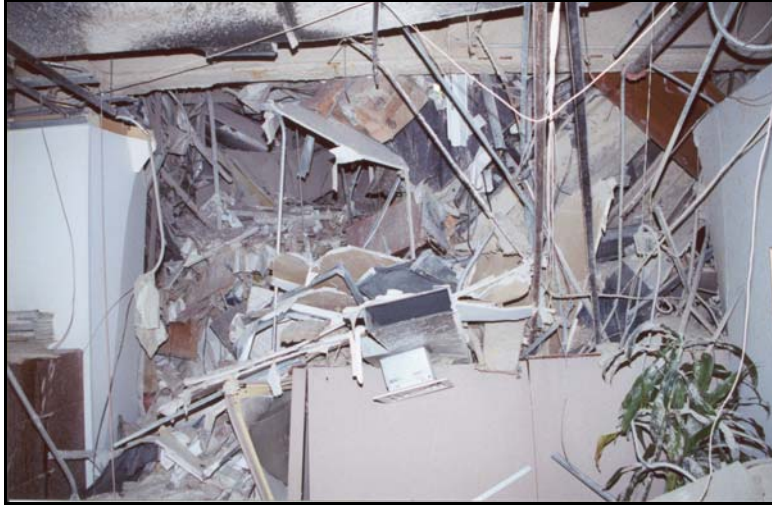
Figure 13 shows two photographs of damage at tenant level 9. Figure 13a shows the complete destruction of one zone of the floor immediately adjacent to the northern face of the building. Part b of the figure shows the interior face of the section of tower 2 façade seen in Figures 4a and 12b that caused much of the damage to the building.

**Figure 13a. Building damage at tenant level 9—
complete destruction of one zone of the building.**

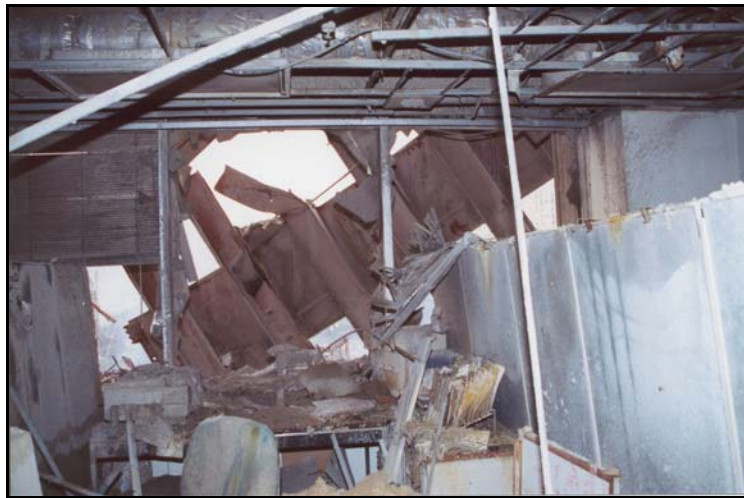
**Figure 13b. Building damage at tenant level 9—
view of inside face of tower 2 façade element.**

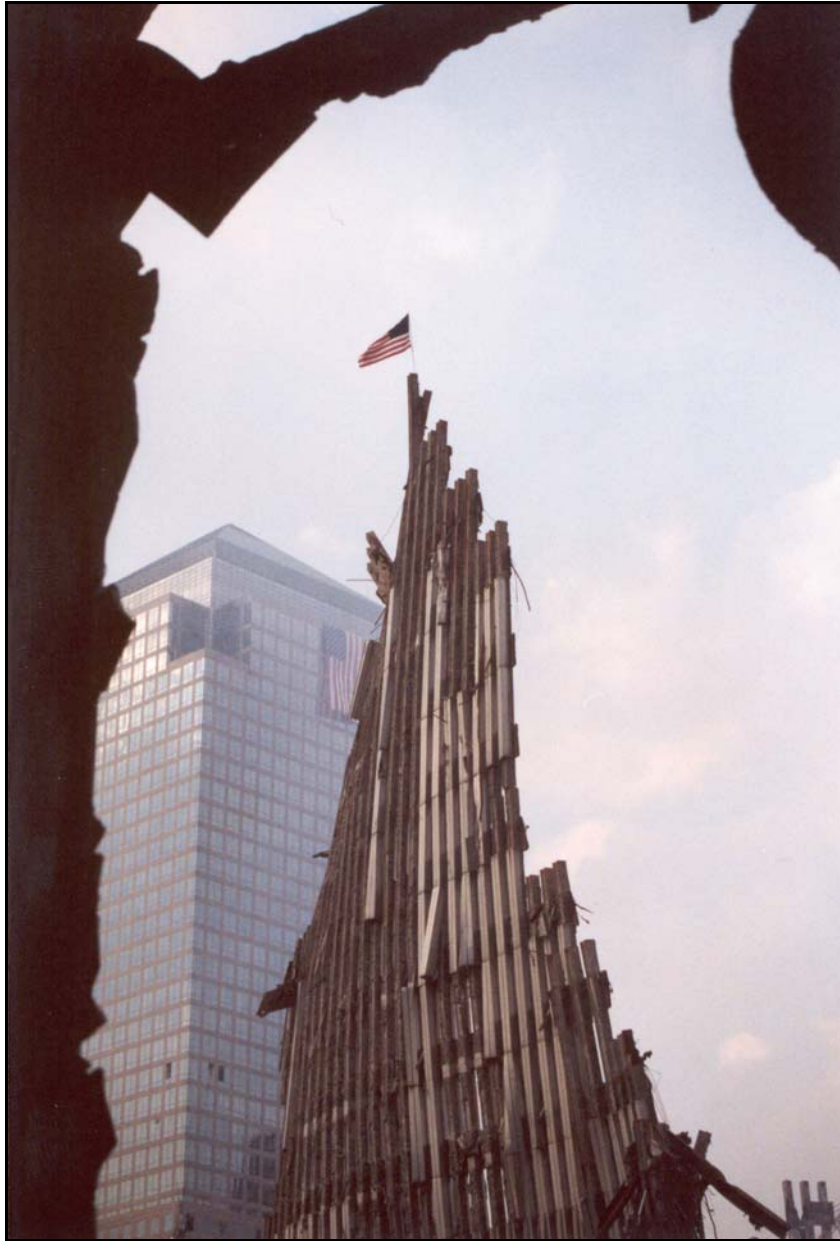
Structural damage below the mechanical plant rooms that were located below tenant level 9 was modest and no photographs were taken at the levels between tenant level 9 and the entryway to the building. Figure 14 is a photograph taken inside the building looking north towards a standing section of the tower 2 façade.

Figure 14. View of the tower 2 façade looking northwest from the foyer of the building.
