# MCEER NHRAIC RESPONSE

# COLLECTION OF SATELLITE-REFERENCED BUILDING DAMAGE INFORMATION IN THE AFTERMATH OF HURRICANE CHARLEY

***Beverley J. Adams, J. Arn Womble, Michael Z. Mio, John B. Turner, Kishor C. Mehta and Shubharoop Ghosh***

*ImageCat, Inc. and Texas Tech University, Wind Engineering Research (WISE) Center*

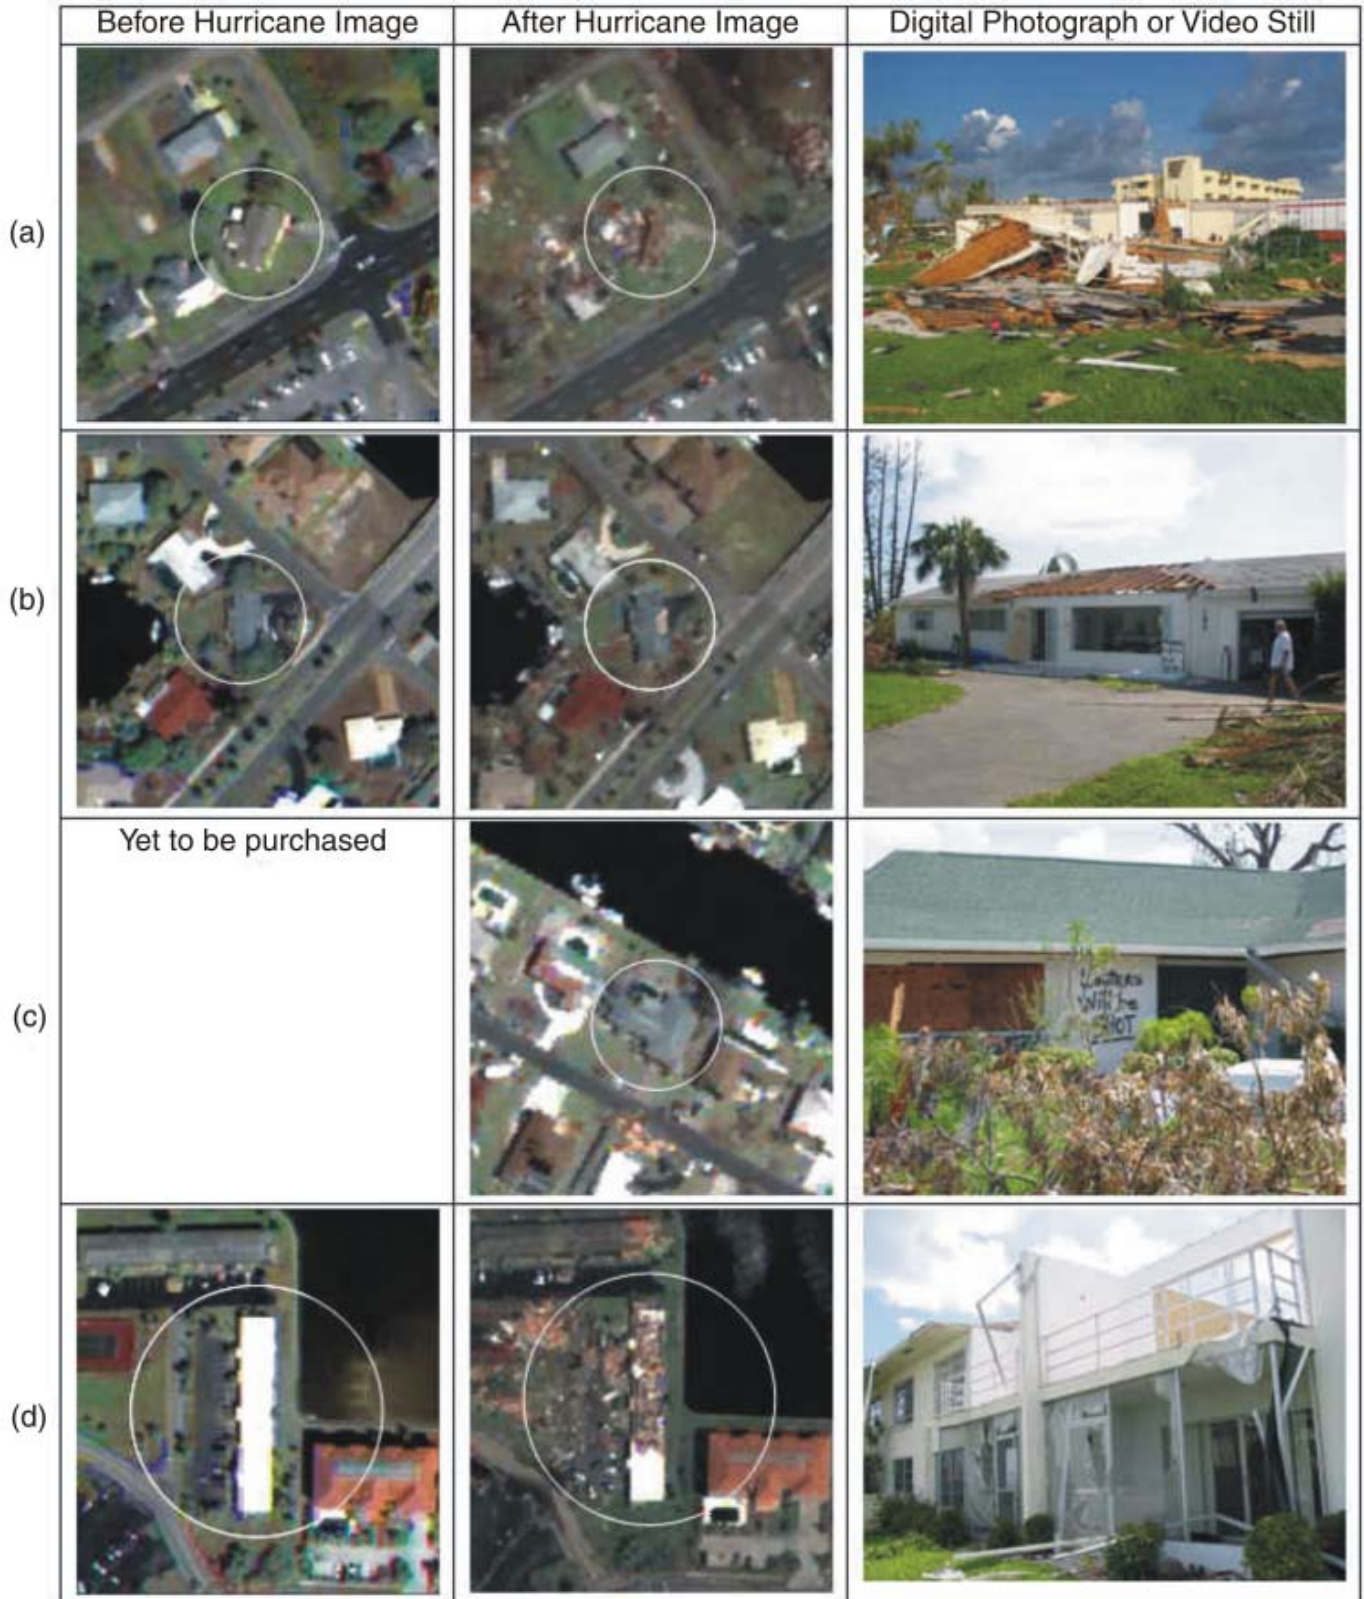
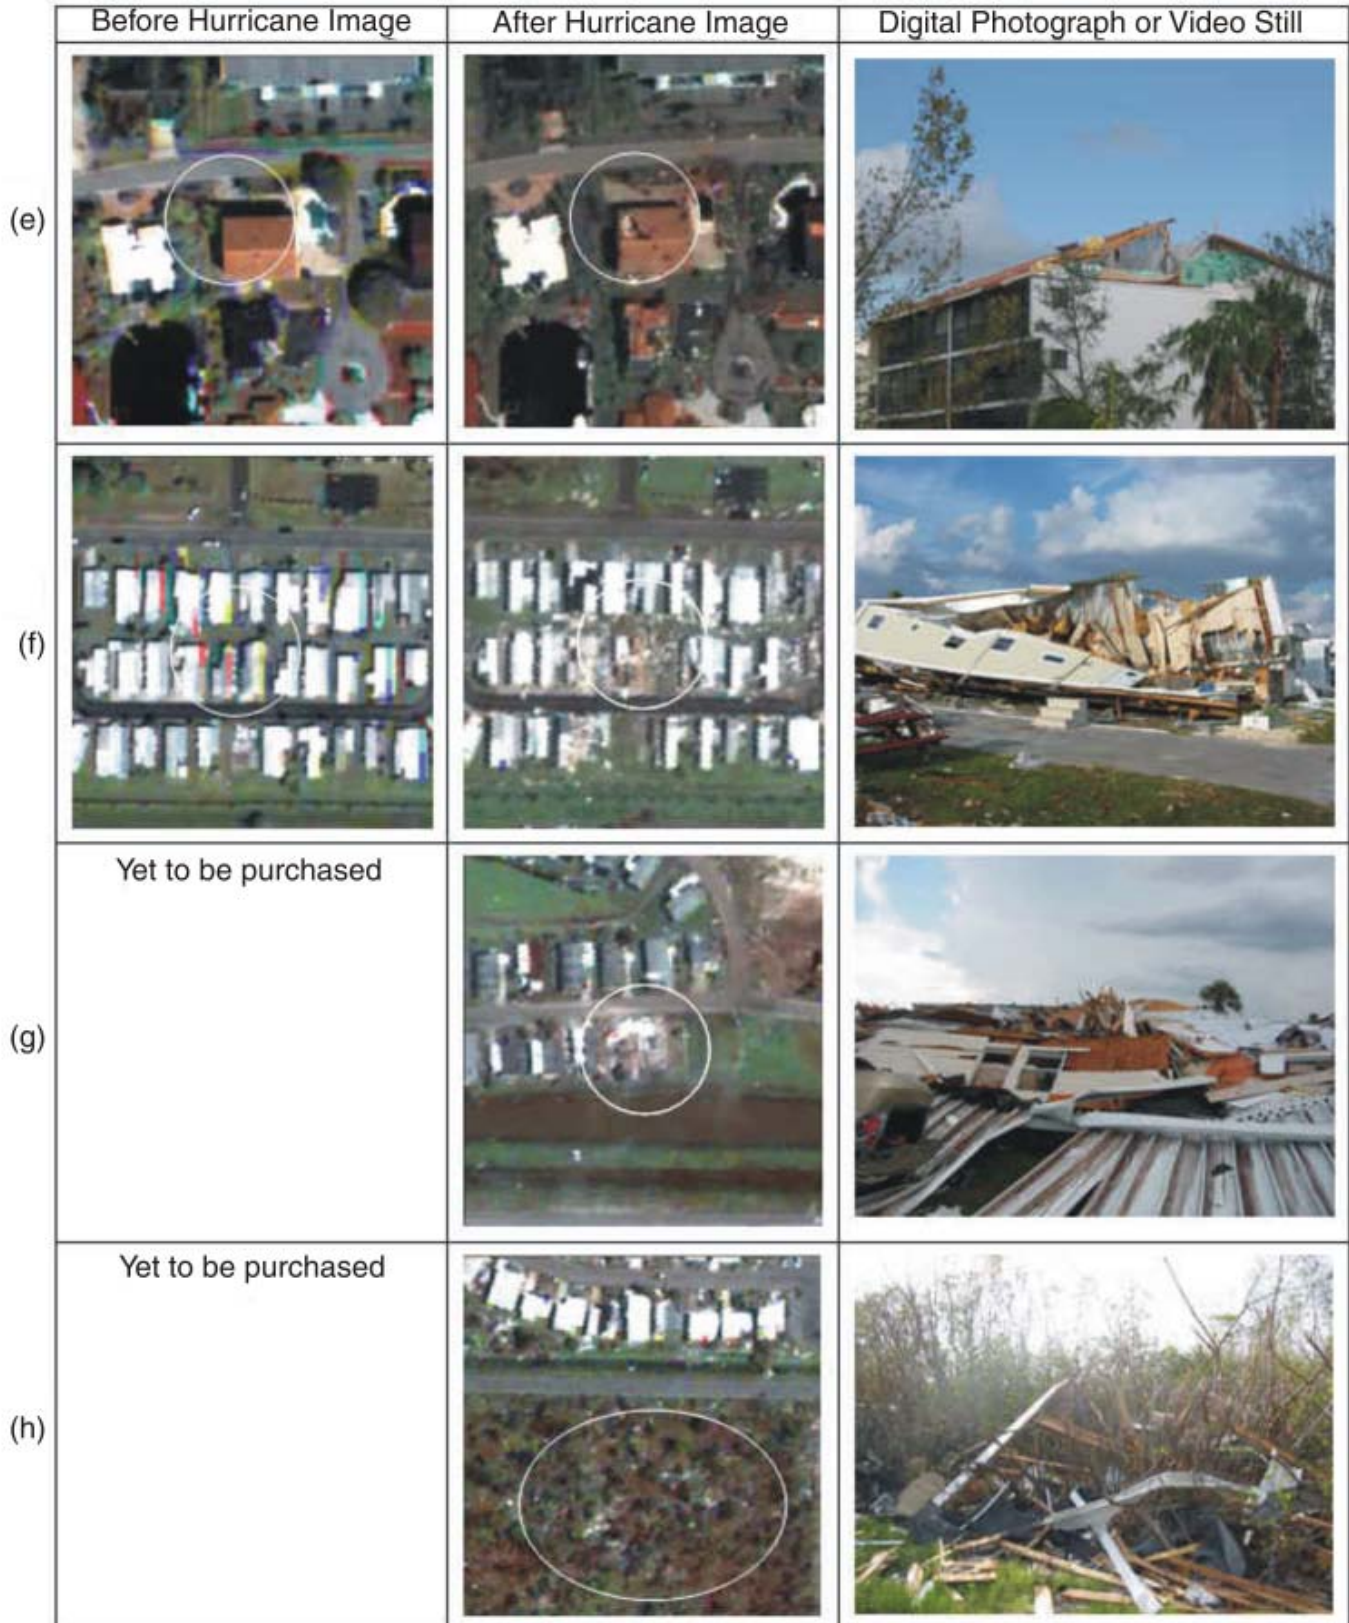
Three main types of residential structure were studied during the survey: (i) single family houses; (ii) apartment complexes; and (iii) mobile homes. For family houses, all levels of damage (see Table 2) were observed, ranging from complete failure of the roof structure (Figure 7a), through partial loss of the roof cover (e.g., tiles and asphalt shingles) and the wooden roof deck below (Figure 7b), to minimal removal of roof coverings (Figure 7c). Figure 7c also illustrates how looting was a major concern in the immediate aftermath of the event. Graffiti-style notices such as this were common throughout all neighborhoods, although in most cases this method was used

to convey the resident's insurance company and claim number. Although difficult to detect from the satellite imagery, damage to garage doors was prevalent and numerous cases of window failure were observed. Where present, wall failure was principally sustained by car ports and pool covers.

Apartment complexes also exhibited mixed performance during the hurricane. As was the case for family dwellings, damage ranged from failure of the roof structure (Figure 7d and Figure 7e) to cosmetic losses of roof covering. Residents' car shelters fared poorly during the storm, with many examples of mangled metal sheeting scattered across apartment parking lots. In many locations, scattered debris

Of the three residential categories, mobile homes sustained by far the highest degree of damage. The field team witnessed numerous examples where mobile homes had been turned into mangled piles of debris (Figure 7f). In some instances, mobile homes had been thrown onto adjacent structures, crushing them both (Figure 7g). Roof cover failure was commonly observed, together with the collapse of attached car ports. Debris from the mobile homes was often scattered across a wide geographic area, extending up to one kilometer from the source. In Figure 7h, highly reflective metallic debris from the

Figure 7. Photo mosaic of damage to residential structures in Port Charlotte and Punta Gorda. For family dwellings: (a) complete roof failure; (b) partial roof cover and roof deck failure; and (c) limited roof damage. For apartment blocks: (d-e) roof structure failure. For mobile homes: (f-g) catastrophic destruction; and (h) scattering of debris across an extended geographic area. For image/photo locations, see Figure 4.

mobile home park to the north of Van Buren Avenue in Port Charlotte, can be detected in nearby hedgerows and spread across fields to the south.

From a remote sensing perspective, Figure 7f and Figure 7g also illustrate the importance of acquiring both pre- and post-event satellite imagery; it is easier to determine the extent of damage in terms of change with respect to the non-damage scenario. When before imagery is unavailable (as for Figure 7g), interpretation relies on comparison with the appearance of surrounding structures. In the given example this method is also successful, since the degree of damage is high and the mobile homes no longer exhibit a 'normal' rectangular form. However, this approach may prove limited for lesser damage states.

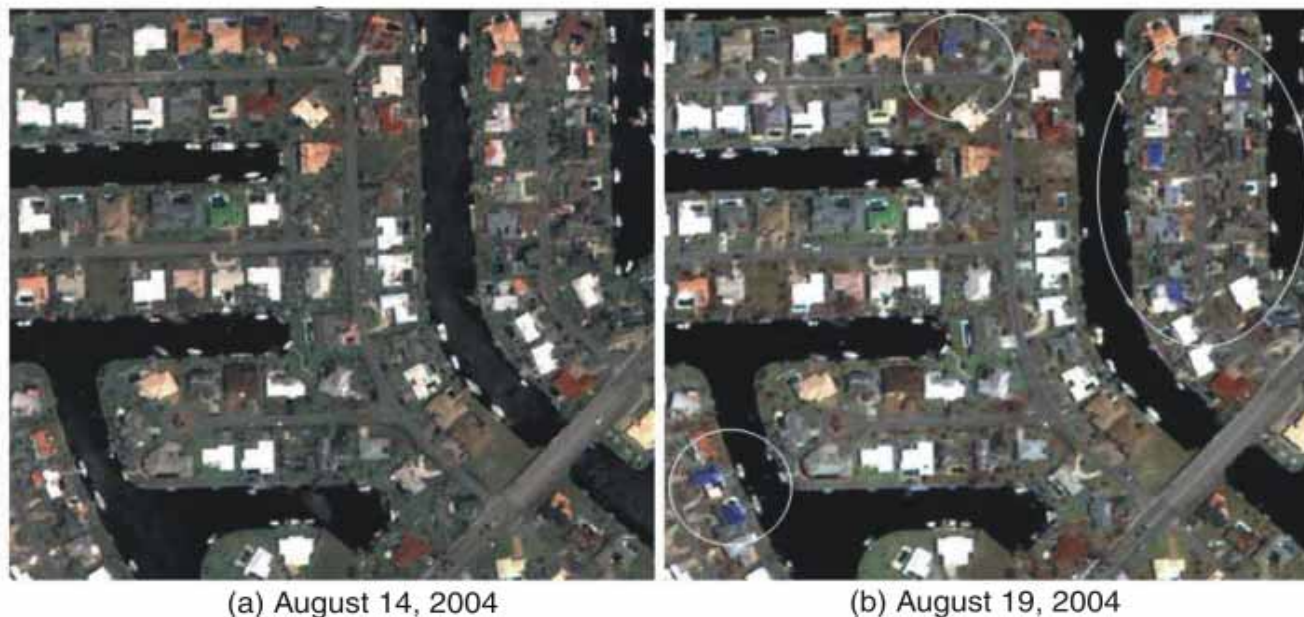
The perishable nature of post-disaster building damage data is borne out by differences to residential properties observed between the two field deployments and between the temporal sequence of 'after' satellite images (see Table 2). In the days immediately following the disaster, many damaged roofs remained exposed to the elements. During the initial field deployment, comparatively few

were tarped, and there was little evidence of repair. At this stage, residents appeared to be focusing on securing of personal effects and building contents and on the clearance of debris and vegetation. Temporary roof-covering materials may have also been in short supply in the local area immediately following the hurricane. During the second deployment, there was a substantial increase in the presence of tarps and plastic covers. This trend is apparent from the Quickbird satellite scenes in Figure 9, which were acquired 1- and 6-days after the hurricane struck. During the second field visit, workers were observed making permanent repairs to the roofs of family dwellings. However, recovery efforts were progressing far more slowly in the mobile homes, where in many cases, debris clearance was only just commencing. Many of the mobile home in these parks are apparently used as winter vacation homes by people living elsewhere, and thus many residents may not have been in the area at the time of the storm to make temporary repairs to their properties.

Figure 9. The perishable nature of building roof damage data is evident by comparing the Quickbird scenes acquired on: (a) August 14, 2004, 1 day after; and (b) August 19, 2004, 6 days after Hurricane Charley. In the latter case, a number of roofs are now tarped.

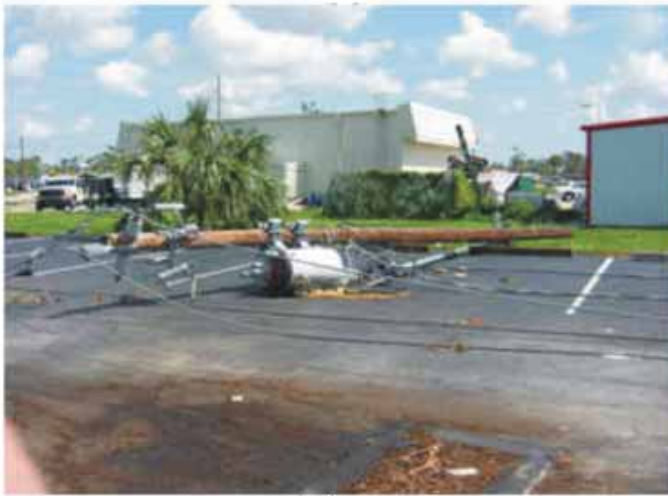
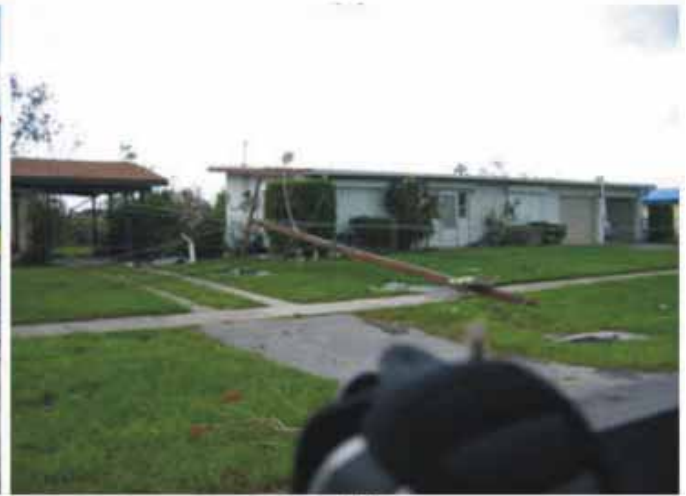
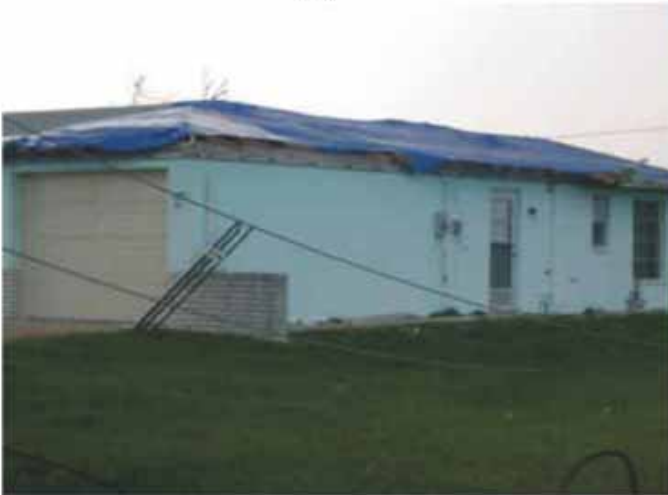
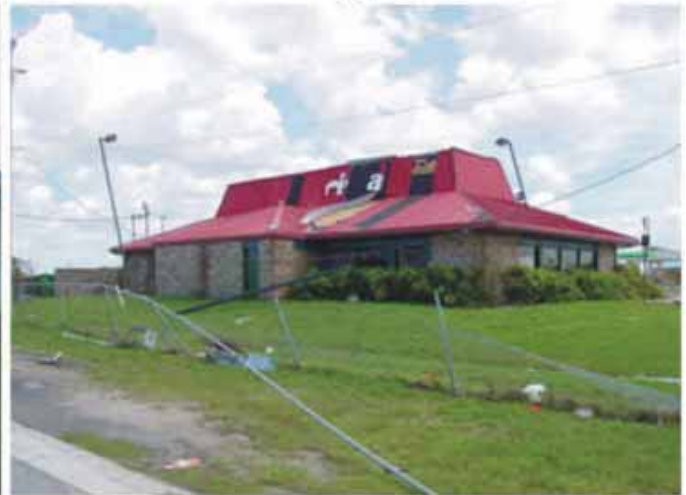
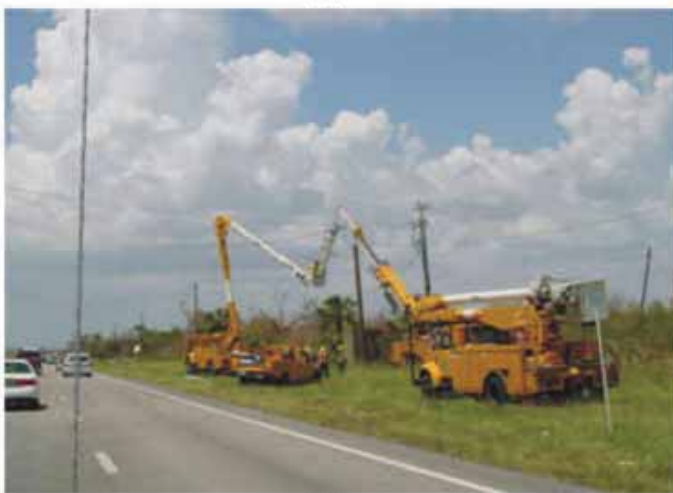
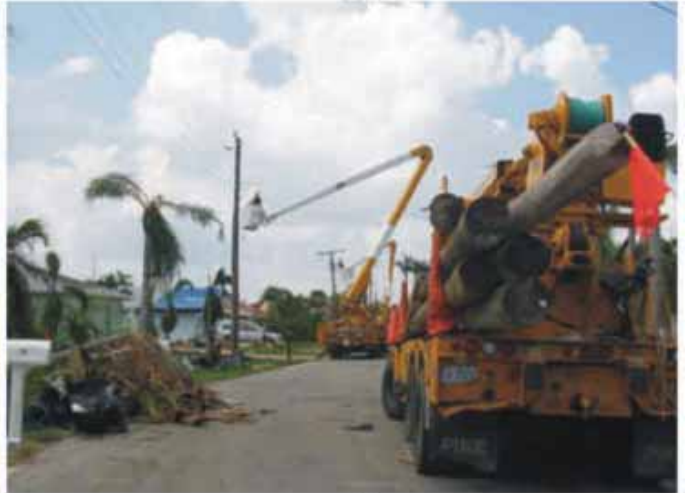
because stop lights were not working and the police were directing traffic. Damage to the supply system was severe (Figure 11a). Residential neighborhoods were hard hit, with power lines lying cross people's front yards (Figure 11b), several occurrences of power poles impacting roofs, and evidence of severed connections (Figure 11c). Most businesses in Port Charlotte and Punta Gorda were closed at this time (Figure 11d), since there was no power supply. When the field team returned on August 25, some businesses had re-opened along the major highways 175 and SR41. During the initial reconnaissance trip, a number of routes were obstructed by fallen power poles and power lines. For the second visit, roads instead were closed by repair teams (Figure 11e-f). At the present time, the manifestation of windstorm-related damage to the power system on high-resolution remote sensing imagery has yet to be explored. This remains a topic for future research.

Figure 11. Damage to the power system in Port Charlotte and Punta Gorda. Residential and commercial properties experienced loss of supply as power poles were toppled and lines severed. During the second field deployment, repairs were ongoing.
