The ShakeOut Scenario

Oil and Gas Pipelines

By
Donald Ballantyne
MMI Engineering, Inc.
Tacoma WA
May 2008

M7.8 Southern San Andreas Fault Earthquake Scenario: Oil and Gas Pipelines

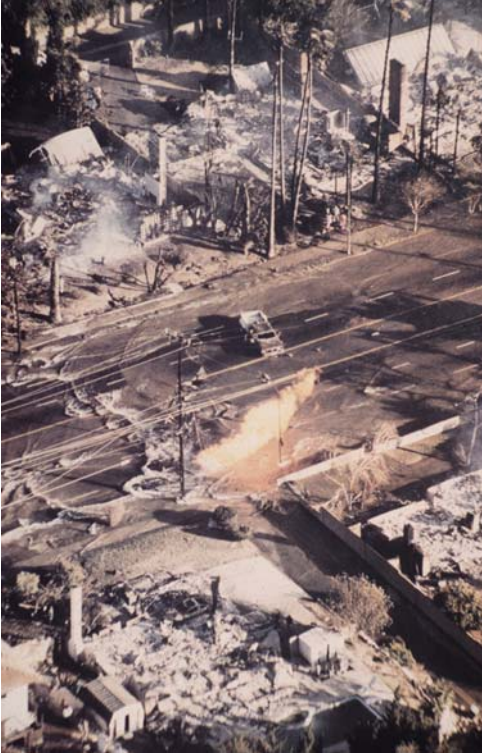
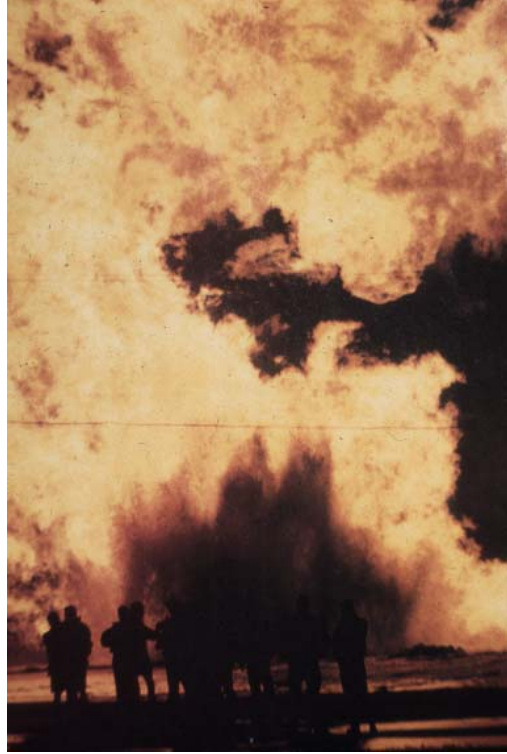
In the 1994 Northridge earthquake, there were 209 repairs required to metallic distribution lines, and 27 to polyethylene lines. There were 35 non-corrosion –related transmission pipeline repairs of which 27 occurred on pipe joint with oxy-acetylene girth welds in pre-1930 pipelines. At one of those failures, gas leaked from a failed 56-cm line on Balboa Boulevard and was ignited by the ignition system on a nearby truck (T. O'Rourke, 1994). The fire resulted in burning nearby houses (Figure 1).

Figure 1. Balboa Neighborhood Burned by Exploding Gas Line in Northridge Earthquake (left); Fire ball that Burned the Neighborhood.

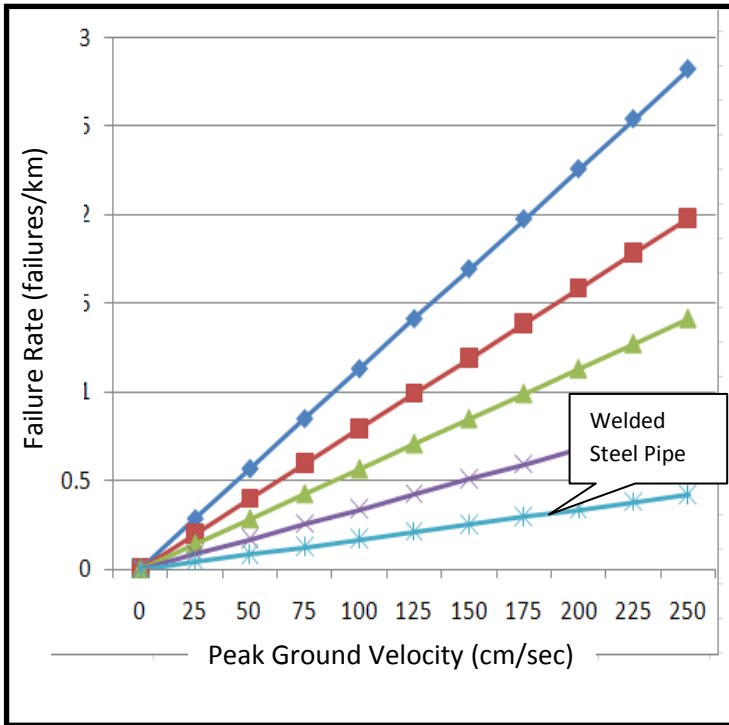
The most extreme shaking intensity in the study area is expected to be about 250 cm/second, located just north of Cajon Pass and in the Palm Dessert-Coachella area along the Kinder Morgan pipeline. For this level of shaking, the American Lifelines Alliance (2001) estimates failure rates on the order of 0.4/km for high quality welded steel pipelines (Figure 2). Pipelines in the San Bernardino and Palmdale areas would be expected to experience velocities of 150 to 200 cm/sec resulting in failure rates of 0.28/km for high quality electric arc joint welded pipe.

Figure 2. Wave Propagation Pipeline Fragility (After ALA 2001)

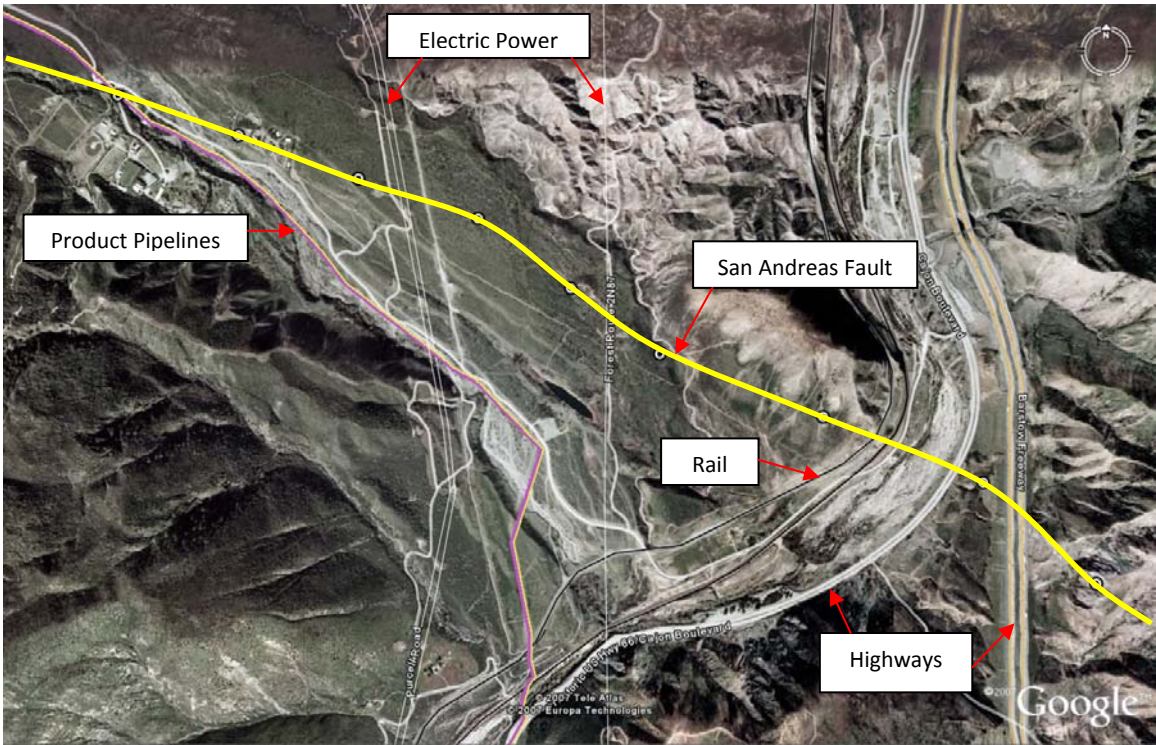
One of the two Southern California Gas transmission pipelines at Cajon Pass will rupture at the fault and explode (See Figure 3) resulting in a large crater (see Figure 4). The Southern California Gas pipeline-fault interface occurs where the pipeline intersects the CalNev 14-inch product pipeline, so when the explosion occurs the CalNev pipeline ruptures. The CalNev pipeline is transporting gasoline, so the gasoline adds to the fire (see Figure 5). Power transmission lines are overhead, and the fire reaches the lines causing them to fail.

Figure 3. Oil, Electric Power, Highway, and Railway Lifelines in Relationship to the San Andreas Fault at Cajon Pass (Natural Gas Pipelines Not Shown).

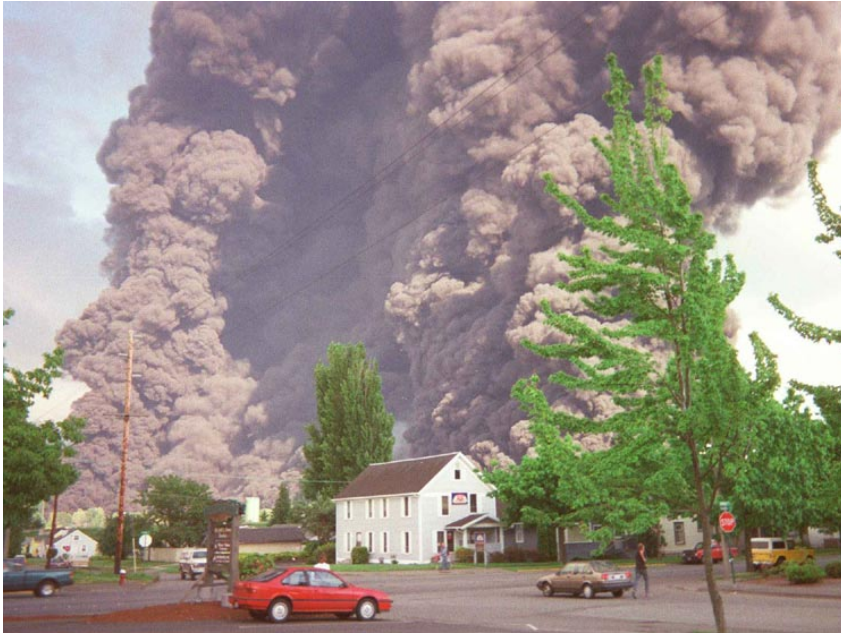
In Washington State, two high pressure gas transmission line failures occurred in 1997, both resulting from ground movement. Another failure occurred in 2003. One of the 1997 failures resulted in an explosion. In 1999, a pipeline carrying gasoline failed due to damage caused by a third party during construction on adjacent facilities. The pipeline failure resulted in discharging 277,000 gallons of product into a creek bed. In the ensuing fire, two boys burned to death, and one young man was killed after he was overcome by fumes.

Figure 5. Smoke Plume from 1999 Gasline Fire in Bellingham Washington resulting from Product Pipeline Failure due to Third Party damage. (Photo Credit – City of Bellingham)

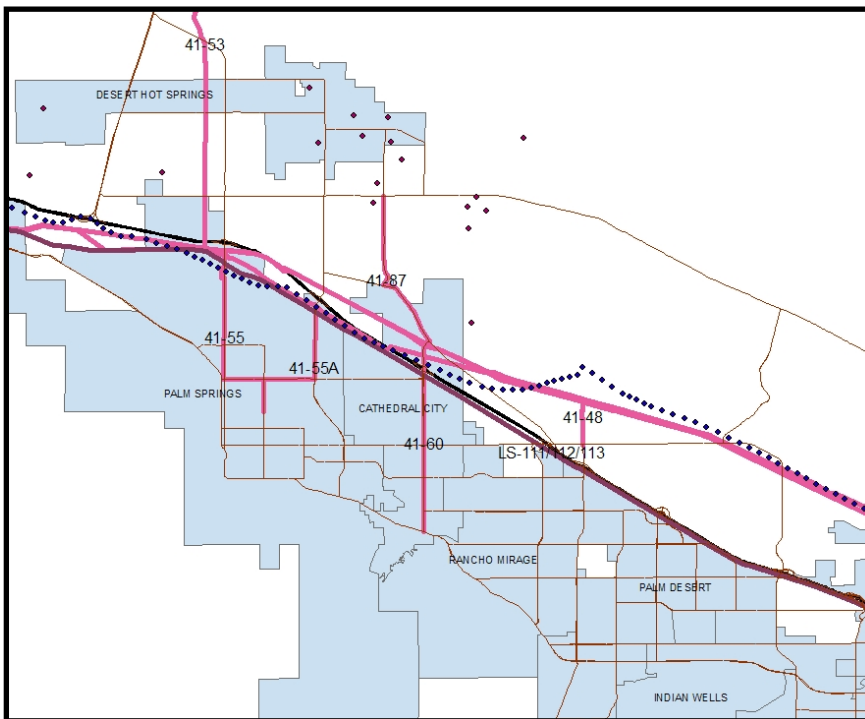
The 20-inch Kinder Morgan product line is ruptured in Palm Springs (Figure 6). The pipeline is aligned directly over the fault. When the earthquake occurs, the pipeline is shortened five meters causing it to wrinkle and rupture (Figure 7). The pipeline is carrying diesel which is sprayed into the air. Ultimately 200,000 gallons of product is discharged into the local drainage until the line can be isolated. A smaller natural gas distribution pipeline is located in the same right-of-way. The fault displacement also ruptures this line. Although the volume of discharging gas is much smaller than that coming from the break at Cajon Pass, the gas hampers response efforts. The Kinder Morgan Pipeline fails at an additional 15 locations due to shaking at locations along the 60 km alignment paralleling the fault trace. Each failure location requires environmental cleanup of the discharged diesel product.

Figure 6. Layout of Kinder Morgan 20-inch Product Line (brown) and Southern California Gas Pipelines (pink). Relative the San Andreas Fault in Palm Springs (dotted).

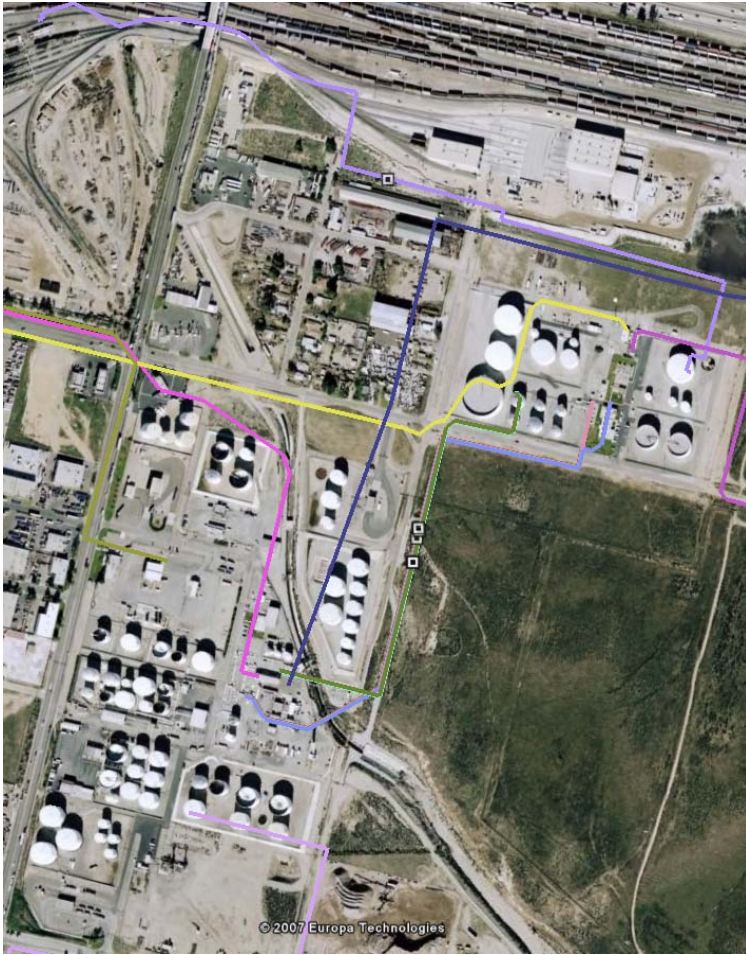
The Colton Receiving Station (Figure 8) is subjected to 40 percent g shaking. The receiving station is a node for distribution of gasoline, diesel and jet fuel. The facility also controls flow of jet fuel to March Air Force Base. Unanchored tanks bounce around breaking connecting pipe. Fuel discharges into the retaining dikes, and is ignited by passing vehicle ignition system.

Figure 8. Colton Receiving Facility with Tank Farm Vulnerable to Earthquake Ground Motion
