The ShakeOut Scenario

Unreinforced Masonry (URM) Buildings

By
Richard L. Hess, S.E.
Hess Engineering Inc.
Los Alamitos CA
May 2008

Impacts of a M7.8 Southern San Andreas Earthquake on Unreinforced Masonry (URM) Buildings

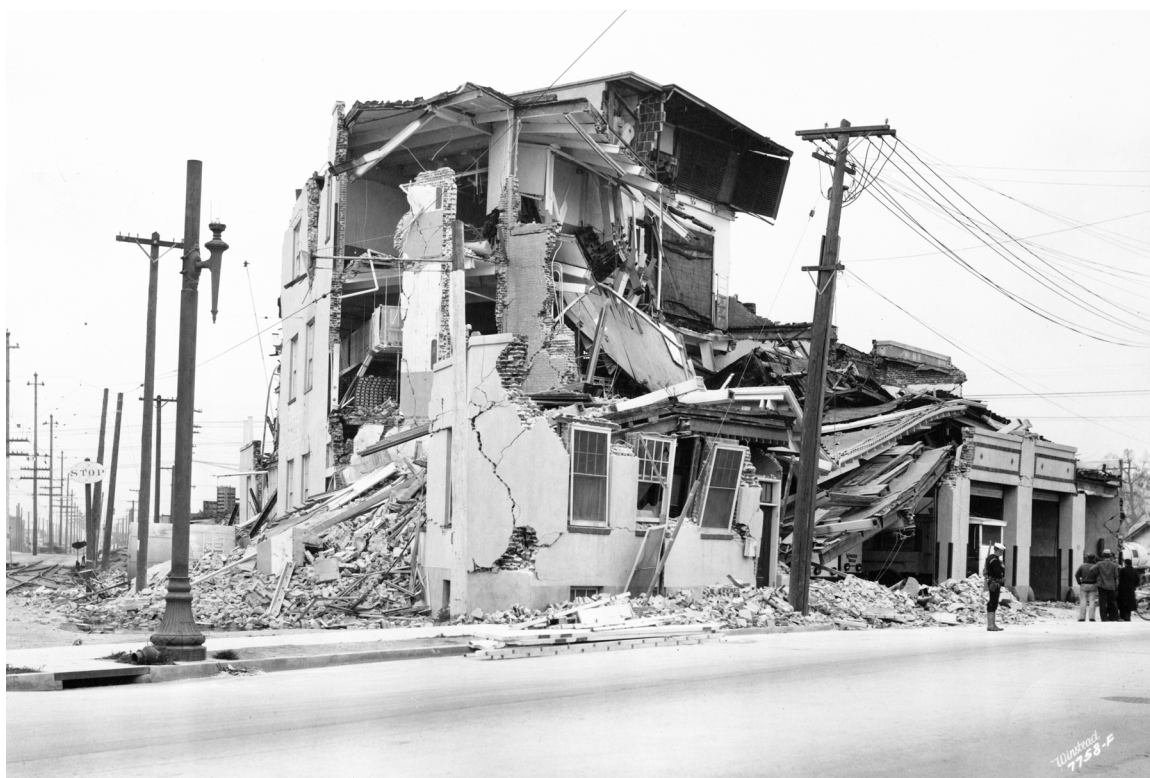
Figure 1

Most photographed commercial URM building in town, the Continental Baking Company, Long Beach, California 1933 – complete collapse
(Historical Society of Long Beach, PO Box 1869, Long Beach, CA 90801 (562) 424-2220)

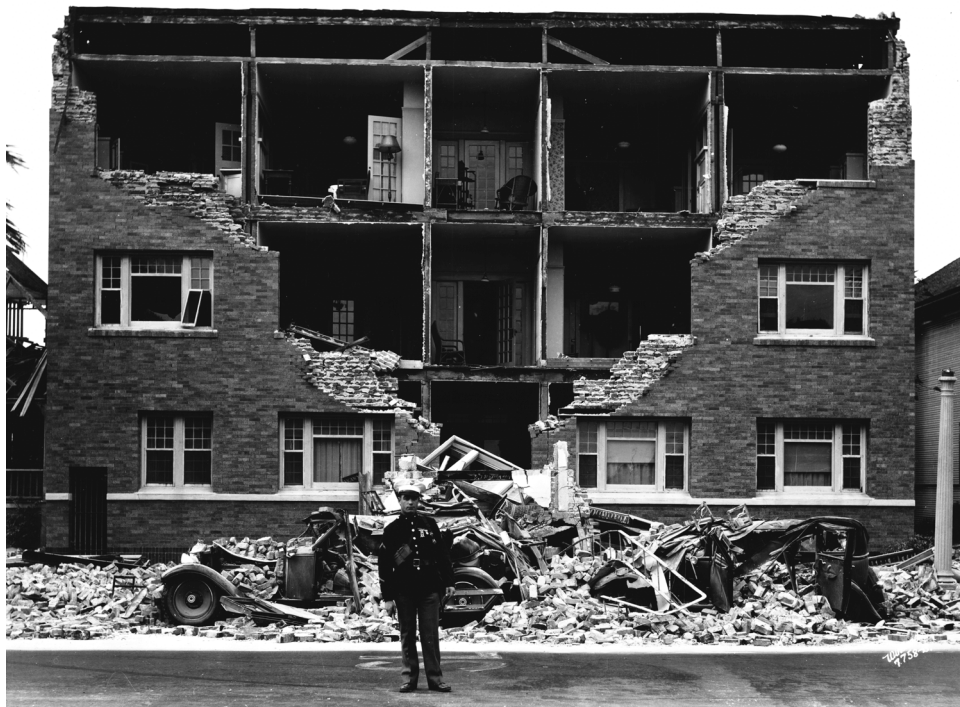
Figure 2
Morrison Apartments, 915 E. Ocean, Long Beach, California 1933 – Front wall
only fell away from floors and roof onto street below due to directional
properties of earthquake
(Historical Society of Long Beach, PO Box 1869, Long Beach, CA 90801 (562) 424-2220)

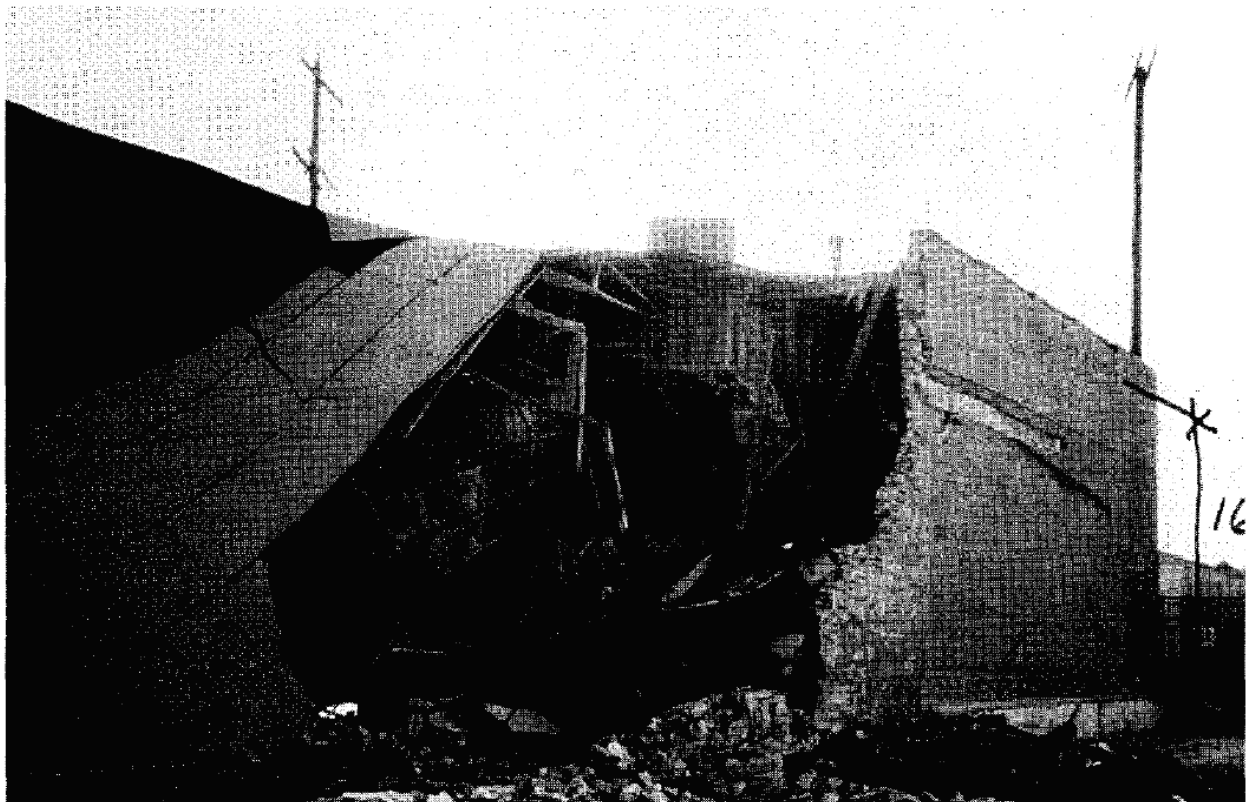
Figure 3
Partial collapse of a retrofitted URM with walls that exceed h/t limitations.
(Earthquake Spectra, January 1996 Supplement C to Volume 11)

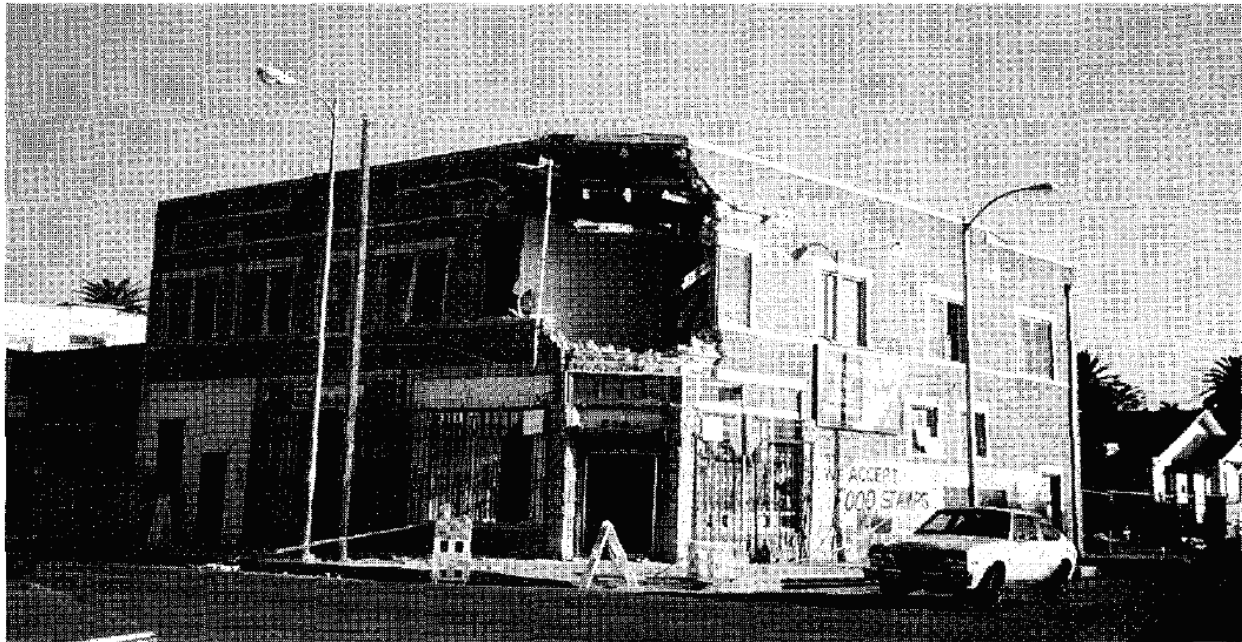
Figure 4
Out-of-plane damage to a retrofitted URM building with a clipped corner
(Earthquake Spectra, January 1996 Supplement C to Volume 11)

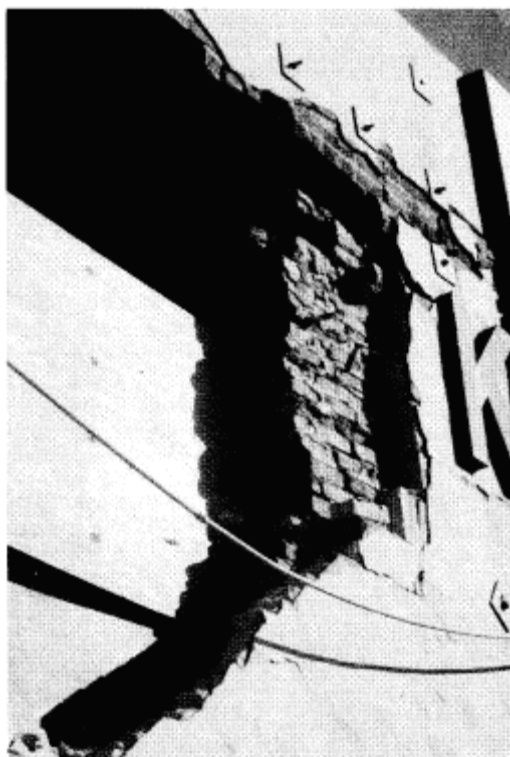
Figure 5

Typical failure of a 9-inch masonry wall with an unbonded veneer course. Note successful performance of the wall anchors.
(Earthquake Spectra, January 1996 Supplement C to Volume 11)

Another deficiency sometimes found in a retrofitted URM building is that the exterior wythe may not be connected by headers and therefore should be considered veneer and not be counted in the width of the wall. Most codes require that not less than 4% of the area of each wall face be composed of headers. In an earthquake, the veneer may fall away, leaving a height-to-thickness ratio of the remaining structural wall inadequate to support the imposed loads. This falling veneer can be a major threat to life on the surrounding streets.

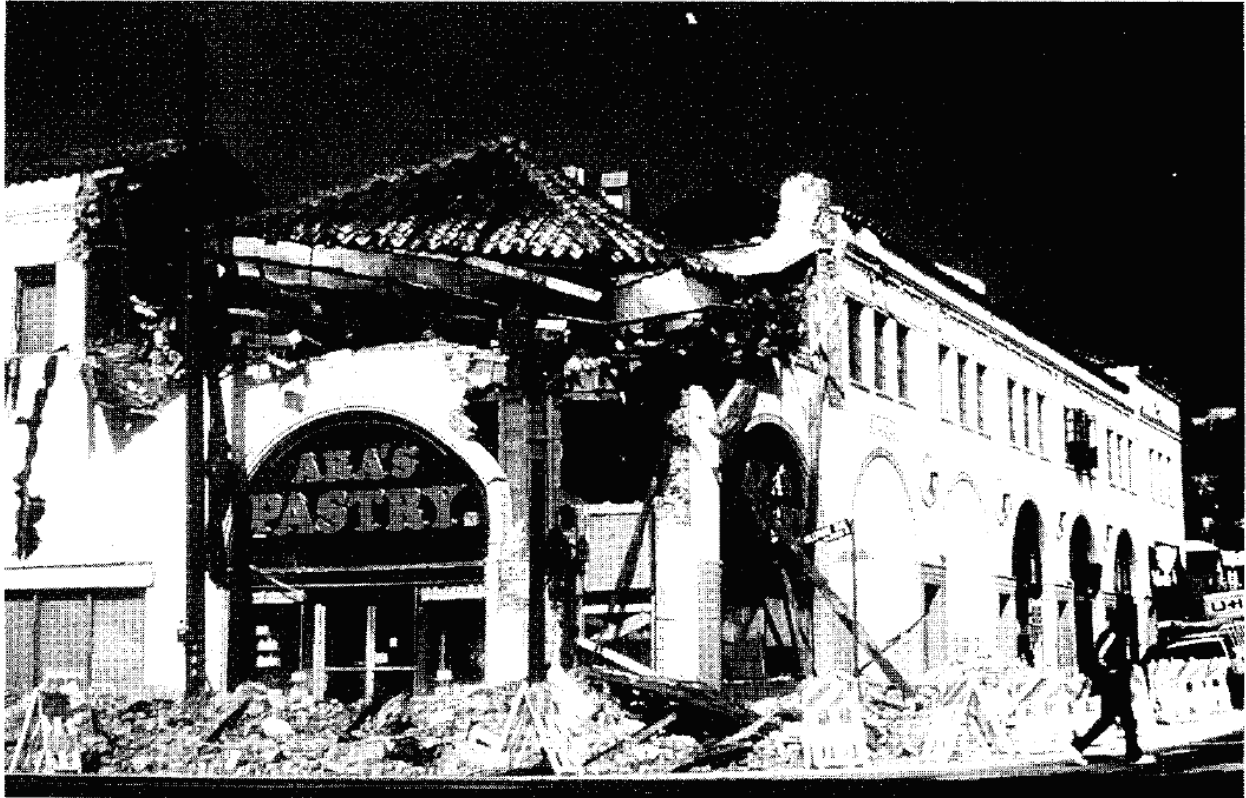
Figure 6

Collapse of a retrofitted URM tower onto the second floor and the street below.
(Earthquake Spectra, January 1996 Supplement C to Volume 11)
