World Monuments Fund
HAITI GINGERBREAD RECONNAISSANCE
Short Report (DRAFT)

by Martin Hammer, Architect
Photographs by author unless noted

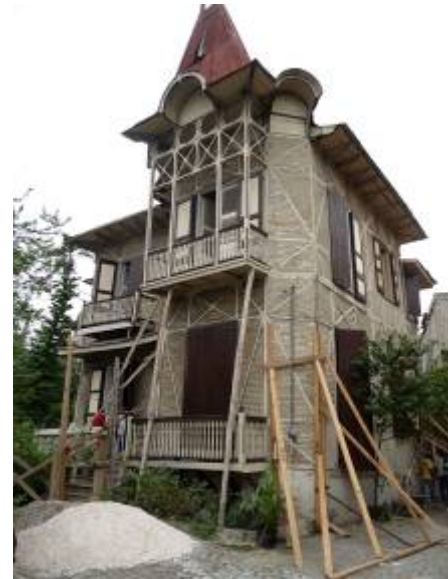
Fig. 1. A Gingerbread house in Port-au-Prince's Gingerbread District, (32 Lamartiniere)

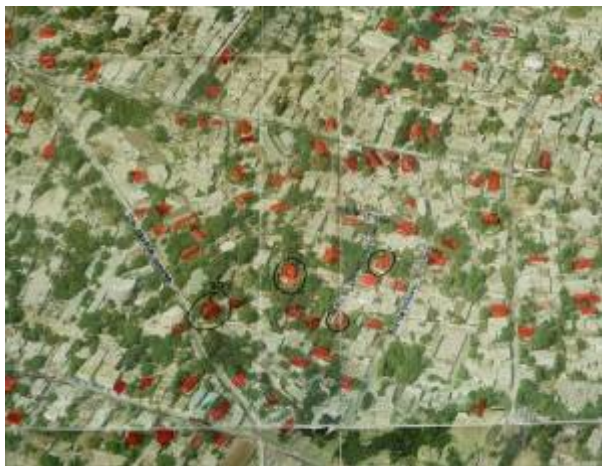
Fig. 2. Oblique aerial photography map of a portion of the Gingerbread District. Assessed buildings in red. (Original photos by ImageCat, photo mosaic by Randolph Langenbach)

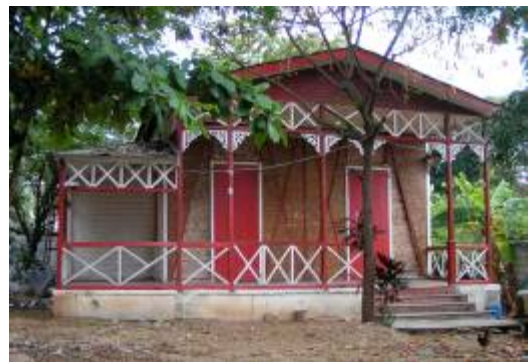
Fig. 5. A smaller and simpler gingerbread. (26 Rue 7)

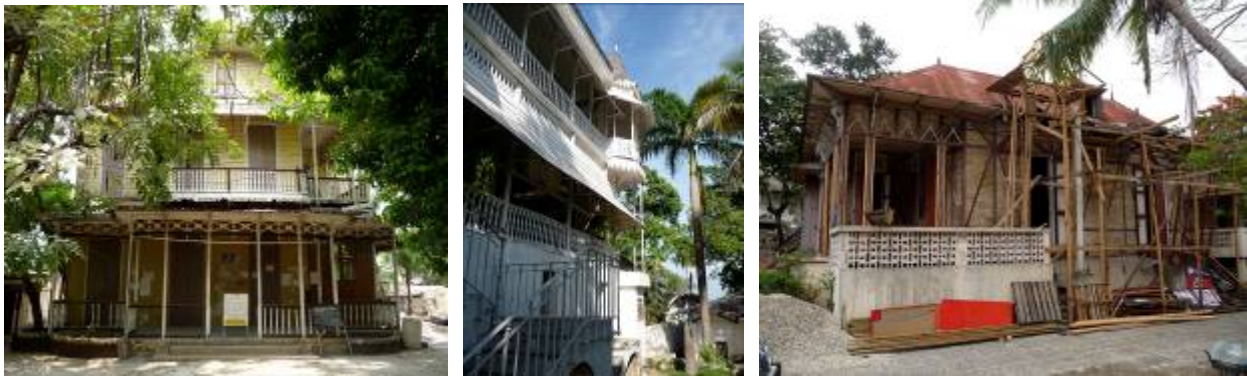
Fig. 6. Non-residential uses of gingerbread buildings: Left – College de Jeunes Filles (10 Lavaud 1); Center – the Hotel Oloffson has been a hotel since 1936, and was a U.S military hospital from 1915-1935; Right - 84 Lamartiniere is being repaired and renovated as a restaurant.

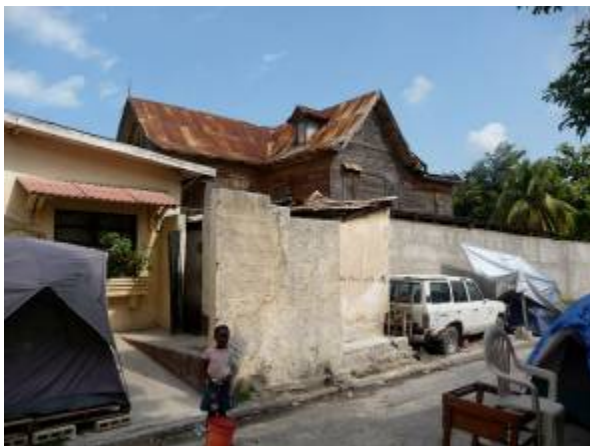
Fig 7. A security wall and a modern streetside residence obscure most of a weathered gingerbread building from public view.

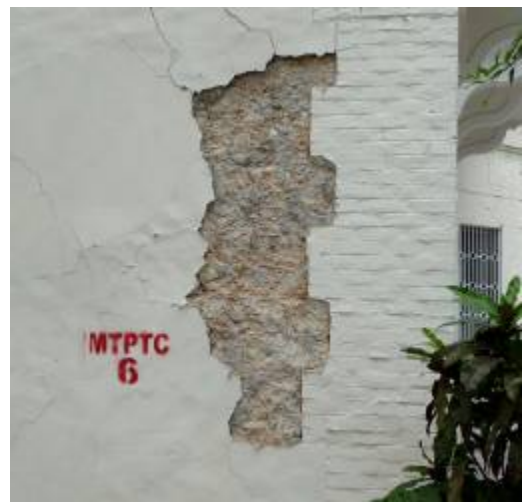
Fig. 10. Delamination of finish plaster reveals the limestone infill panel bounded by the corner brick pier. **MTPTC 6** indicates inspection deemed tower unsafe for occupancy.

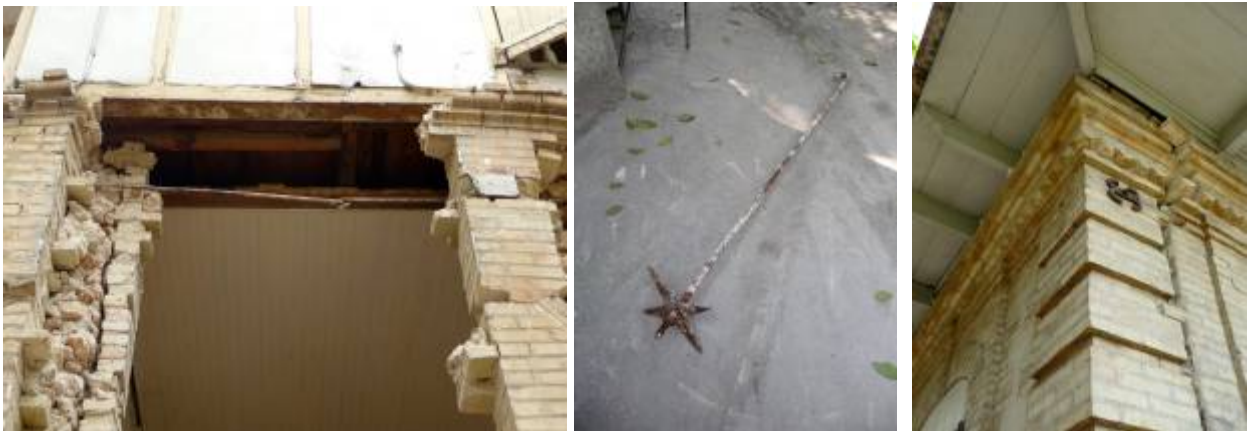
Fig. 11. Iron tension rods. Left – Linked rods exposed. Limestone infill panel was discharged. Tension rod may have prevented complete wall collapse. Center - End rod isolated, showing hooked end and threaded end with star plate and nut. Right - Brick corner with one end plate missing, showing separation of corner pier from rest of wall in that direction.

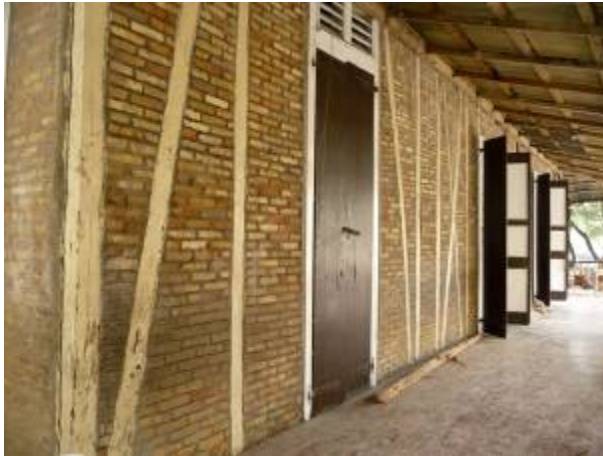
Fig. 12. Colombage with brick and lime mortar infill. (30 Lamartiniere)

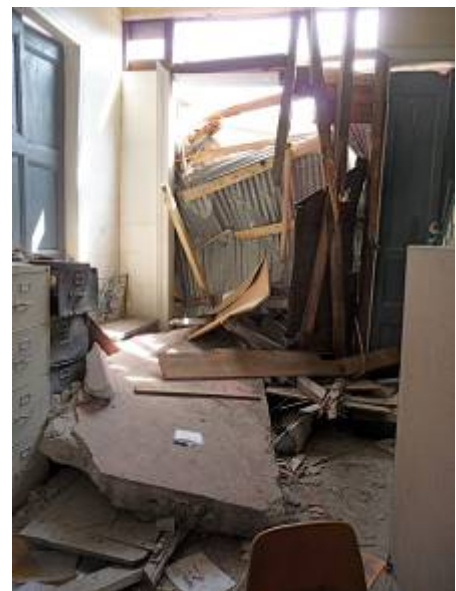
Fig. 15. The most damage this building suffered was from a concrete slab ejected through its back door from the collapsed concrete building behind.

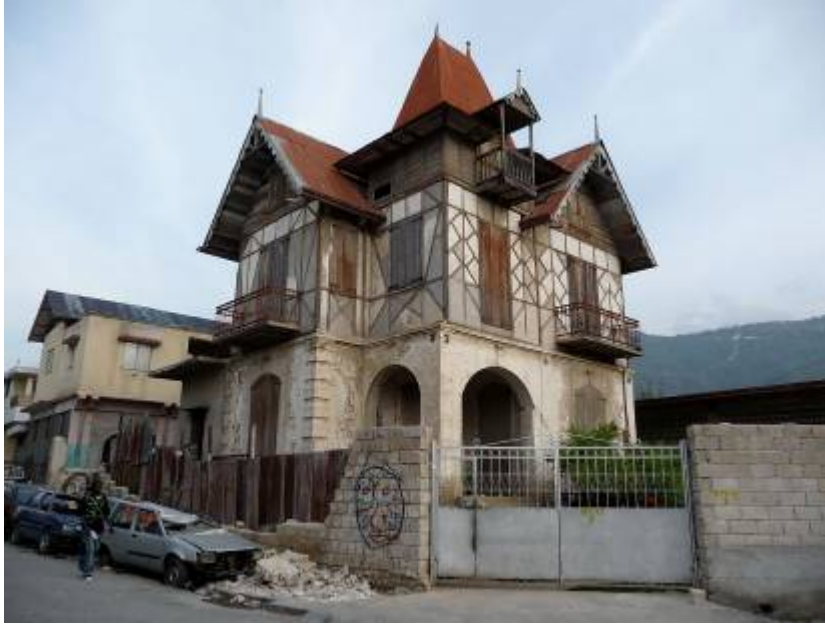
< Fig. 16. Hybrids are very common. This gingerbread house utilizes all three wall construction systems.

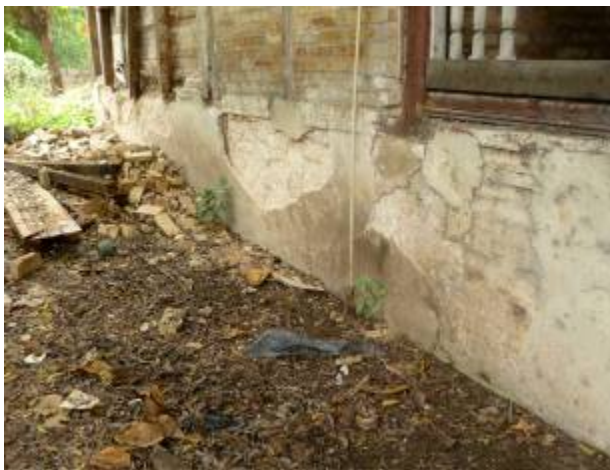
Fig. 17. Spalling of the exterior finish plaster reveals two contiguous sections of foundation stem wall. One of irregular limestone (left), and one of brick (right). (84 Lamartiniere)

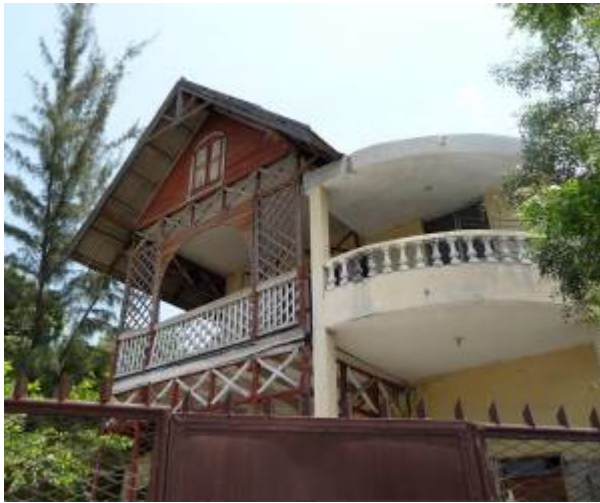
Fig. 24. Concrete additions are often awkward or compromise the gingerbread buildings architecturally. (51 Ave. Christophe)

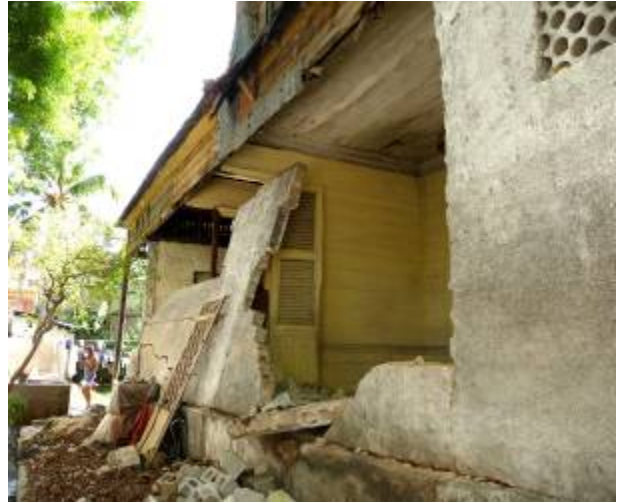
Fig. 25. A replacement side wall of concrete block suffered partial collapse. (19 Lamartiniere)

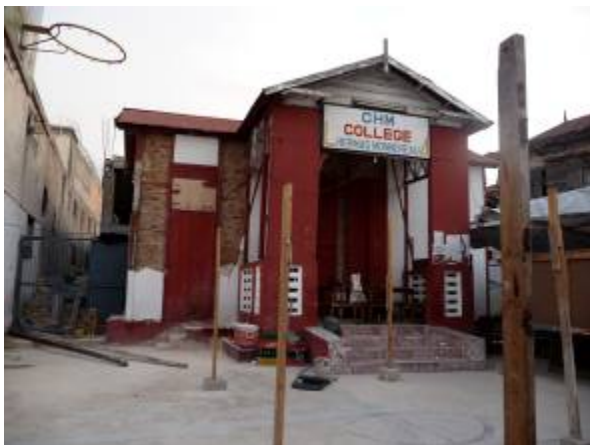
Fig. 26. A small colomage school building suffered minor damage to infill panels. (16 Lamartiniere)

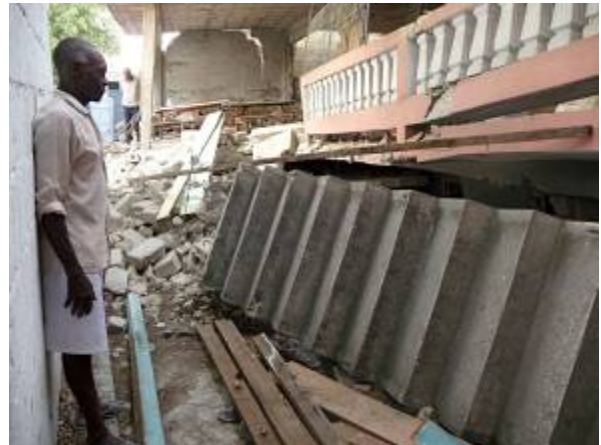
Fig. 27. An expansive two-story, concrete classroom addition behind the original building suffered first story collapse.

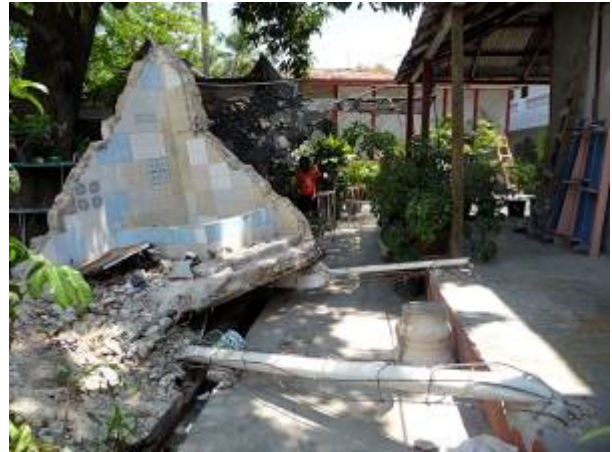
Fig. 28. This second floor concrete bathroom addition landed on the ground after its concrete columns buckled as it pulled away from its parent gingerbread house. Note sewer pipes in the center of the rebar of the buckled columns. (5 Lamartiniere)

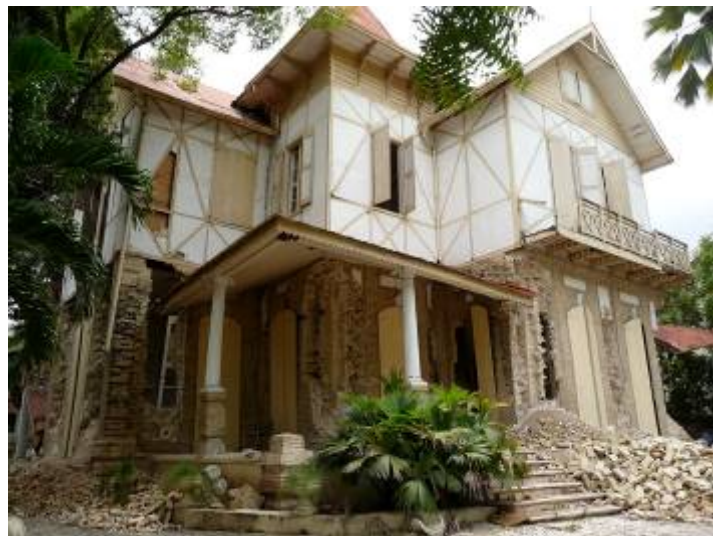
Fig. 29. The Dufort House, a hybrid structure, exhibited substantial damage to the masonry first story walls, including its limestone panels and brick piers, but significantly less damage to its colombage and wood frame second story walls. Notwithstanding the increased seismic loads on the first floor walls, the difference in performance of the systems is indicative of a tendency seen throughout the surveyed buildings. (Rue du Travail II)

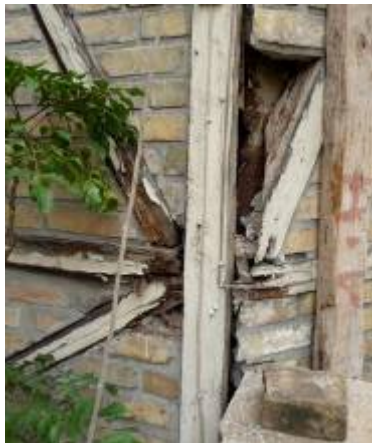
Fig. 31. Rot of timber frame members at corner of colombage house. (32 Lamartiniere)

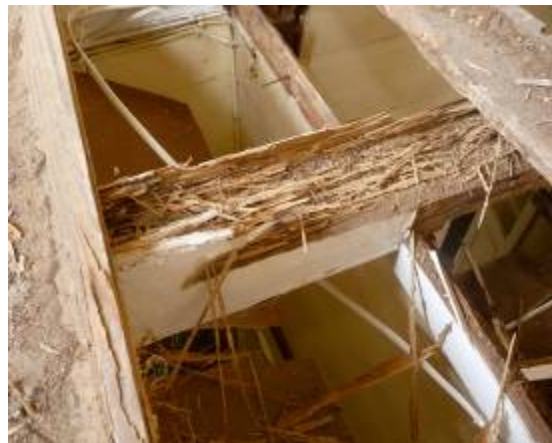
Fig. 32. Termite damage in second story floor joists.

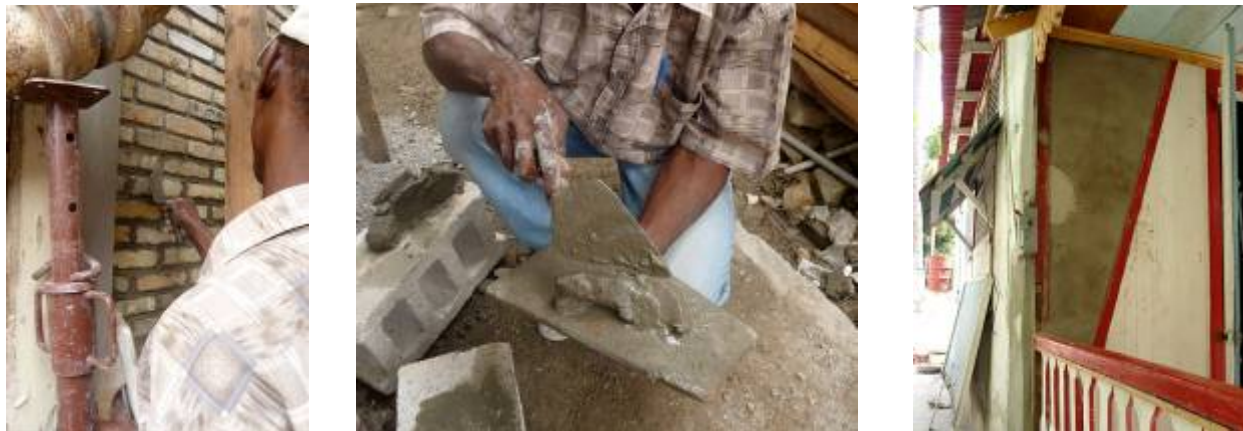
Fig. 32. Well-intentioned but improper repairs with cement mortar in brick work (left and center), and cement plaster for colombage infill (right). Lime mortar and lime plaster should be used.
