The ShakeOut Scenario

Supplemental Study

High-Rise Steel Buildings

SHAKEOUT 2008: Tall Steel Moment Frame Building Response
Swaminathan Krishnan and Matthew Muto
California Institute of Technology

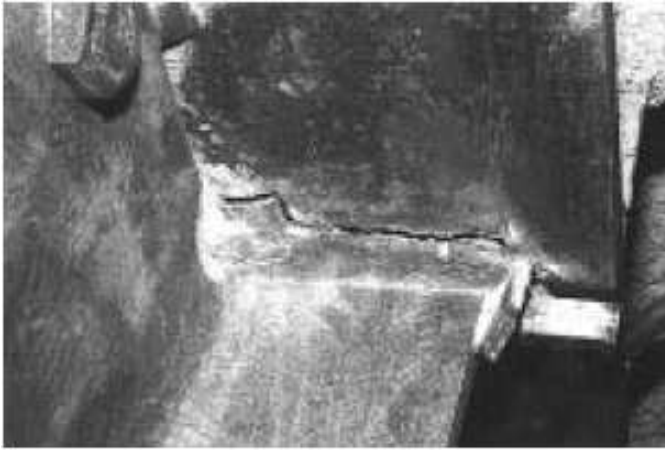
entire column cross-section (Figure 4). Such fractures can lead to a significant loss of stiffness and strength in the moment frames and can dramatically lower the capacity of the structure to resist collapse.

Figure 4: Fractures observed in beam-to-column connections during the 1994 Northridge earthquake (Source: FEMA-355E): [A] Fracture at the fused zone; [B] Column flange “divot” fracture; [C] Fracture through column flange; [D] Fracture progresses through column web; and [E] Vertical fracture through beam shear plate connection.

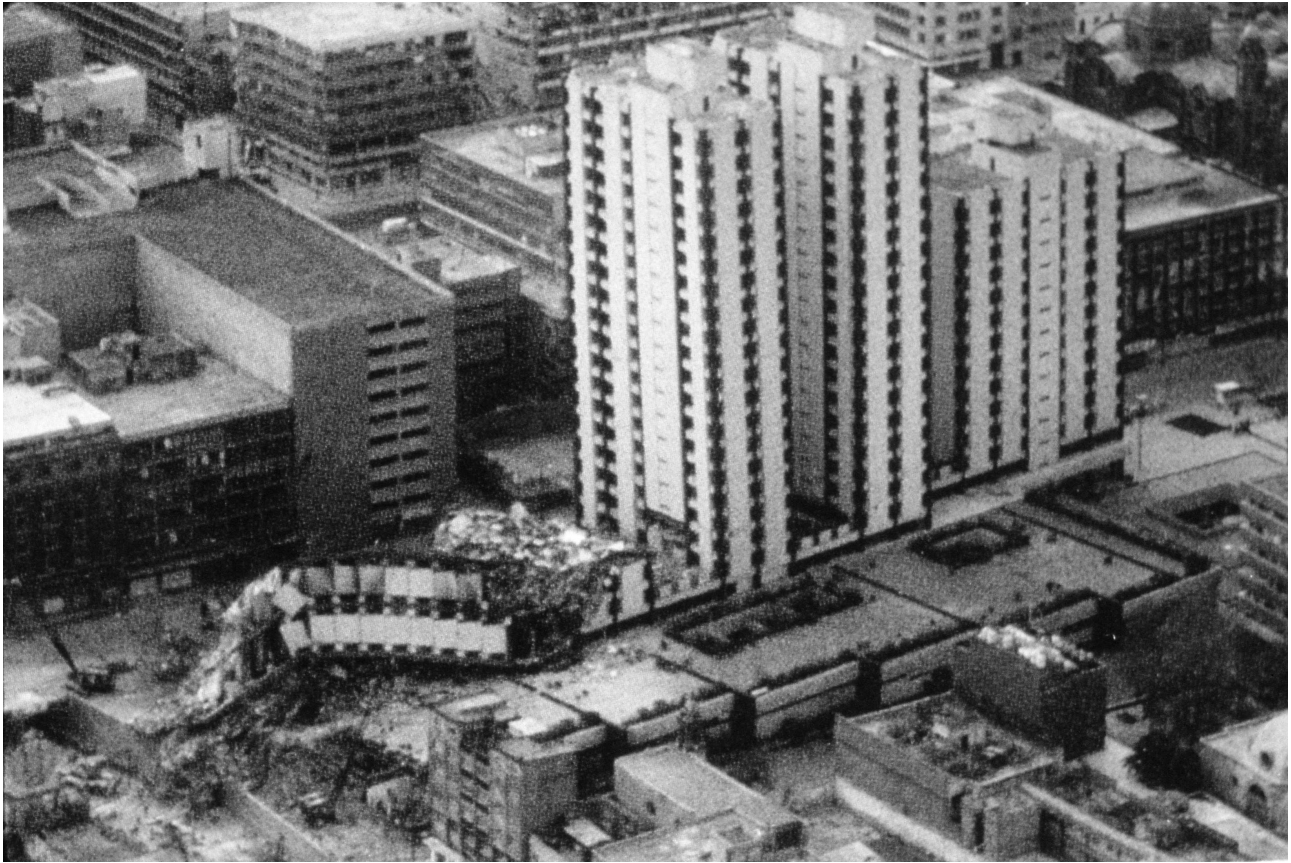
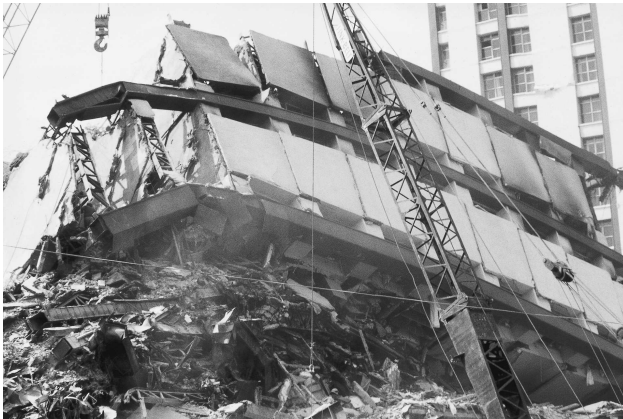
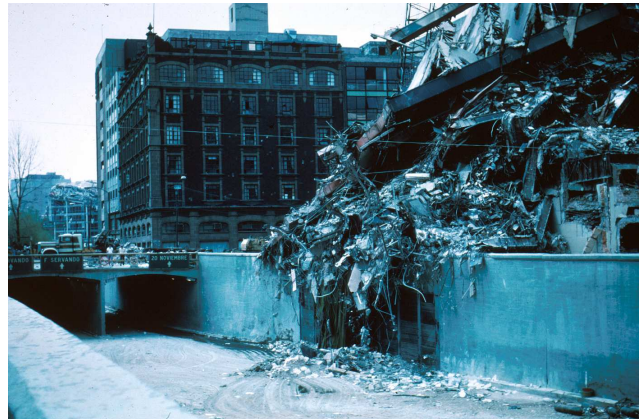
Figure 5: Mexico City Earthquake, September 19, 1985: [A] Collapse of a 21-story building on top of a 14-story building in the Pino Suarez complex. Three towers are left standing with extensive damage to the two 21-story towers. Source: Bob Reitherman; [B] Failure in the welds connecting the flanges and webs of built-up box column possibly led to local flange-buckling of the column and eventual collapse. Source: Bob Reitherman; [C] Debris of tower collapse spilled on to the streets. Source: Mehmet Celebi, USGS.

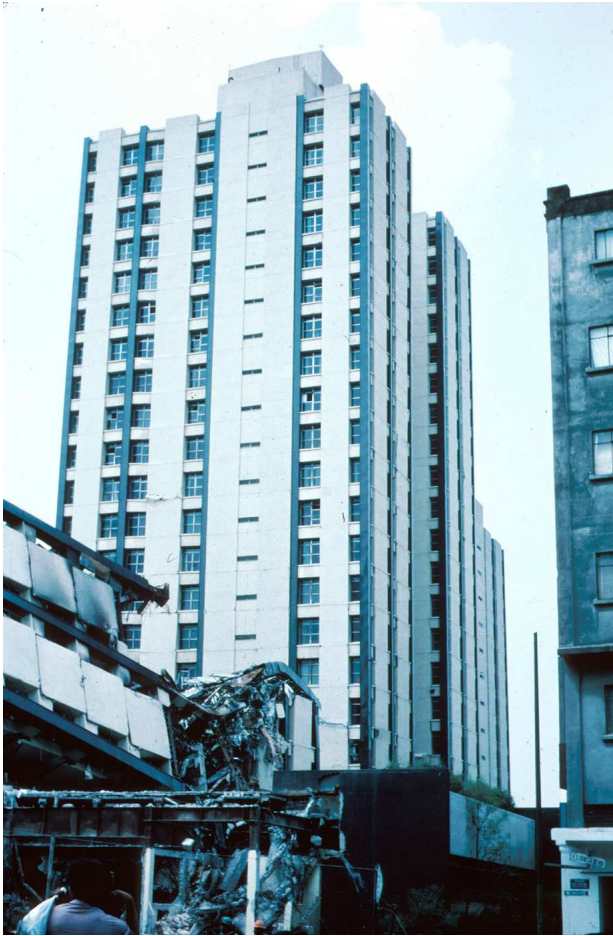
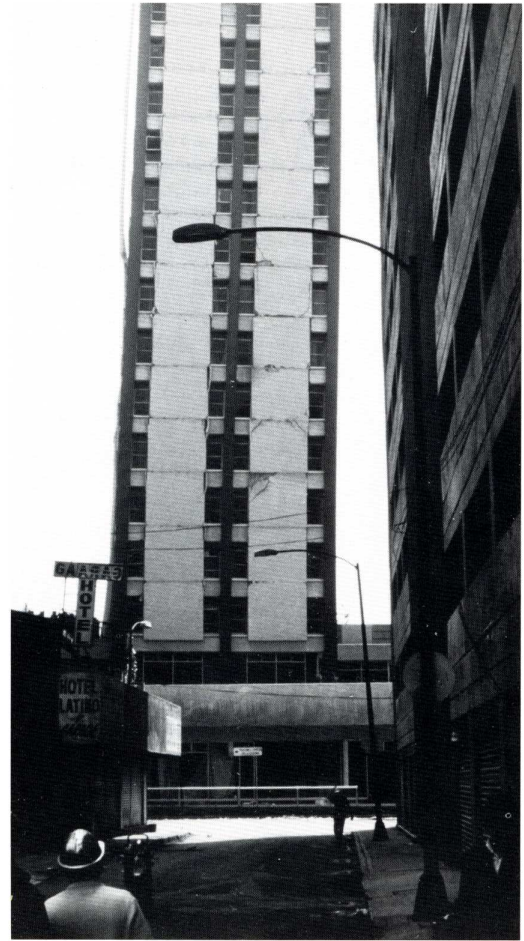
Figure 6: Mexico City Earthquake, September 19, 1985: [A] Wreckage of a 21-story steel building in the Pino Suarez Apartment Complex (Source: Mehmet Celebi, USGS); and [B] A second 21-story steel building in the same complex remained standing, but was leaning six feet out of plumb at the roof level due to yielding that resulted in a permanent interstory drift (Source: Jim Beck, Caltech). Such permanent tilting following an earthquake would most likely render the vertical transportation system (elevators) unusable due to misalignment. In addition, doors to staircase shafts may be jammed due to deformation of the frames, possibly hampering evacuation efforts.

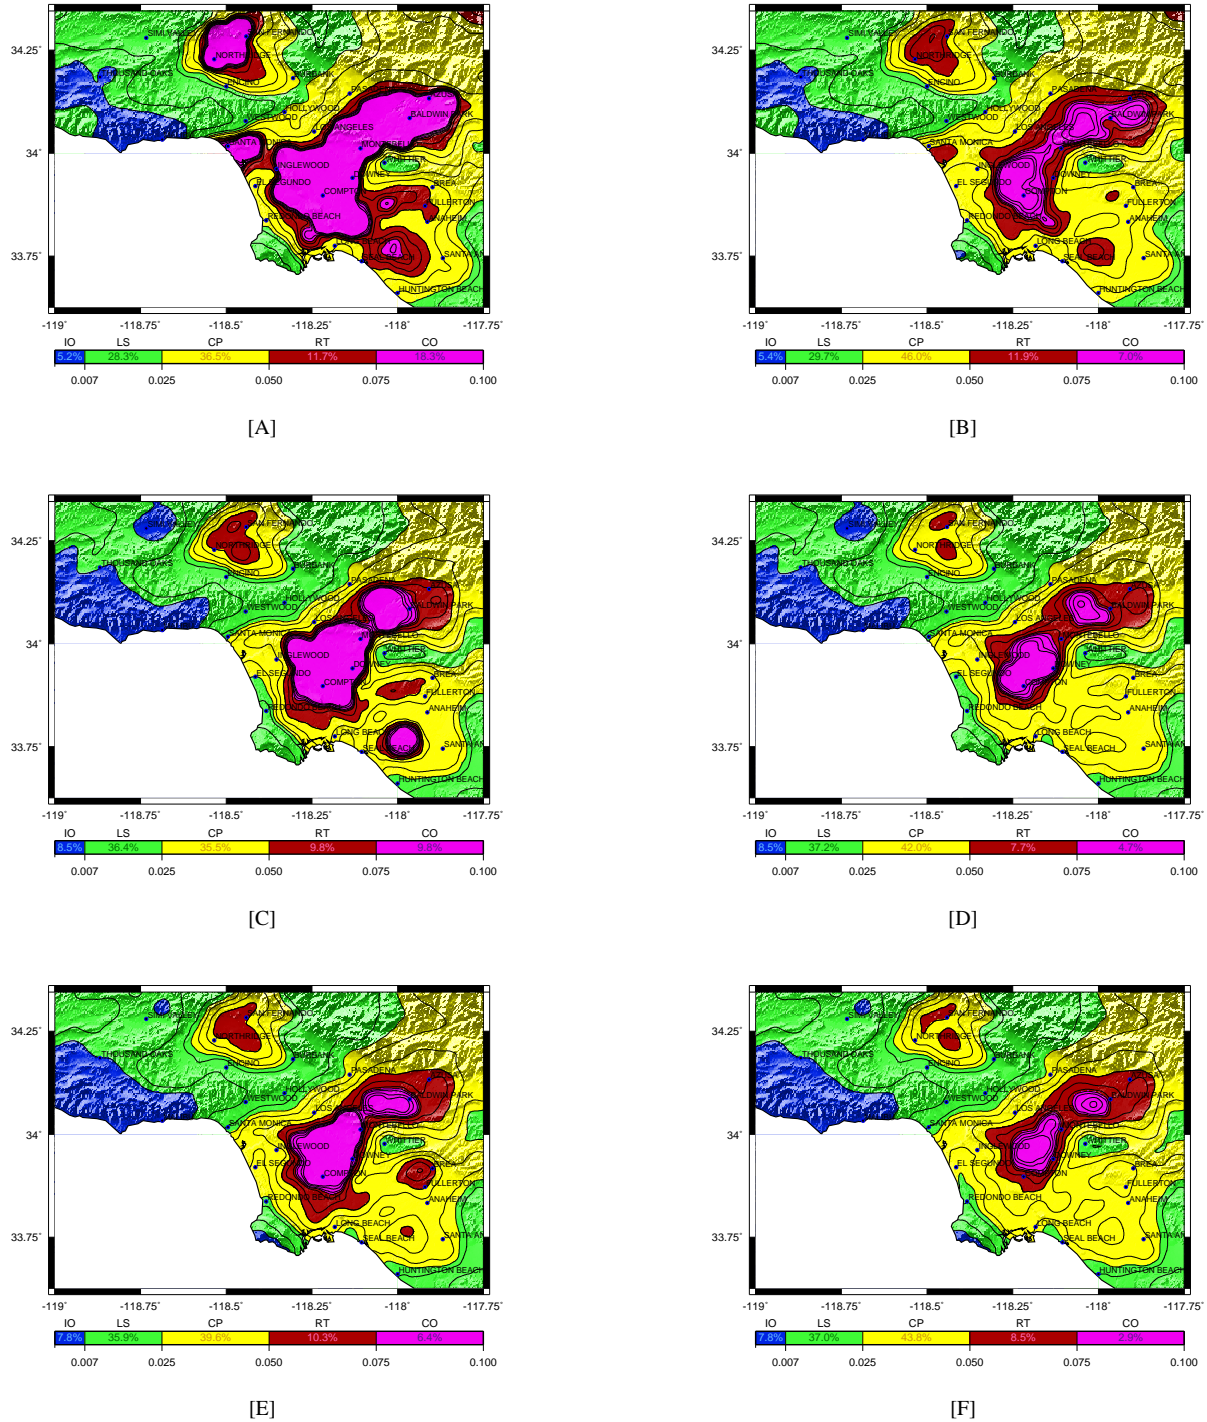
regions representing regions where the structures can be considered to have collapsed. Building 1 which was designed according to the 1982 UBC exhibits the worst performance with the susceptible connection model collapsing at 18.3% of the 784 analysis sites and being red-tagged at 11.7% of the sites. The L-shaped building 3 performs the best with the percentage of collapsed and red-tagged instances being 10.3% and 6.4%, respectively. The performance of building 2 is only slightly worse than building 3. If we assume that the beam-to-column connections are perfect, then there is a significant drop in the number of collapsed and red-tagged buildings, for e.g., for building 1 the percentage of collapsed instances is 7.0%, while the percentage of red-tagged instances is 11.9%. The performance of the buildings is summarized in Table 1.

Figure 9: Maps of peak interstory drift ratios of models of the three buildings placed in the base orientation. For each building two cases are considered one with perfect connections ([B], [D], and [F] for buildings 1, 2, and 3, respectively), and the other with susceptible connections ([A], [C], and [E] for buildings 1, 2, and 3, respectively). The numbers in the color bar represent the instances in each of the 5 performance categories as a percentage of the total number of analysis sites (784). IO (blue): Immediately occupiable after the earthquake; LS (green): Visible damage, but no loss of life; repairs may require building closure; CP (yellow): Heavy damage with loss of life, but collapse is prevented; RT (red): Severely damaged and on the verge of collapse; red-tagged; CO (pink): Collapsed.

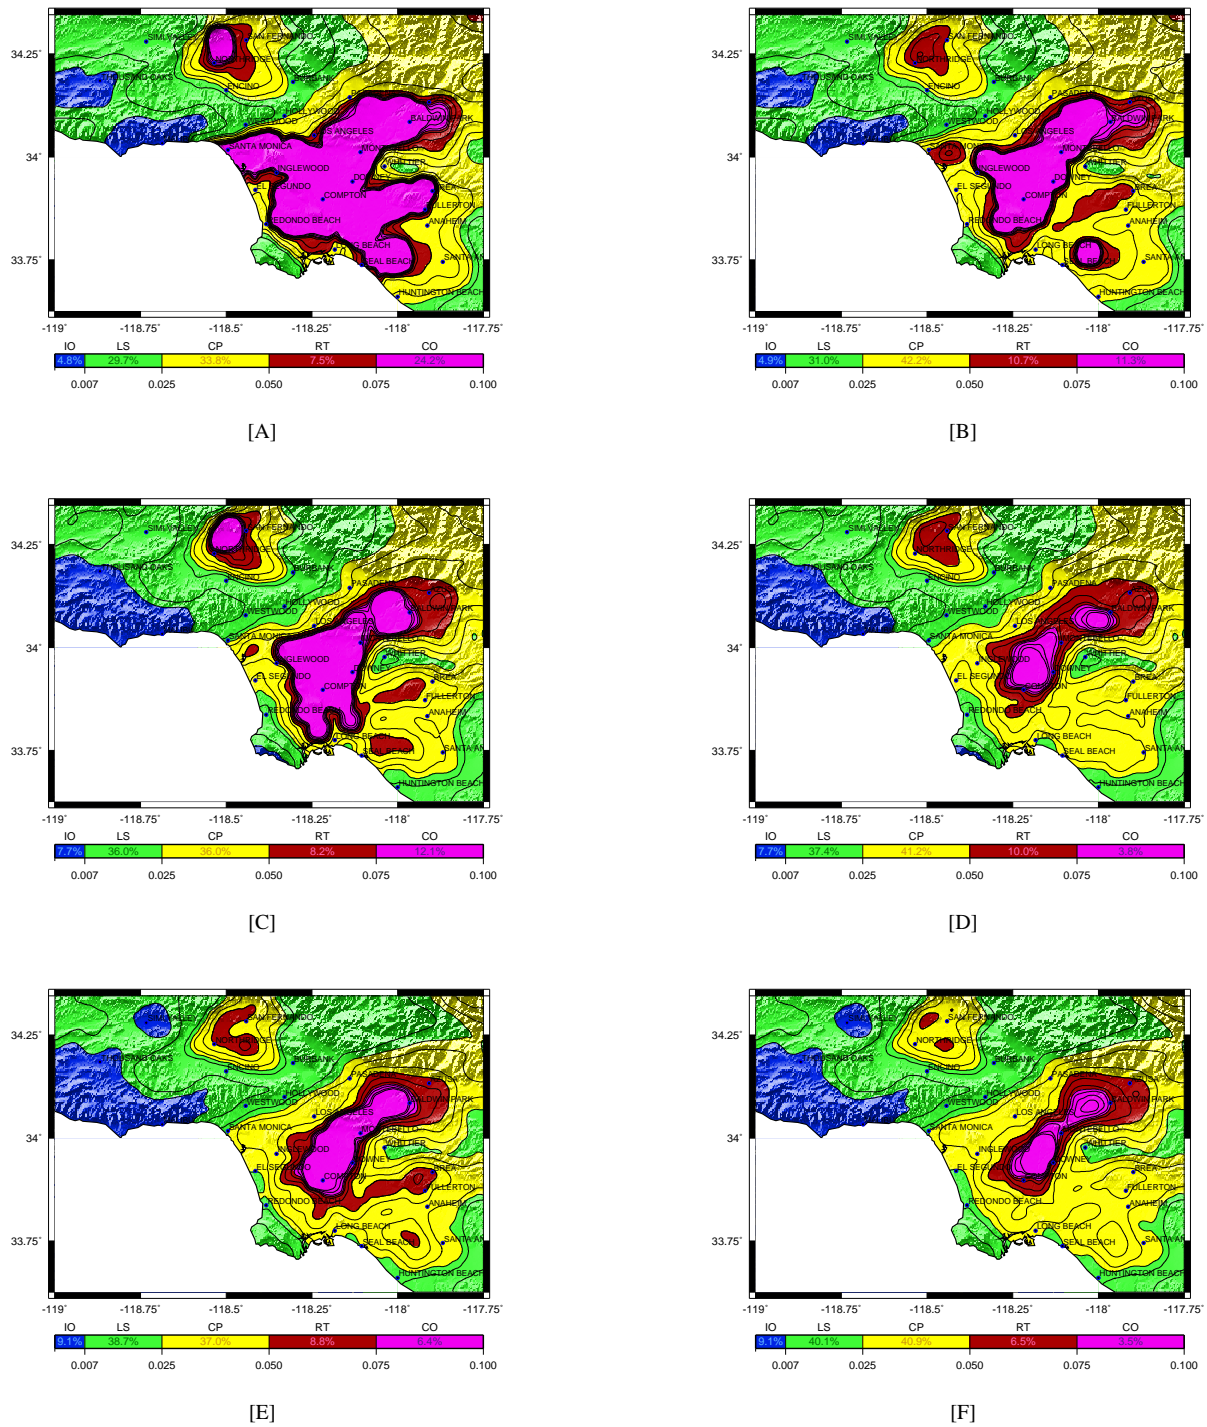
The results for the rotated cases for each of the three buildings with perfect and susceptible connections are summarized on peak interstory drift ratio maps in Figure 10. The rotated orientation is detrimental to buildings 1 and 2 with a 2-4% increase in the percentage of collapses. Notably, downtown Los Angeles with the greatest concentration of high-rise buildings, and hence the location with the greatest likelihood of existence of steel moment frame buildings of this class, falls in the red-tagged zone for the susceptible connection case of building 1. There is a slight improvement in the performance of the rotated L-shaped building 3 with a 1.5% drop in the percentage of red-tagged instances.

Figure 10: Maps of peak interstory drift ratios of models of the three buildings, with buildings 1 and 2 oriented 90° counter-clockwise to the base orientation, and the L-shaped building 3 oriented 45° counter-clockwise to the base orientation. [B], [D], and [F]: Buildings 1, 2, and 3, respectively, with perfect beam-to-column connections; [A], [C], and [E]: Buildings 1, 2, and 3, respectively, with susceptible connections. The numbers in the color bar represent the instances in each of the 5 performance categories as a percentage of the total number of analysis sites (784).

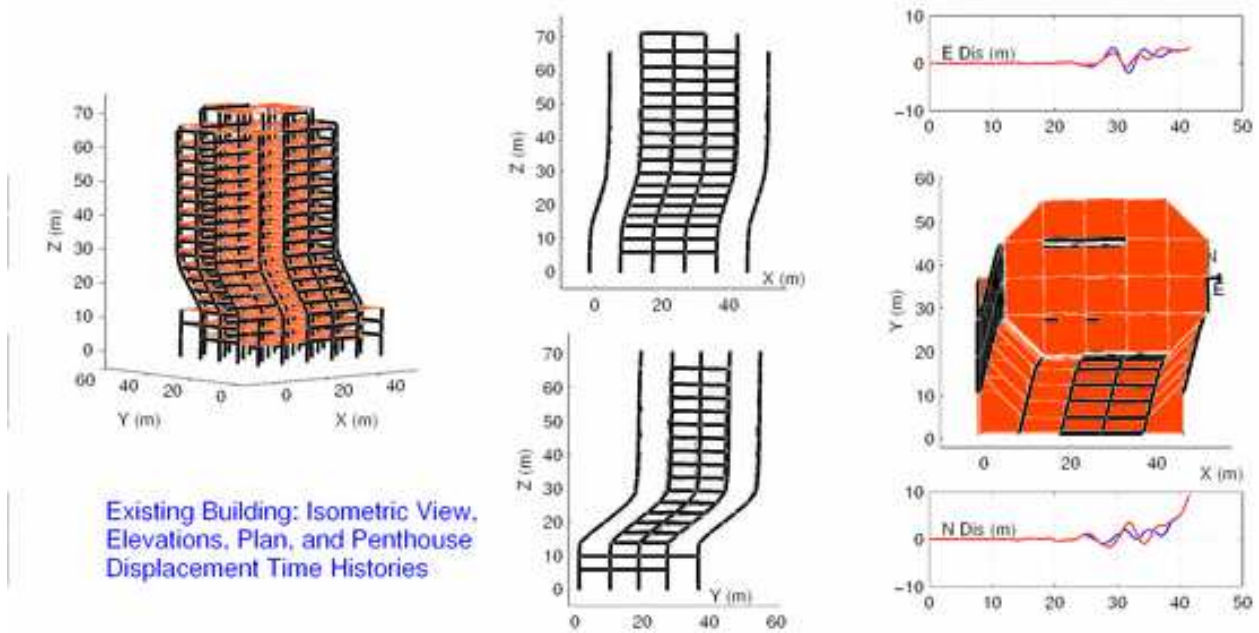
Figure 12: Snapshot of the response of the susceptible connection model of building 1, located at Baldwin Park with base orientation, at the initiation of collapse. The displacements are scaled by a factor of 2 for better visualization of the collapse mechanism.
