Spatial Patterns of Mortality Risk within a Tornado Path:
A Fine-scale Spatial Analysis of Spatial Video-collected Damage Data for the
Newcastle-Moore Tornado of May 21, 2013

Andrew Curtis*, Spencer Baker, Xinyue Ye, Jacqueline W. Curtis, Grant Floyd

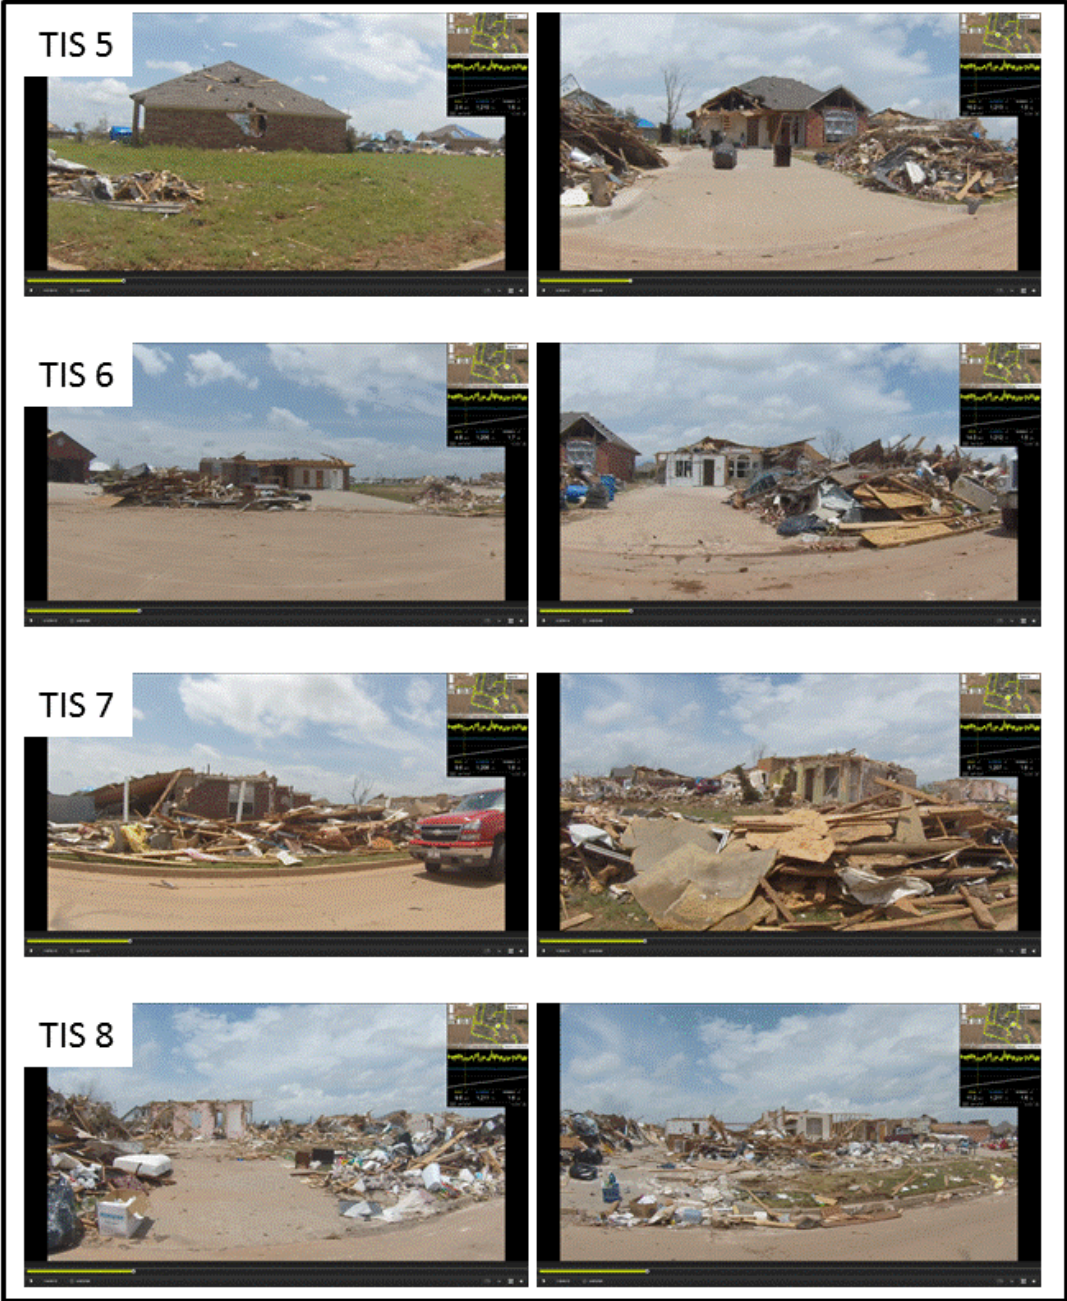
Figure 1. Example TIS Scores from the Newcastle-Moore, Oklahoma tornado

Figure 1 presents two examples of TIS scores 5 to 9 for the 2013 Newcastle-Moore tornado. Each image is extracted from Contour Storyteller software which allows for the mapped display of the spatial video. The upper right inset map displays exactly where each video frame was taken, and for this example all images come from a two block area.

For TIS 5, the first building shows damage and holes to the exterior shell, including a sizeable puncture in the wall. The second TIS 5 image has a large section of damage at the roof-wall intersection. For TIS 6, both images show homes where the roof has been removed. For TIS 7, the two images show the range for this score; the first building has lost its roof and sections of exterior wall, while the second has suffered multiple failures to exterior walls. For both TIS 8 images the majority of the outer shell has been destroyed leaving just an interior section. The visual damage for TIS 9 and 10 would be a debris pile or just a concrete slab.

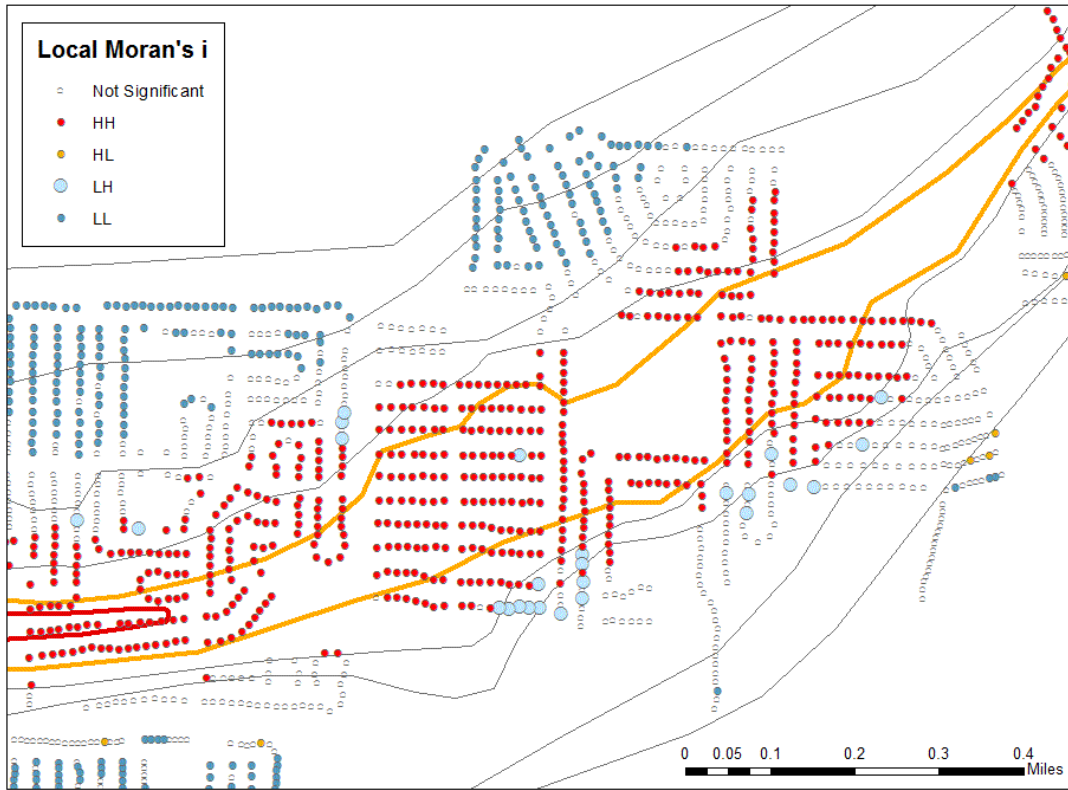
Figure 4. Local Moran's i analysis of TIS coded structures within the Moore, Oklahoma tornado path of May 21st, 2013.

In order to further investigate such fine-scale variation, a local spatial autocorrelation analysis was performed using a local Moran's *i* function in ArcGIS 10.1⁵. This analysis identifies both hot and cold spots of TIS, but more importantly, it identifies outliers; LH are buildings that had a lower TIS than other surrounding structures, and HL had a higher TIS than the immediate neighborhood. Table 1 again summarizes these results, with the majority falling in the HH and LL categories, with 14 buildings being significantly worse (higher TIS) than their surrounds, and 42 faring significantly better. Both of these values should be further investigated to establish exactly why these outliers occurred. Figure 4 displays the same inset area map from Figure 2, but this time with buildings coded according to their local Moran's *i* score. The LH buildings (structures that performed significantly better than their surrounds) have been exaggerated as larger pale blue circles.

From a spatial perspective, maps of Fujita or Enhanced Fujita scale damage tend to be overestimates because the purpose of the classification is to identify evidence for the strongest wind field in (usually) a coarsely drawn area. The contours found in the results maps of Figures 2 to 4 illustrate this point. There have been a few attempts to create more spatially specific intensity patterns, for example as intra-urban damage maps (Speheger, et al. 2002). In this case,
