# The ShakeOut Scenario

*Supplemental Study*

## Older Reinforced Concrete Buildings

# M7.8 Southern San Andreas Fault Earthquake Scenario: Non-ductile Reinforced Concrete Building Stock

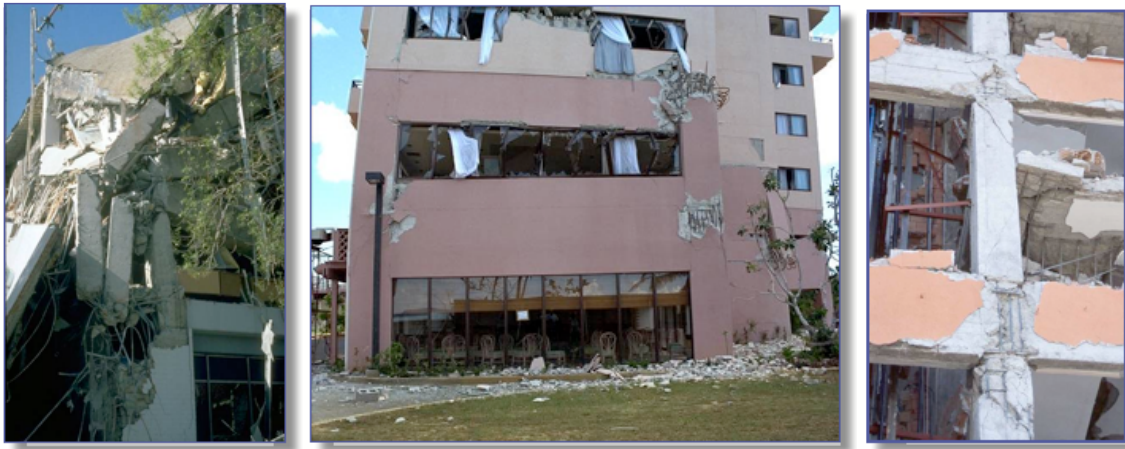
**Figure 2.** Joint failures observed in non-ductile reinforced concrete buildings due to strong ground shaking (Figure reprinted from Moehle *et al.*, 2xxx).

Figures 2 through 7 exemplify the strikingly poor performance of NDRCB's observed during recent earthquakes in the U.S. and around the world. They bear a significant risk of complete or partial collapse under strong ground motions. While there might be a marked difference between the casualty figures between a partial and a complete collapse, the building in question would be a complete economic loss in either case.

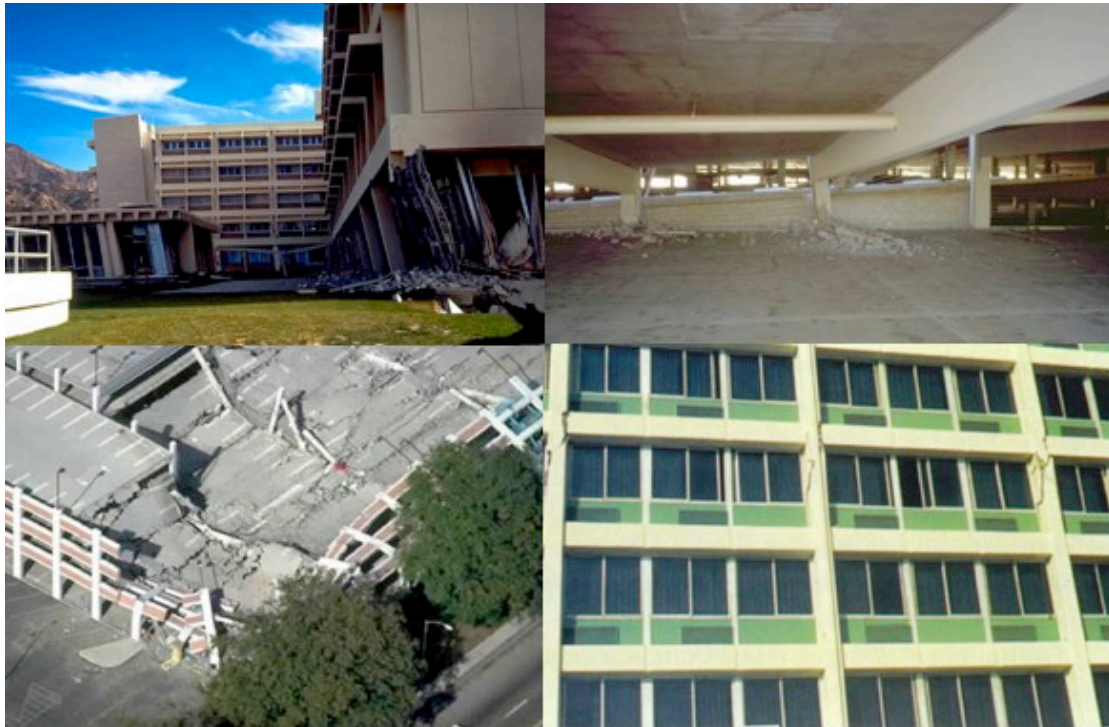
**Figure 3.** Damage to non-ductile reinforced concrete buildings due to 1994 Northridge Earthquake (Photos procured from USGS archives).

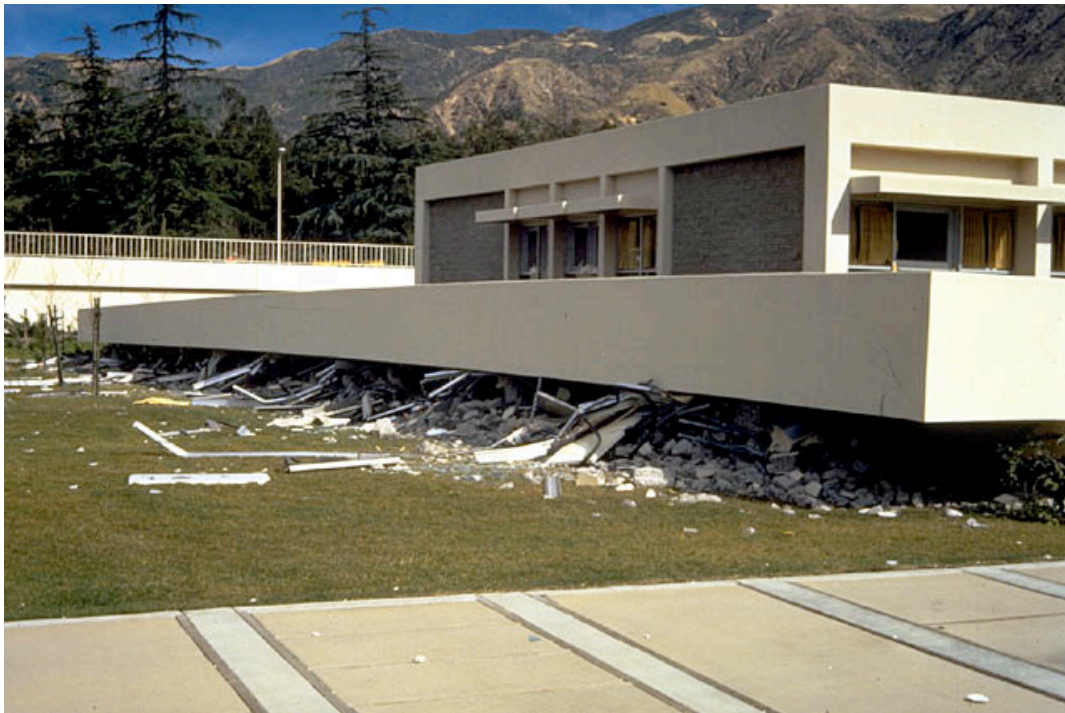
**Figure 4.** Olive View Hospital, Psychiatric Unit. This unit was a 2-story reinforced concrete building. The structural system was a moment resisting frame. Earthquake: San Fernando, California earthquake, Feb. 9, 1971 Magnitude: 6.6 (Figure and caption procured from USGS archives).

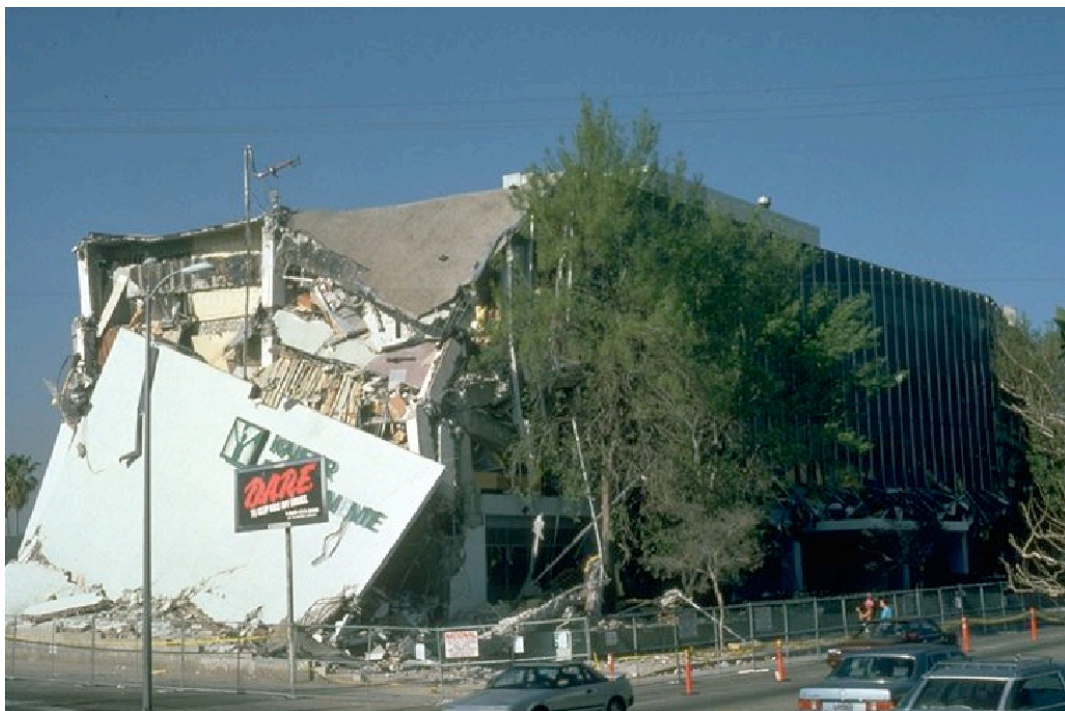
**Figure 5.** Overall view of Kaiser Permanente office building looking toward the northeast. The brick facades at either end of the structure have separated from the concrete frame, and the second floor of the structure has completely collapsed. The bays at the north and south ends of the building are also partially collapsed from the second to the fifth floor. Earthquake: Northridge, California earthquake, Jan. 17, 1994 Magnitude: 6.69 (Figure and caption procured from USGS archives).

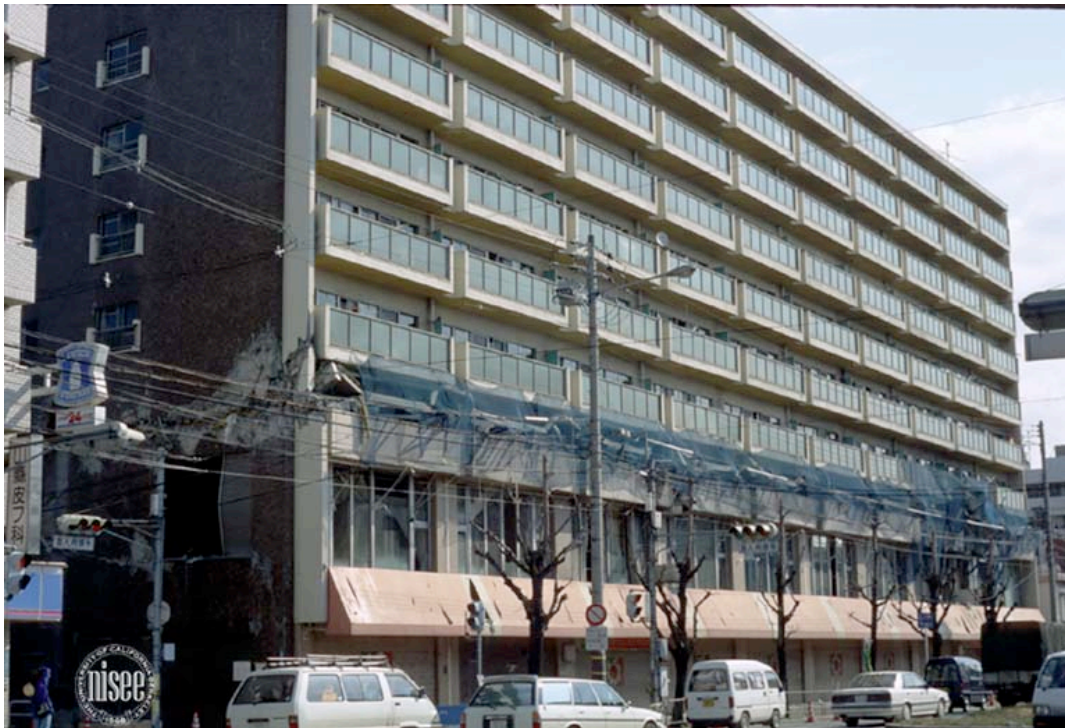
**Figure 6.** South elevation (front view) of an irregular, U-shaped reinforced concrete building in Nishinomiya with 3rd floor collapse. (Kobe, Japan). Earthquake: Kobe, Japan earthquake, Jan. 17, 1995 Magnitude: 6.69 (Figure and caption procured from USGS archives).

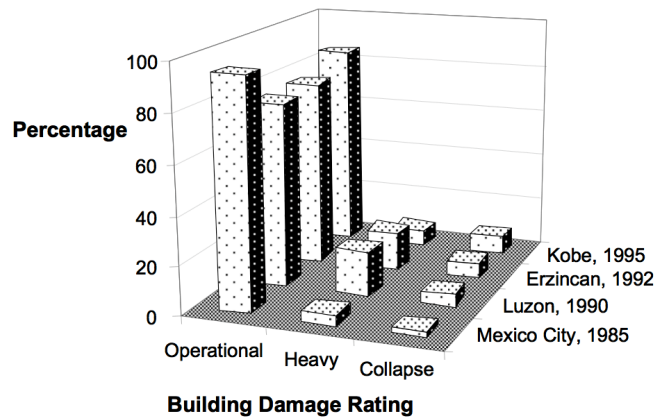
**Figure 8.** Damage statistics for lightly reinforced concrete buildings from four earthquakes. (Figure reprinted from Moehle *et al.*, 2004.)

Given the engineering analyses just mentioned and the historical damage reflected in Figure 8, we suggest a realistic range of possible outcomes is that on the order of 10 to 100 NDRCBs in Riverside, San Bernardino, and Los Angeles Counties will collapse, a somewhat larger fraction will be heavily damaged (to the extent of being red-tagged and therefore both unsafe to enter and also potentially a total economic loss), and the rest might be operational, even if damaged and requiring repair. Given the level of shaking in Palm Springs, it seems realistic to assume that most NDRCBs in that city would be at least heavily damaged by the
