The ShakeOut Scenario

Telecommunications

By
Alex Tang, P.E.
L & T Engineering and Project Management Consulting
Mississauga Ontario
May 2008

Assessing the Impacts of A M7.8 Southern San Andreas Fault Earthquake on Telecommunications

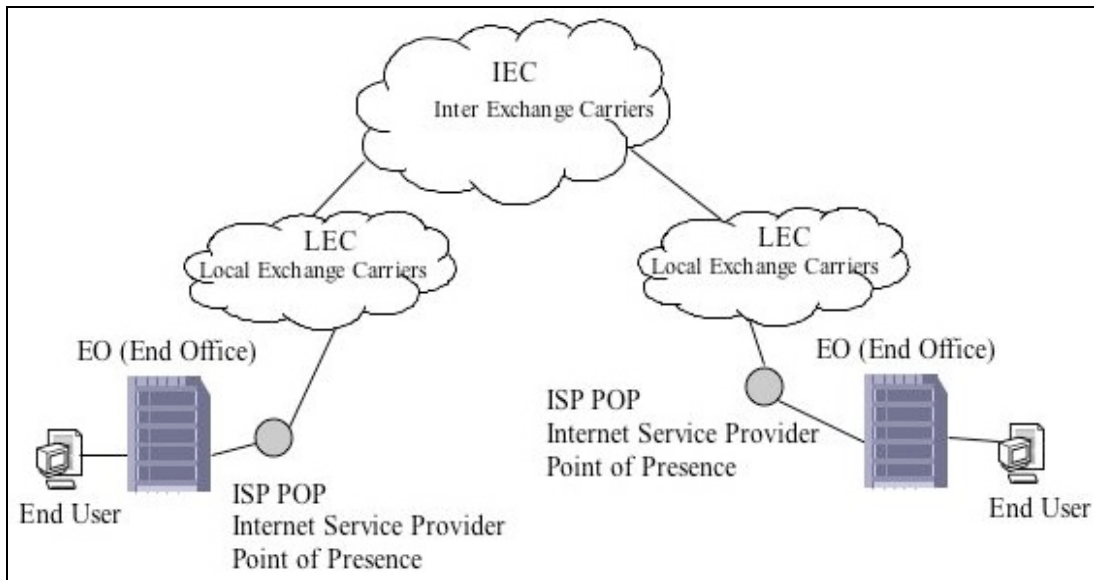
Figure 1 A over simplified Internet network

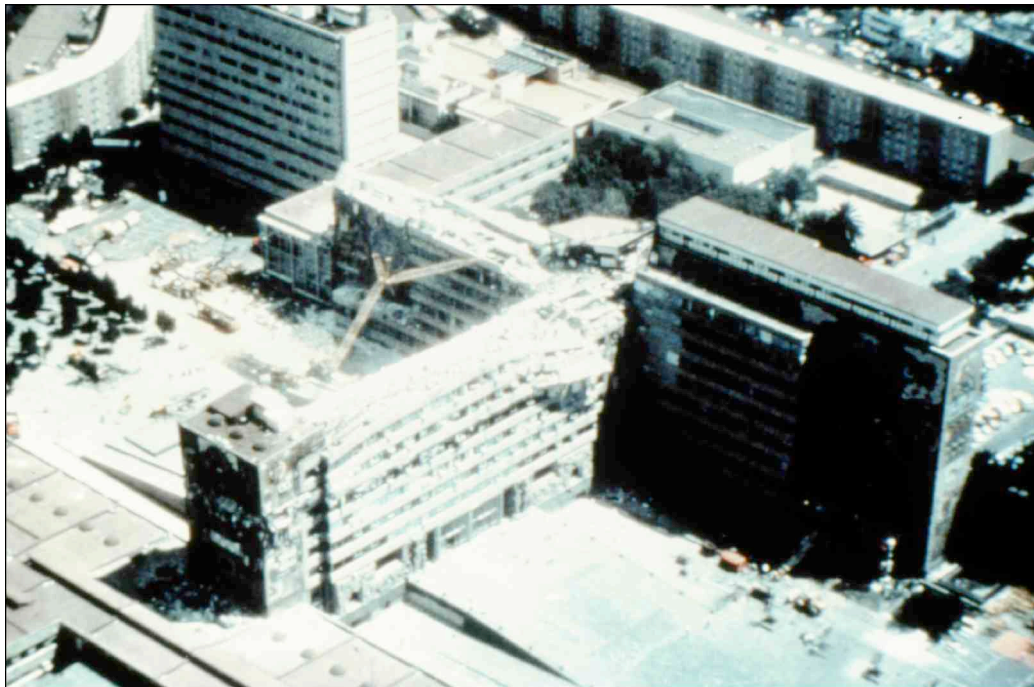
Figure 6. The top three floors of this communications building collapsed, cutting off long distance calls and significantly impacting local services in Mexico City in 1985 earthquake.

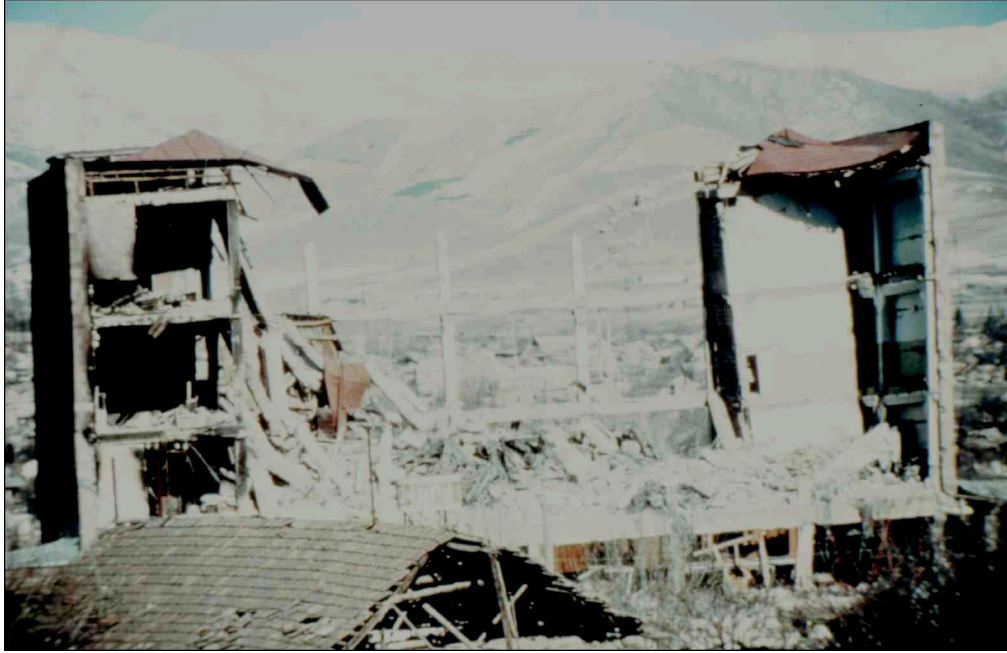
Figure 8. This Central Office in Spitak collapsed.

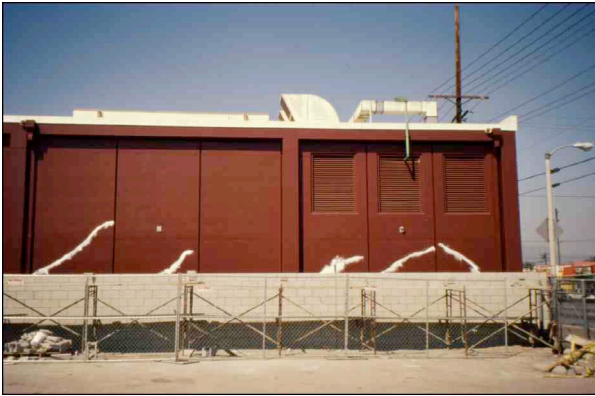
Fig. 9 A CO in Northridge after the 1994 earthquake with a few external wall cracks.

The above Figures 9 to 12 demonstrated the need to evaluate the CO structure against the latest seismic knowledge of the region. Although some of the equipment in this CO sustained minor damage, there was no capacity reduction due to the damage. The air condition unit on the roof was damaged and was replaced. Luckily the earthquake occurred in January and by opening doors with electric fans kept the air circulation and the equipment cool before the air condition was installed Figure 13.

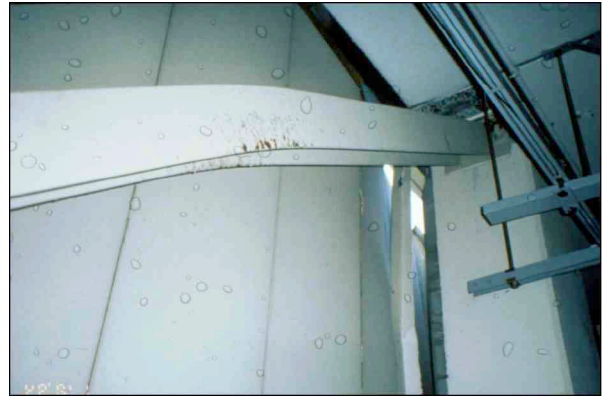
Fig. 10 This CO was upgraded, but the added bracing sustained damage but the building was saved.

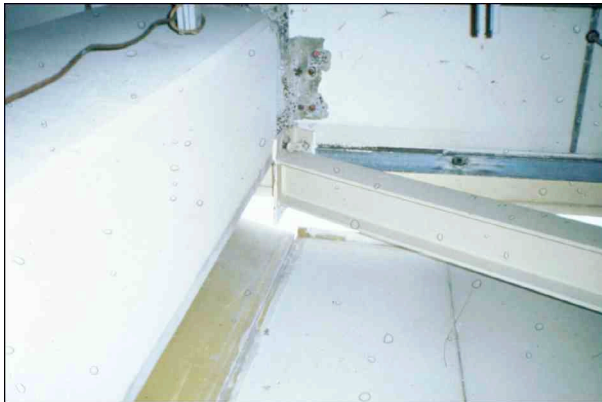
Fig. 11 This shows the anchors securing the diagonal bracing member to the structure were sheared.

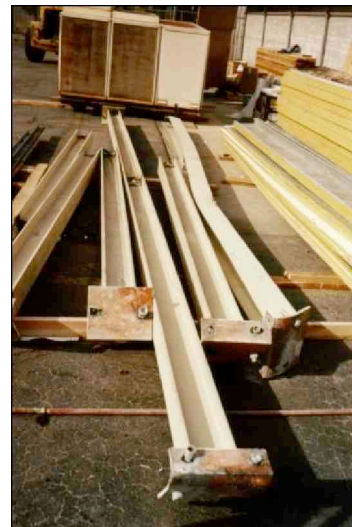
Fig. 12 The damaged bracing beams were removed and placed in the yard.

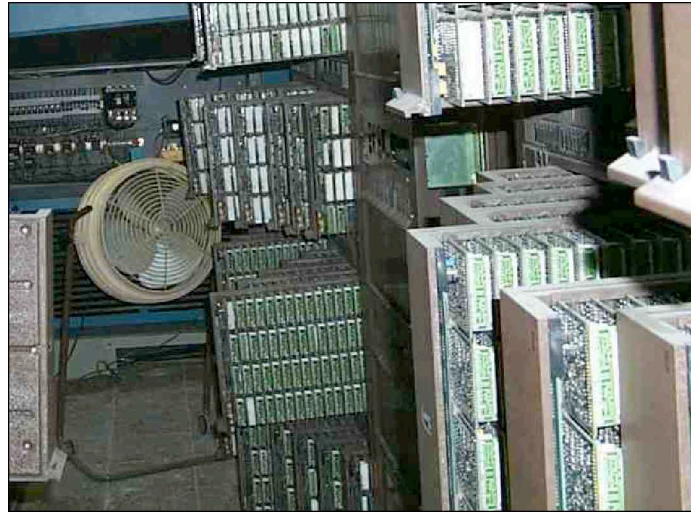
Fig. 13 Fan was used to cool the electronics, note that the units were pulled out to have better cooling effect.

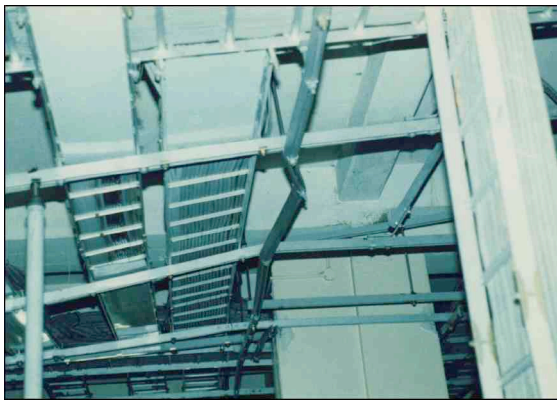
Fig. 14 The cable racks fell and were supported by jiffy poles, in Whittier Narrow earthquake.

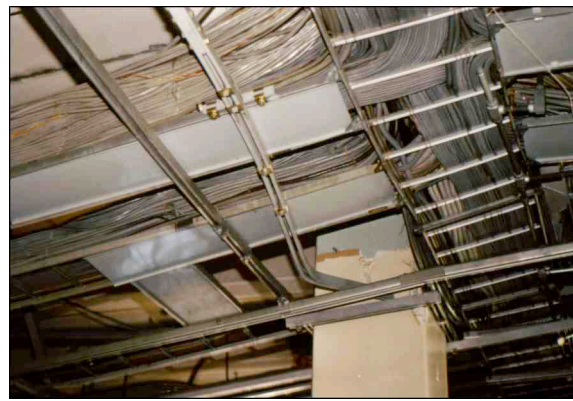
Fig. 15 This cable rack was overloaded and sustained extensive damage in Northridge earthquake.

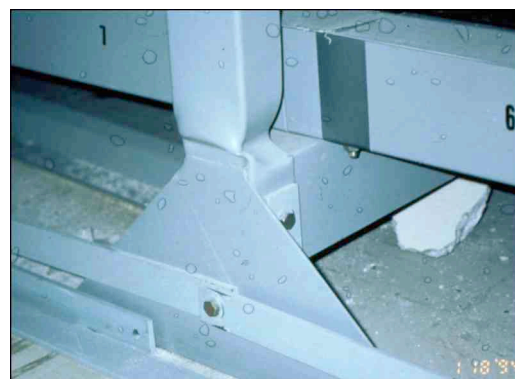
Fig. 17 This battery rack column showed insufficient load carrying capacity in Northridge earthquake.

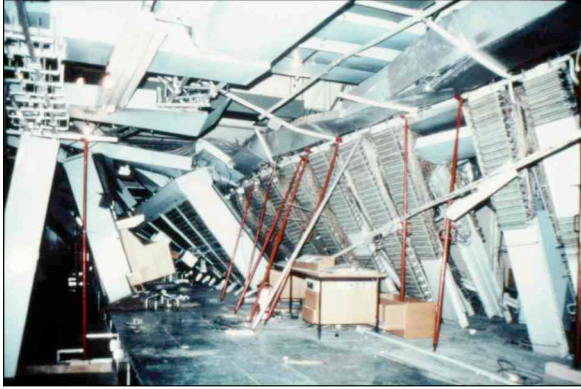
Fig. 18 This CO was non-functional equipment damage. Also this becomes a safety concern for the technicians working among the equipment.

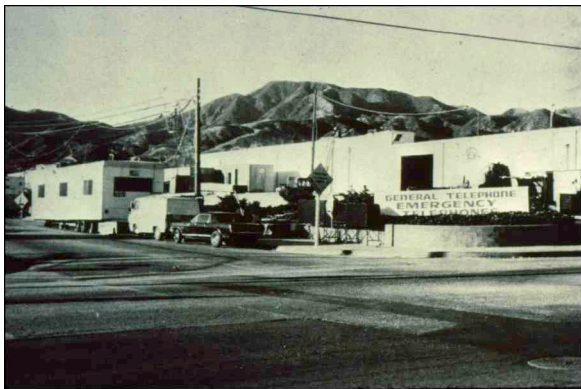
Fig. 20 This is the exterior of the CO after the 1971 San Fernando earthquake. The trailer outside housed a small switching unit to provide limited service to the area.

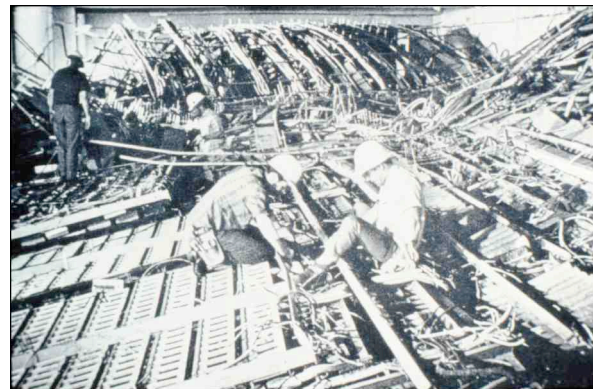
Fig. 21 The inside of the CO with all the switching equipment toppled. This was the old electro-mechanical switching unit.

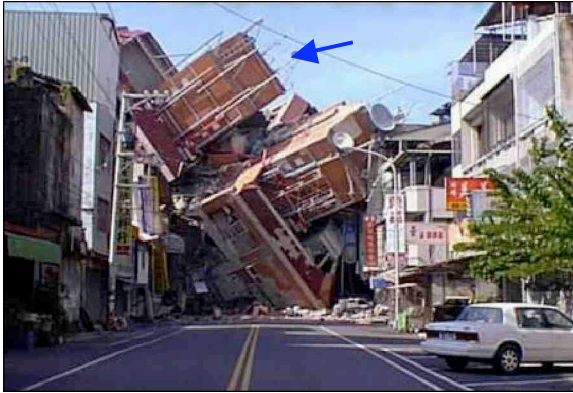
Fig. 22 A cell site that was installed on the roof of a commercial building was damaged due to building collapse. This is 1999 Chi Chi earthquake.

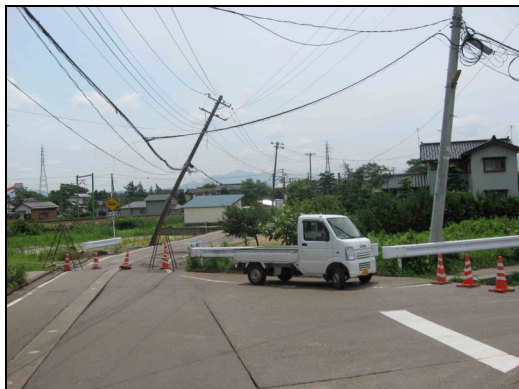
Fig. 27 Damaged poles due to lateral ground spreading

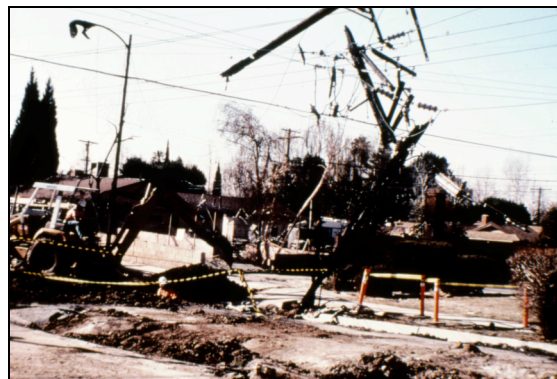
Fig. 28 Fire burned these poles taking out both electric power and telecommunications.

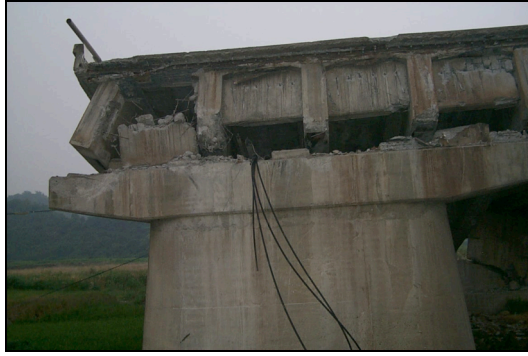
Fig. 29 One of the bridge deck collapsed and severed the cables under the bridge deck.

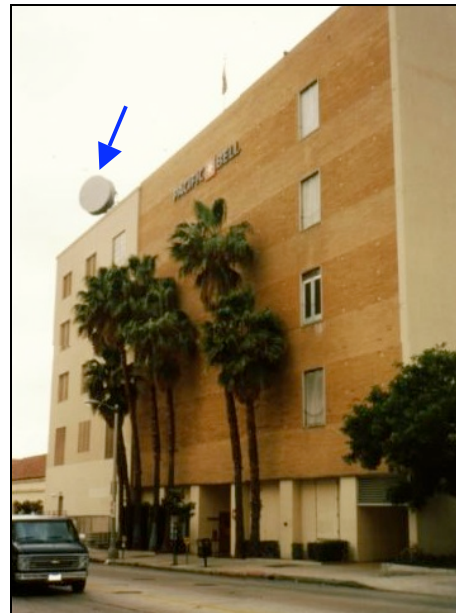
Fig. 32 Microwave dish on the roof of this CO.

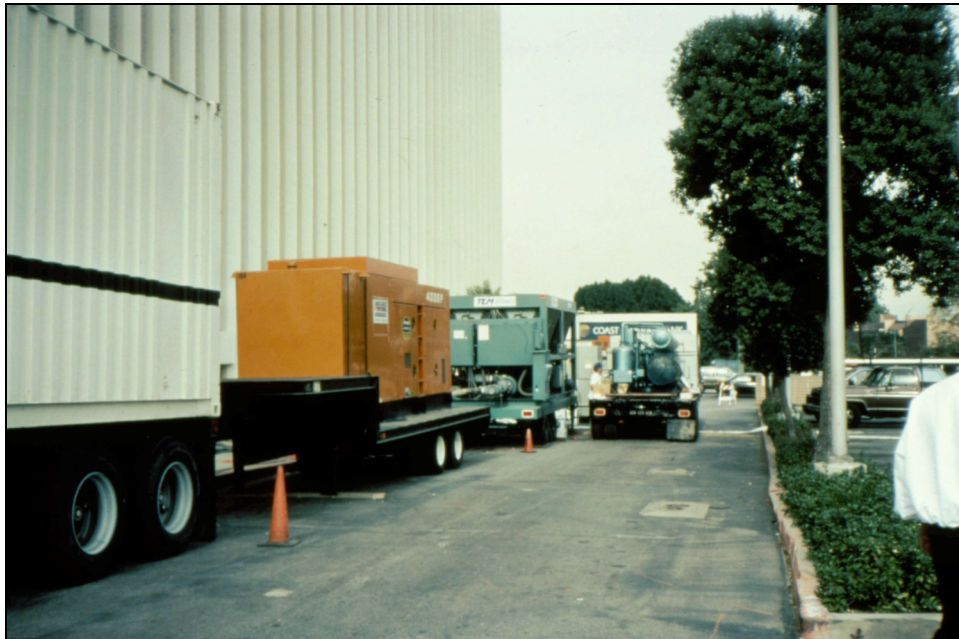
Fig. 41 Temporary mobile electric power generator was used after the Northridge earthquake at this node. The backup power generator was damaged and would be replaced. This building houses the network control center, the PSAP call center and a CO.
