Process of Housing Damage Assessment: The 1995 Hanshin-Awaji Earthquake Disaster Case

Key words: damage assessment, assessment process, assessment system, housing damage, Hanshin-Awaji Earthquake Disaster.

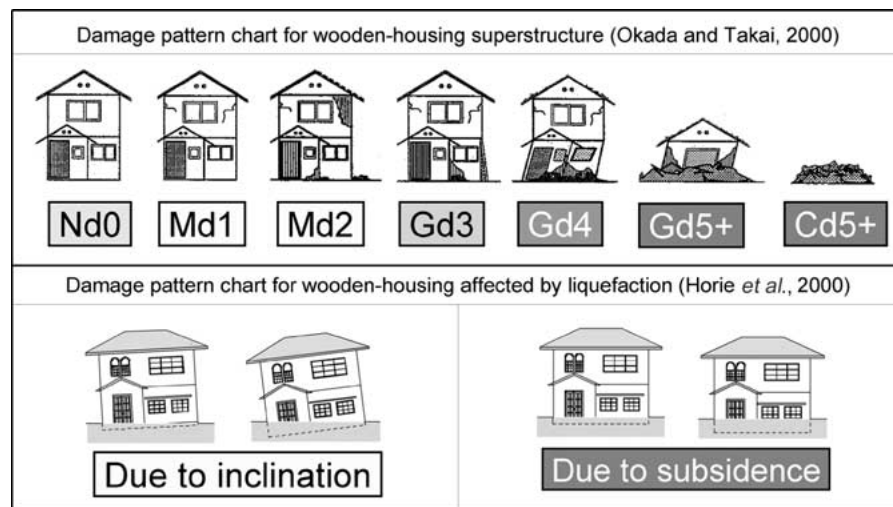
Figure 5. Example of building damage charts.

Okada and Takai (2000) classified building damage patterns using photographs of building damages taken in Hokudan Town, Awaji Island, in the Hanshin-Awaji Earthquake Disaster, and proposed a damage pattern chart for wooden-housing superstructures. A damage chart for wooden-housing affected by liquefaction was also developed based on the analysis of damaged buildings in the Tukiji area, Amagasaki City (Horie *et al.*, 2000a). These damage pattern charts are illustrated by the schematics of building damages as shown in Figure 5. They are expected to facilitate damage assessment and reduce the error in judgment due to differences in the viewpoints among investigators.

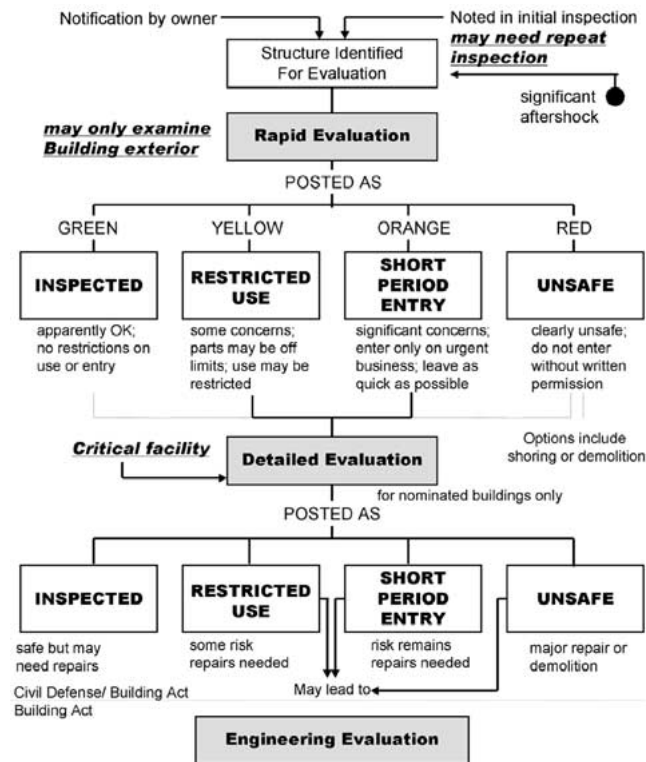
Figure 8. Process of Post-earthquake building inspections in New Zealand.

The building damage assessment system in New Zealand is described in *Post-Earthquake Building Safety Evaluation Procedures* (New Zealand National Society for Earthquake Engineering, 1998). This procedure was derived from the ATC 20 and ATC 20-2. The evaluation conducted after an earthquake has five types as shown in Table VIII. The evaluation timing, purpose and organization were established clearly in each evaluation. The assessment process is shown in Figure 8. Although it was similar to ATC, the result of evaluation was divided into four levels: unsafe, short period entry, restricted use and inspected. As characteristics in the process, buildings might be inspected exterior only in a rapid evaluation. Critical facilities were given priority, and a detailed evaluation was first conducted. In the case of New Zealand, measures for aftershocks and safety of inspectors were
