Plenary: Multidisciplinary Perspective on the 2010 Haiti Earthquake

A NEW CHAPTER IN RAPID DAMAGE ASSESSMENT: USING TECHNOLOGY & THE POWER OF THE CROWD

Annual Workshop 2010

Shubharoop Ghosh Vice President. ImageCat

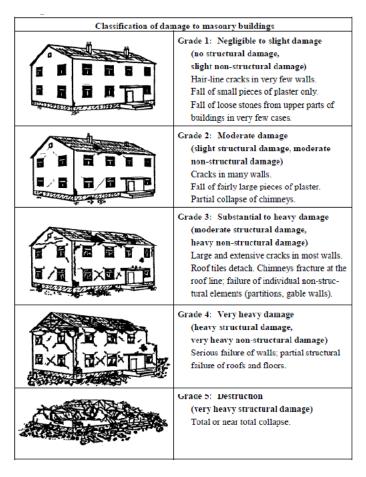
EMS-98 damage scale

Damage Interpretation Guidelines

<u>Level 5 - Destruction</u>: All or most of building structure collapsed. Here: Collapsed/broken roof, walls destroyed (debris surrounding building)

Level 3 - Substantial to heavy damage: Limited damage observed to building, or no damage observed but immediately adjacent to destroyed or very heavily damaged building. Here: Centre building assessed has limited damage (some debris to the left of building), but bright building adjacent (above) severely damaged as seen in collapsed walls (debris to the left of building)

<u>Level 4 - Very heavy damage</u>: Part of building structure collapsed, such as part of roof or one or more fallen walls Wall fallen into street (bright debris)

No visible damage: Assessed building does not appear to l damaged. Here: Centre building with brown roof seems intact. No debris or collapsed structure is observed. Neighboring buildings do not show damage either, providing contextual information to help decide on the "no damage" state.

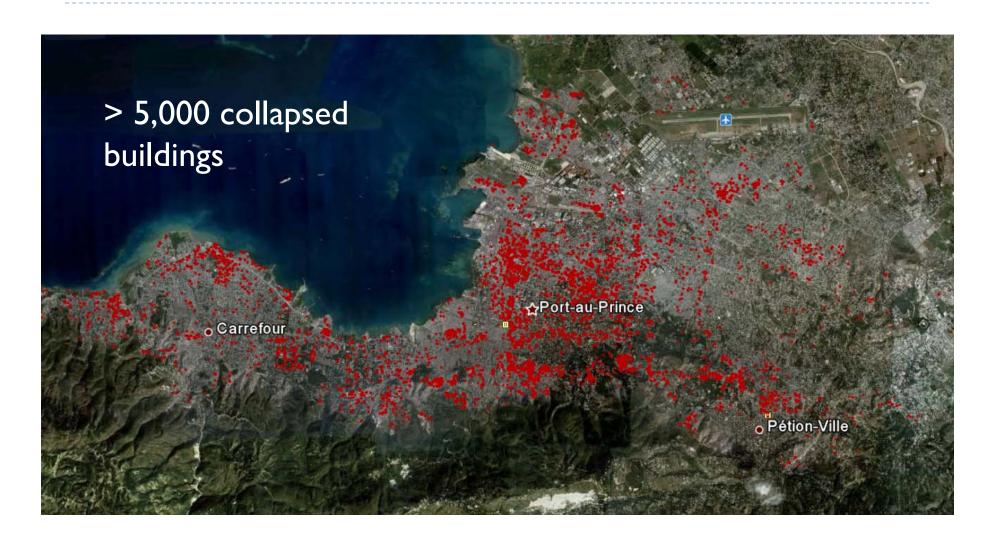
Phase 1 results

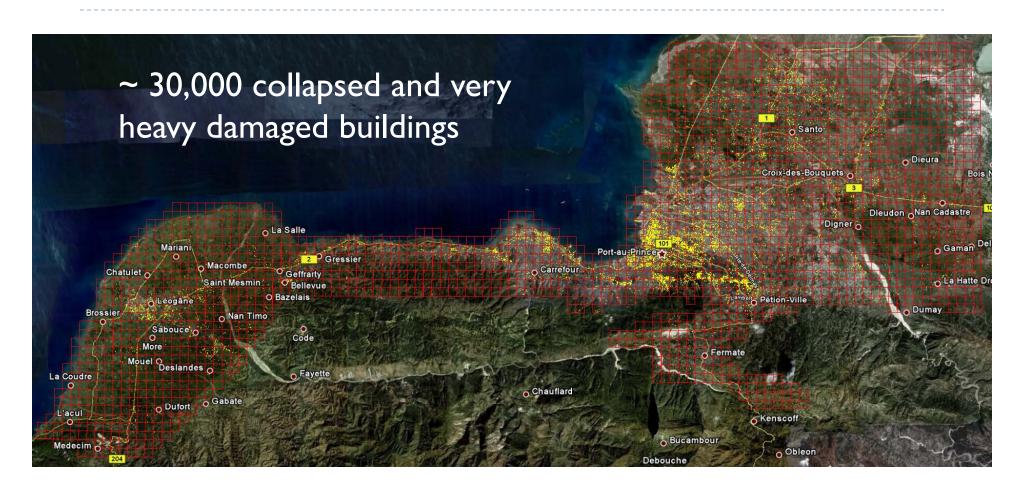
Phase 2 Results

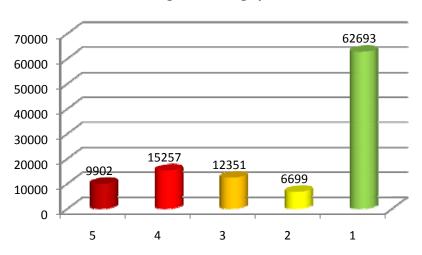
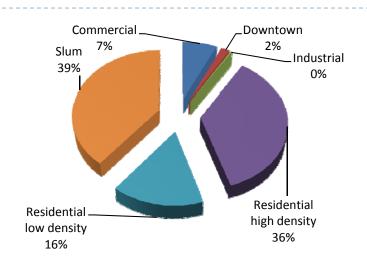
World Bank – UNOSAT – JRC Joint Damage Assessment

Number of Damaged Buildings per EMS-98 Class

Example of Damage Figures for Port au Prince:

- Number of buildings per class
- Damages per land use class
- Floor area per land use type and damage class allowing a monetary estimation of damages (approx. 2.2 billion \$US for Port-au-Prince

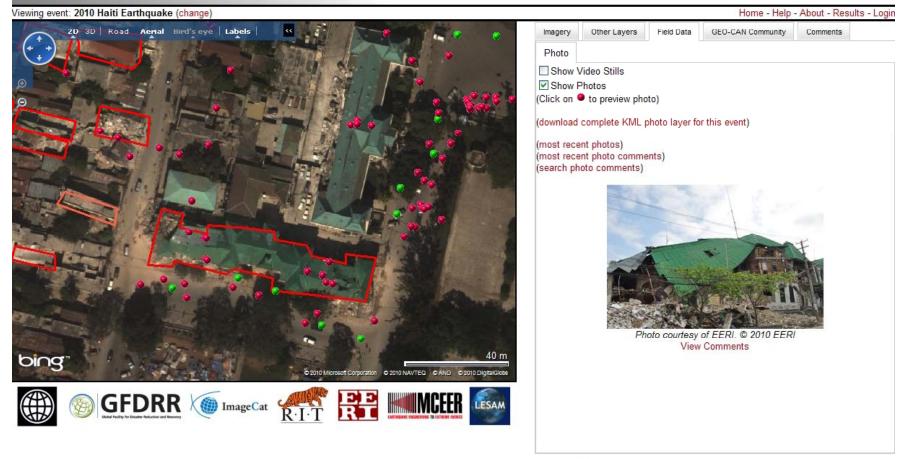
VDV Virtual Disaster Viewer

Note: Photo locations not verified. Analysis results are preliminary.
