An Analysis of the September 20, 2002, Indianapolis Tornado: Public Response to a Tornado Warning and Damage Assessment Difficulties

Jamie D. Mitchem

QUICK RESPONSE RESEARCH REPORT #161

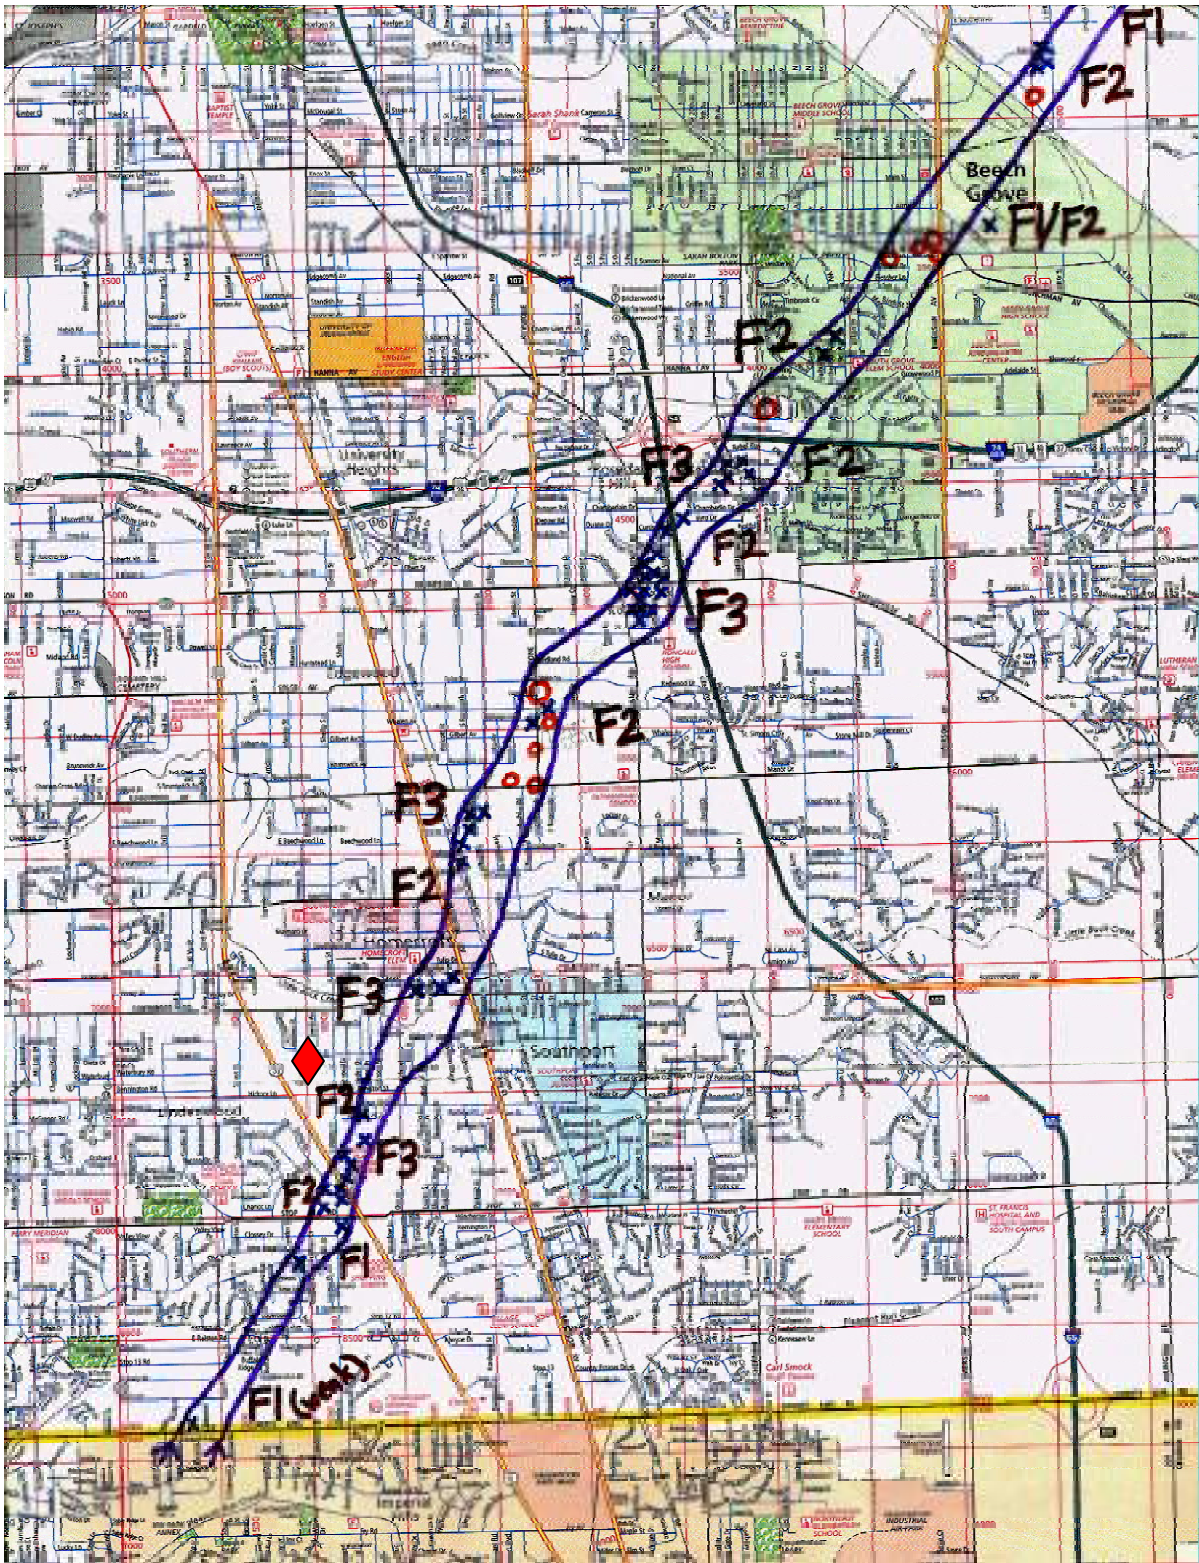
Segment 1 (Figure 4)

The tornado entered Marion County from the southwest (Fig. 1) causing weak F1 (but mainly F0) damage around the Faith & Charity Assembly church on County Line Rd. as it exited Johnson County. The tornado continued producing F1 damage to trees and homes until it crossed Stop 11 Rd. where F2 damage began on the grounds of the Baxter YMCA. The tornado then produced F3 damage as it struck the main building on the Baxter YMCA grounds ripping off the roof and a wall of a classroom that had been evacuated just minutes before. A local news channel showed that the clock had stopped at 1:40 PM as the tornado hit this classroom. The tornado then crossed U.S. Highway 31 at the intersection with South Shelby St., damaging a Wendy's, Boston Market, and another local restaurant. The tornado continued moving northeast, striking Greenwood Place Shopping Center. Here the tornado heavily damaged a freestanding building containing a Shoe Carnival store and another local business, and it destroyed a vacant Pier 1 Imports store. The tornado tossed cars around in the parking lot (some occupied), and then struck the main portion of the shopping center damaging many businesses, particularly the Galyan's Sporting Goods store. The damage in this area was consistent with F3 types of damage, also.
