Investigation of a Damaged High-rise Building near Ground Zero

The building studied is a 39-story office building at 130 Liberty Street in lower Manhattan. It was located to the immediate south of tower 2. Figure 1 shows the building's location with respect to the Trade Center complex.

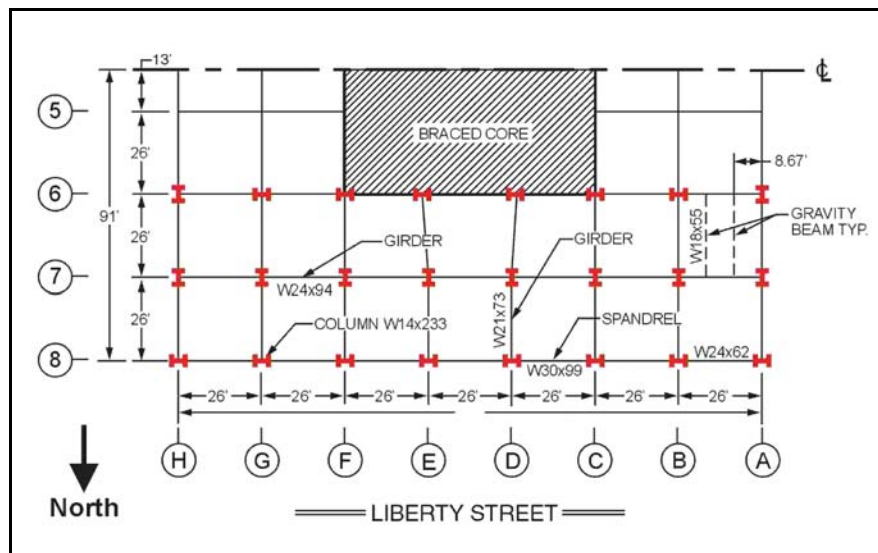
Figure 2. Part plan view of a typical floor with estimated section sizes at tenant level 25.

To facilitate three-dimensional finite element analysis of the building, sections sizes along frame lines 6 and 7, including intermediate perpendicular framing, were determined based on information from the September 23, 2001, reconnaissance visit and gravity load considerations. The resulting column and beam sections at tenant level 25 are shown in Figure 2 for one-half of a typical building floor plan.

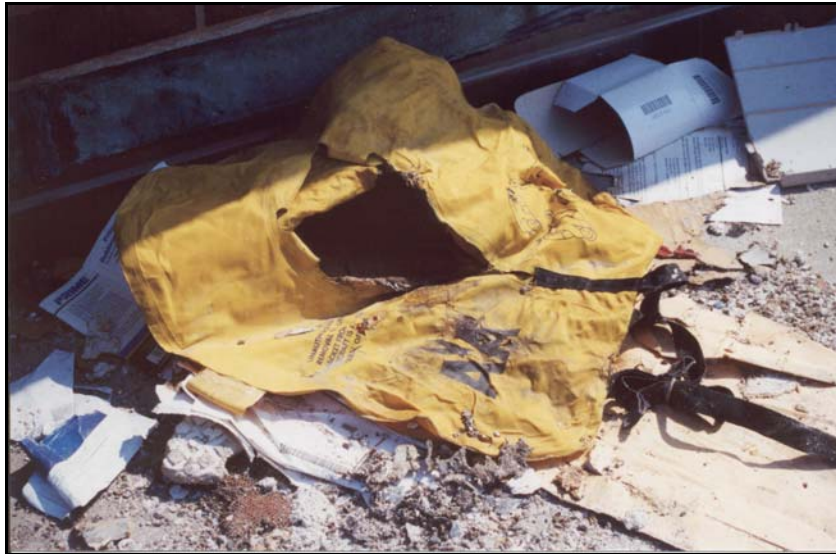
Figure 6 presents photographs taken at the roof level of the building. Part a of the figure is a photograph looking east across the roof. Silver U-shaped aluminum panels from tower 2 can be seen in the figure together with life vests from American Airlines (AA) Flight 11 that struck the north face of tower 1 (approximately 120 meters from 130 Liberty Plaza). Part b of the figure is a photograph looking west across the roof. Aluminum panels and AA life vests are also visible in this figure. Parts c and d of the figure are close-up photographs of an AA life vest and a seat from the AA Flight 11.

**Figure 6c. Debris at the roof level of 130 Liberty Plaza—
American Airlines life vest.**

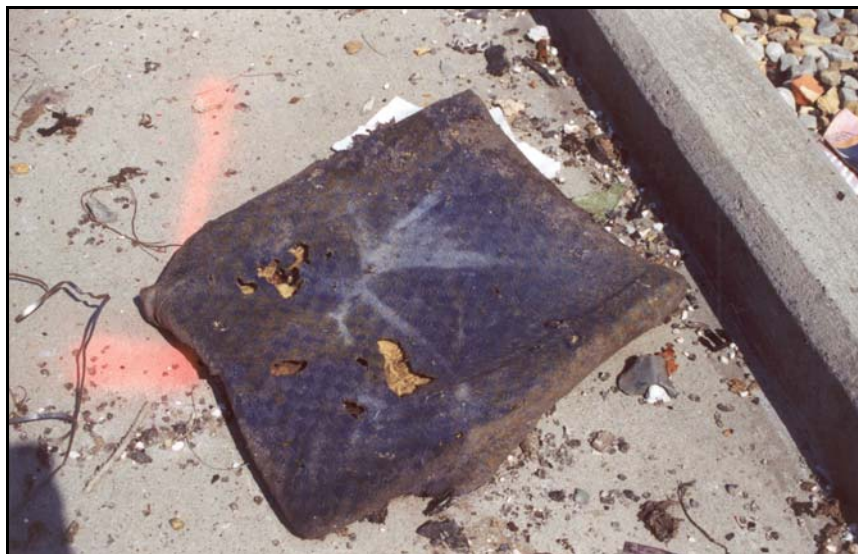
**Figure 6d. Debris at the roof level of 130 Liberty Plaza—
seat from American Airlines plane.**

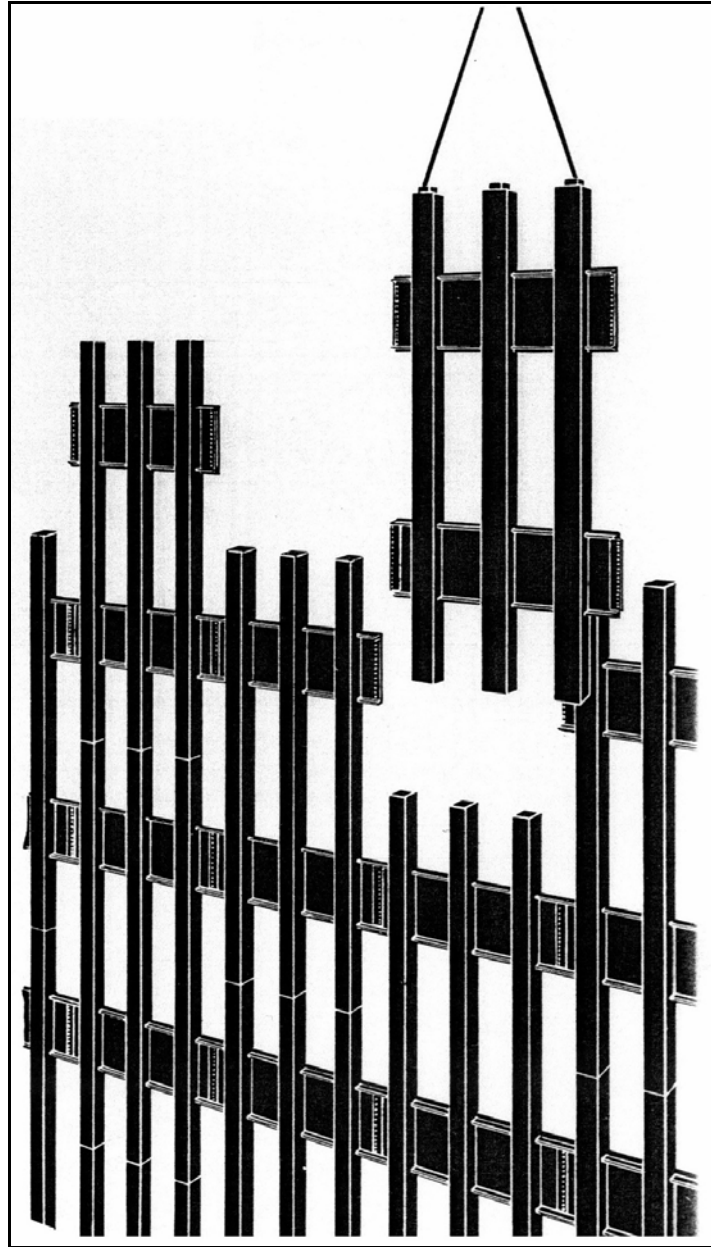
The first major structural damage was observed at tenant level 29 and was due to the impact of one single-story-tall structural steel column from tower 2. (As described in Bruneau et al. (2002), this column was one of three in a typical spandrel module, so the two steel beams linking the three columns were destroyed before the single column hit the 130 Liberty Plaza building.) Figure 8a is a sketch of a typical three-column module. Figure 8b shows the upper end of the column above Level 29. Figure 8c is a photograph of the underside of the column and the damage it caused to the ceiling system. It is noteworthy that the unreinforced slab on metal deck arrested the fall of this substantial steel member.

*Figure 8a. Damage due to column-missile ejected from tower 2—
three-column module used in the construction of tower 2
(from Hart et al., 1978).*

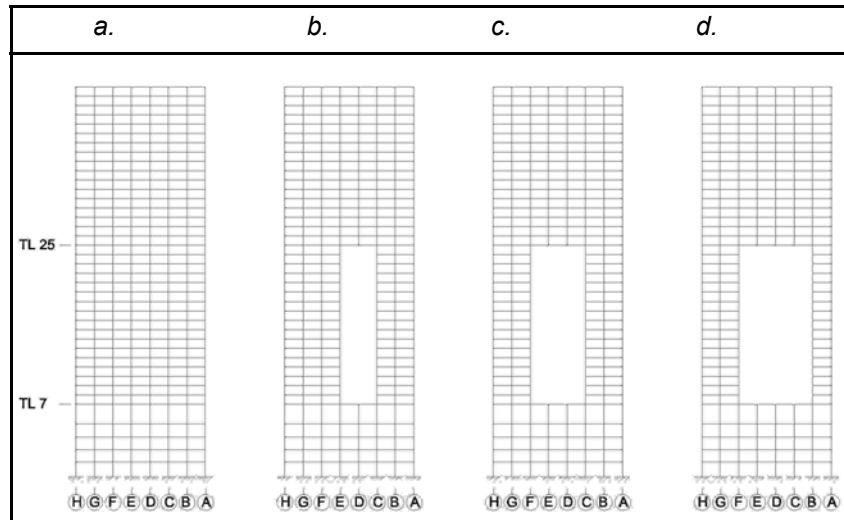
Two- and three-dimensional finite element models were constructed using SAP2000 (Computers and Structures, Inc., 2000). First, a two-dimensional model (Figure 15a) was prepared that considered structural framing over all 39 stories along line 8 (see Figure 2). This model was constructed to study the response of a single frame with varying degrees of damage (or damage states). Second, a three-dimensional model was prepared that considered structural framing over all 39 stories along lines 6, 7, and 8, including intermediate perpendicular framing (Figure 16). This model was prepared to better understand the response of the building for the observed damage state and to

Figure 15. Two-dimensional mathematical models of framing on Line 8:
 a. ND model; b. DS1 model; c. DS2 model; d. DS3 model.

Figure 4a. Each damage state involved the removal of columns on line 8 from tenant level 7 to tenant level 25. The three damage states involved the removal of (1) the column on line D (the observed damage per Figure 15b); (2) the columns on lines D and E; and (3) the columns in lines C, D, and E, denoted DS1, DS2, and DS3, respectively. Maximum member actions under gravity loads were calculated for the undamaged state and the three damage states.

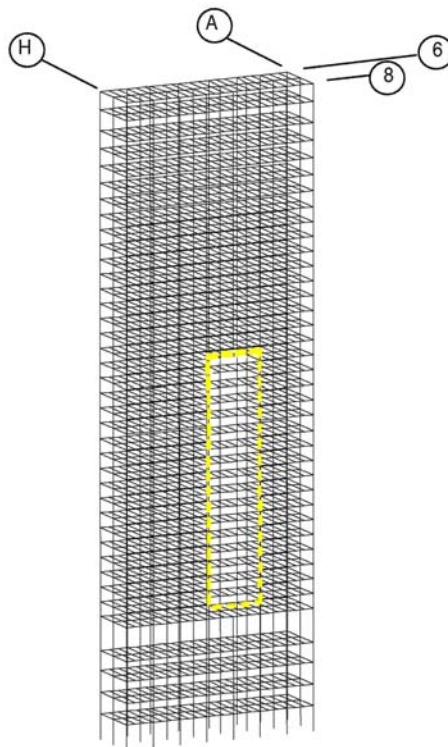
compare the results of two- and three-dimensional analysis. The light dashed line in Figure 16 identifies the zone of observed damage per Figure 15b.

Figure 16. Three-dimensional mathematical model of framing on lines 6, 7, and 8 for DS1.

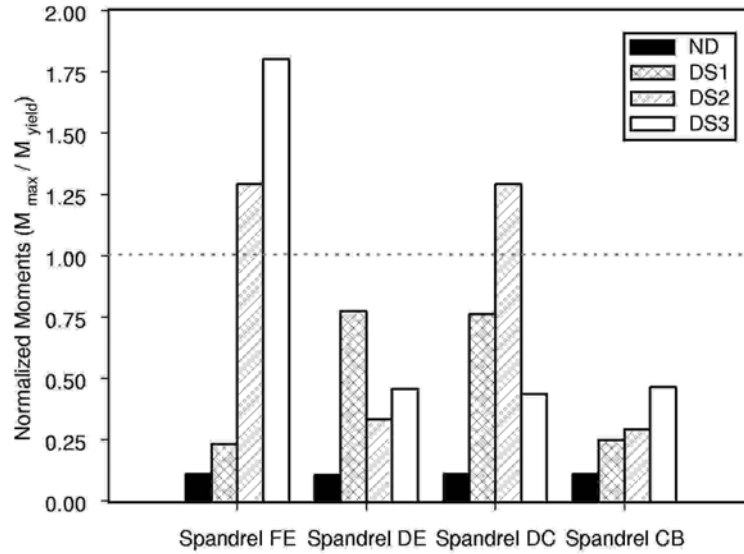
Figures 17 and 18 present some of the results of the two- and three-dimensional analyses, respectively. Shown in these figures are moments normalized by the yield moment for the assumed beam section sizes at tenant level 25—the floor level immediately above the observed damage. The spandrel beam designation (e.g., DE) refers to the grid lines between which the beam spans (e.g., lines D and E). The girder designation (e.g., E87) refers to the grid line along which the girder is aligned (e.g., line E) and the grid lines between which the girder spans (e.g., lines 8 and 7). Such normalized moments represent demand-to-capacity (D/C) ratios for these elements, albeit not exactly, because M_y is used in lieu of ϕM_{nx} and each beam is assumed to be fully braced.

The mathematical models for damage states DS2 and DS3 were prepared to evaluate the robustness of a building frame with characteristics similar to those of 130 Liberty Plaza, where robustness herein is judged by the ability of the framing system to support gravity loads after the loss of multiple perimeter columns. The results of the two-dimensional analysis of the DS2 model show that the frame on line 8 would have been compromised by the loss of columns on lines D and E unless the moment-resisting connections were ductile (i.e., possessed some degree of inelastic rotation capacity).

Figure 17. Demand-to-capacity ratios for two-dimensional linear elastic analysis.

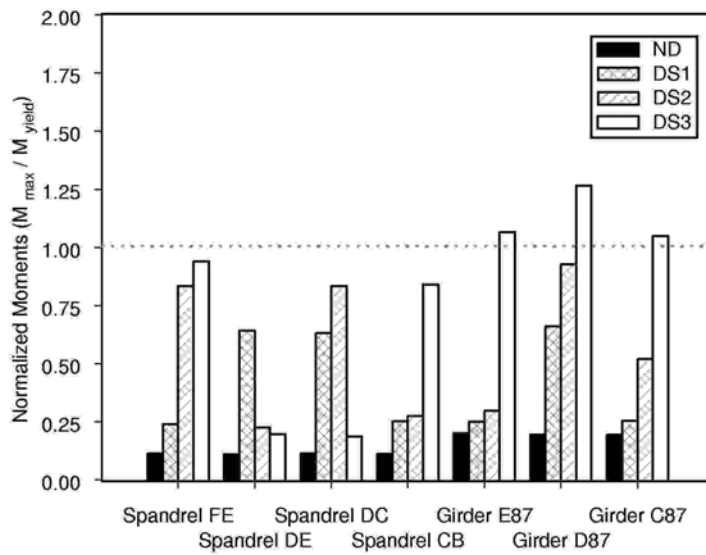
Review of the three-dimensional analysis results of Figure 18, however, shows that use of the results of the two-dimensional analysis leads to conservative conclusions and that moment-resisting framing perpendicular to

Figure 18. Demand-to-capacity ratios for three-dimensional linear elastic analysis.

line 8 also participated in the redistribution of load around the lost columns on lines D and E. Analyses for both the two- and three-dimensional models of DS3 (the loss of columns on lines C, D, and E) show modest overloads in both cases. For the three-dimensional analysis, the D/C ratios are greatest in the framing perpendicular to line 8, namely, girders C87, D87, and E87.

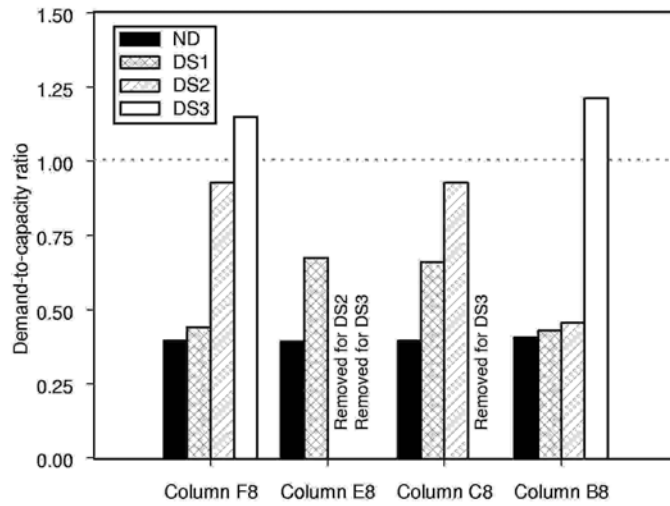
The results of the two-dimensional analyses shown in Figure 19 indicate D/C ratios less than unity for the undamaged state ND and the damage states DS1 and DS2. For damage state DS3, the D/C ratios for columns F8 and B8 exceed unity. Ratios greater than unity can be attributed to an increase in both axial forces and moments due to the removal of columns C8, D8, and E8. This observed increase in bending moment for the two-dimensional analyses ranged from essentially zero for ND to approximately $0.25M_p$ for DS3, where M_p is the plastic moment. Noting that the span between adjacent columns for DS3 is four times the span in the undamaged state ND, an increase in moment demand is expected. The D/C ratios for the three-dimensional model (Figure 20) are less than unity for ND and DS1, DS2, and DS3. Again, the results of the three-dimensional analyses indicate that the use of two-dimensional analysis leads to conservative conclusions and that the presence of perpendicular framing provides additional redundancy and capability for gravity loads to be redistributed to adjacent framing.

Figure 19. Demand-to-capacity ratios for two-dimensional linear elastic analysis.

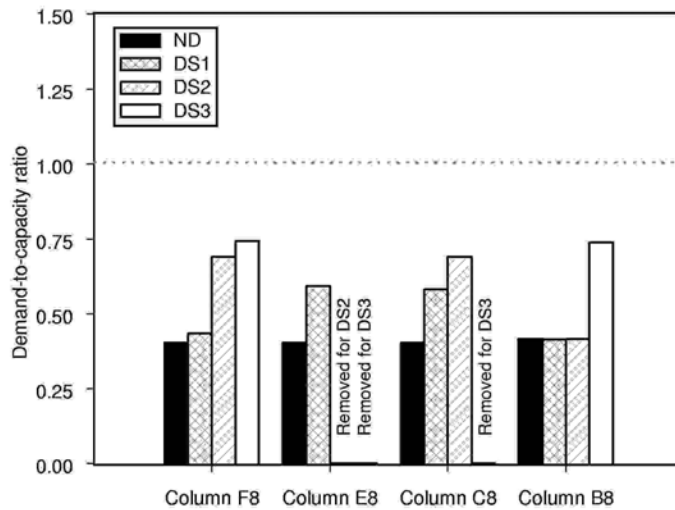
Figure 20. Demand-to-capacity ratios for three-dimensional linear elastic analysis.

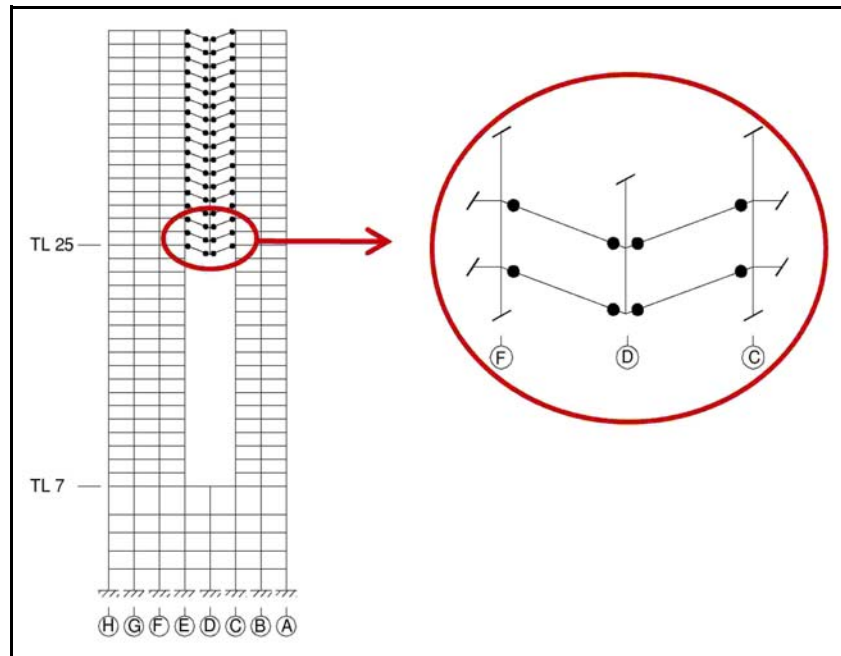
Simple two- and three-dimensional plastic analyses were performed to determine an upper bound on the load-carrying capacity of the framing system for each of the three damage states identified previously. In both the two- and three-dimensional analyses, beam plastic moments were calculated assuming a yield stress of 36 ksi (kips per square inch) and the section sizes determined in the preliminary design (see Figure 2). All sections were assumed to be compact. Further, all beam-to-column connections were assumed to have unlimited rotation capacity. For the two-dimensional analyses, vertical panel mechanisms were assumed to form for each damage state. Figure 21 shows the assumed mechanism for DS1. The assumed mechanisms for the three-dimensional analyses were similar, with the addition of hinges forming in the girders of the perpendicular framing where appropriate. Curtain wall loads and beam plastic moments were taken as known quantities, and the maximum corresponding floor load that could be sustained by the framing was determined for each case. Joint mechanisms involving plastic hinges in the column above and below the beams of tenant level 25 and in the beams of adjacent bays were also considered, however, the gravity loads necessary to cause those mechanisms were found to be larger than those required to form the mechanism of Figure 21.

Figure 21. Two-dimensional collapse mechanism for DS1.

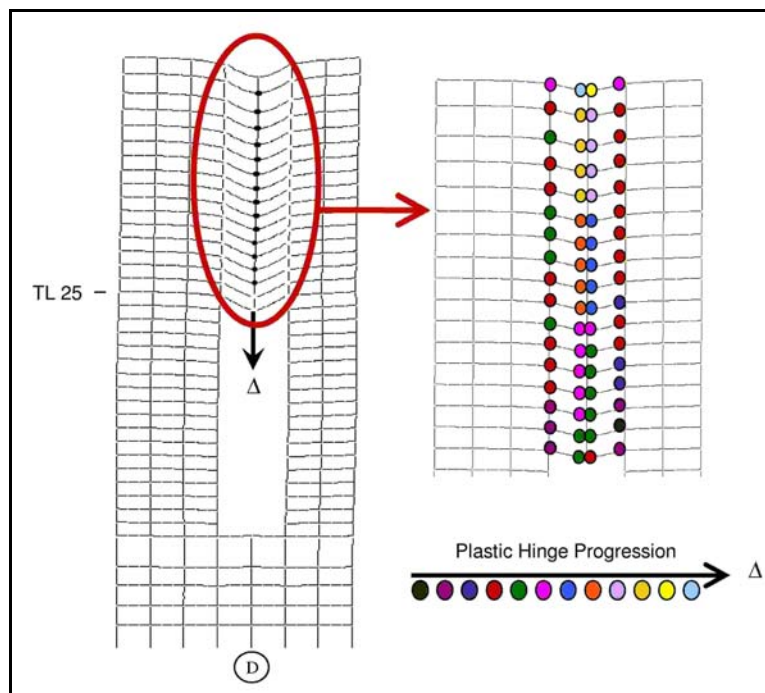
Before running the displacement controlled nonlinear static analysis, the curtain wall load was applied as a single force controlled step to be consistent with simple plastic analysis calculations. Figure 22 shows the observed progression of plastic hinging for DS1. The hinging patterns for DS2 and DS3 were similar to DS1. Hinging started at the beam-to-column connections on lines E and C near tenant level 25, progressed to the connections on frame line D, and then vertically up through the framing on line 8.

Figure 22. Progression of plastic hinge formation in DS1.

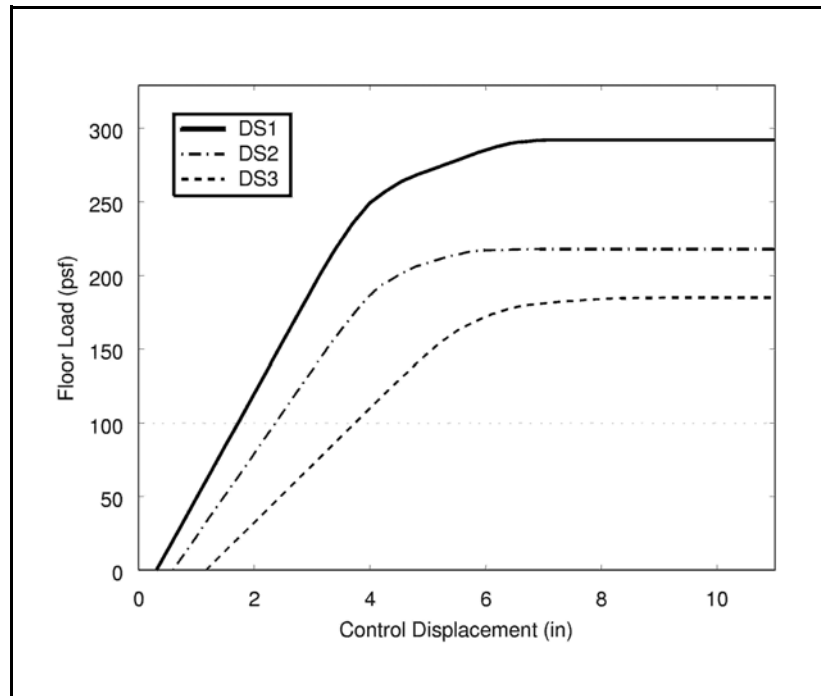
Figure 23 shows the resulting relationships between floor load (psf) and the deflection of line D at tenant level 25 for the three damage states, where the floor load is assumed to be present over the entire width of the damaged zone (i.e., between lines C and E for DS1, lines C and F for DS2, and lines B and F for DS3). The initial displacements seen in the figure correspond to the deflection due to the prior application of the curtain wall load. Also shown in this figure is the research team's estimate of the likely maximum floor loading at the time of the September 11th attacks, of 100 psf. As expected, an increase in damage led to increased structural flexibility and reduced the maximum permissible floor load. The results of the nonlinear static analysis and those of the simple plastic analysis are in good agreement for all damage states.

Figure 23. Two-dimensional vertical nonlinear static analysis for DS1, DS2, and DS3.
