The ShakeOut Scenario:

U.S. Geological Survey Open File Report 2008-1150 California Geological Survey Preliminary Report 25 version 1.0

Impacts of a M7.8 Southern San Andreas Earthquake on the Railway Network

William G. Byers, P.E.

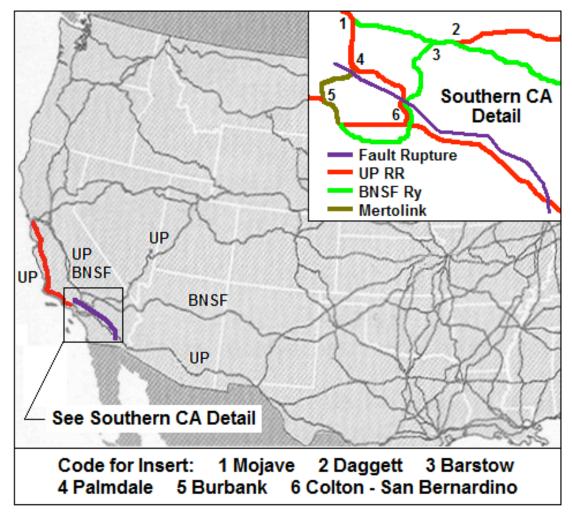
Fig. 1 Railroad network in Western United States

The UP owns a line along the coast, shown in red on the main map of Fig. 1, from a connection with Metrolink at Burbank, through Santa Barbara, to San Jose where it connects with the rest of the U.S. system. Metrolink operates commuter trains as far as Oxnard (beyond Burbank) and UP has freight operations over Metrolink into downtown Los Angeles. The line crosses the San Andreas Fault near Watsonville and should not be significantly affected by the scenario earthquake as it would experience peak ground accelerations less than 0.2g and less than 0.1g except in Burbank. It normally carries traffic for coastal points and is used by Amtrak passenger trains operating north out of downtown Los Angeles over Metrolink. The line normally carries about three percent of the Los Angeles freight traffic. While other lines were impassable, it could probably carry between 20 and 30 percent of the total traffic for a period of a month or more if sufficient qualified crews, and/or pilots to work with crews not qualified on the territory, were available. It is possible that Amtrak employees qualified on the territory could be made available as pilots and, if detouring for sufficient time appears likely, additional crews could be qualified on the territory. Such a level of use would probably not allow sufficient track time for significant maintenance and could not be continued for an extended period without temporary reductions to allow maintenance.

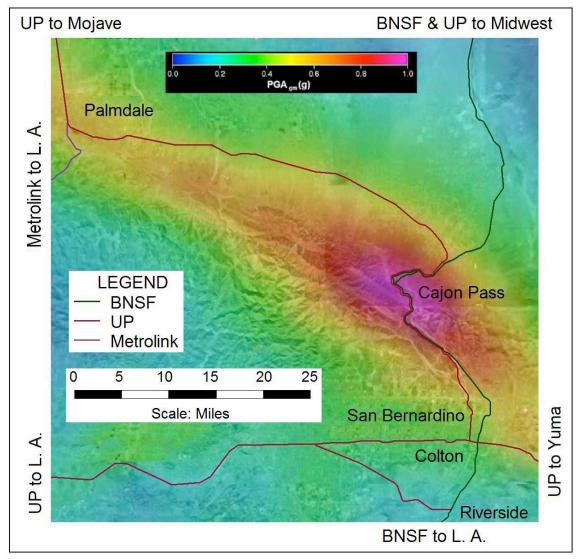
Fig. 2 Railroads and scenario peak ground accelerations near Cajon Pass

The rail lines through Cajon Pass, the area where railroad damage would be most severe and the loss of service would affect over half of the rail traffic, are shown, with scenario peak ground acceleration, in Fig. 2 and, with scenario modified Mercalli intensity, in Fig. 3. In Fig. 4, bridge and overpass locations on the BNSF line with two main tracks which carries nearly half the total Los Angeles area traffic and the location of the single track UP line are shown in greater detail.

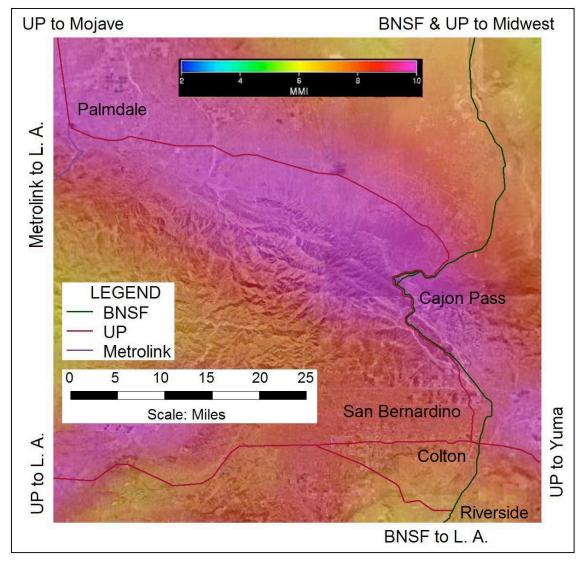
Fig. 3 Railroads and scenario modified Mercalli intensities near Cajon Pass

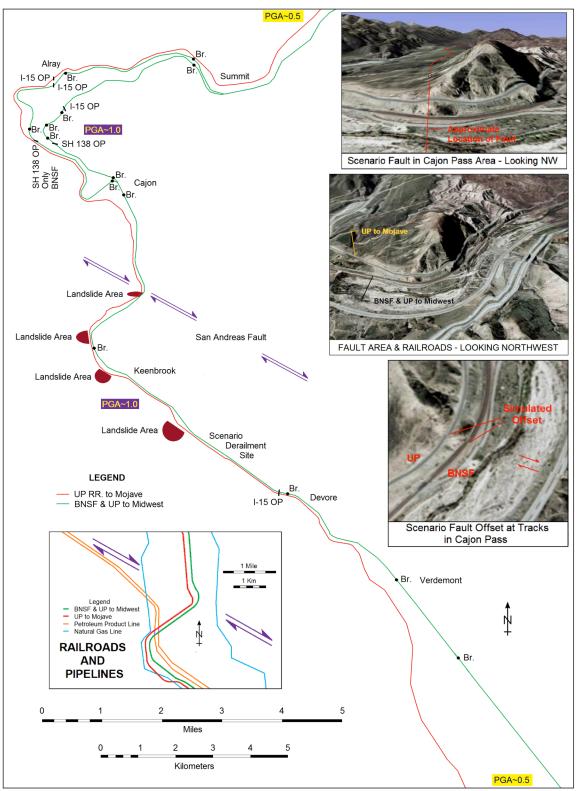
Fig 4 Details of Cajon Pass area

There are natural gas and petroleum product pipelines more-or-less parallel to the railroads through Cajon Pass. Their location, based on Lowe *et al*, is shown in an insert in Fig. 4. It seems almost certain that one or more of these lines would be ruptured and, although there are valves on both sides of the fault and the rupture locations would probably be at an appreciable distance from the tracks, the resulting fires could delay both inspections and repairs of railroad damage. There is even the possibility that large wildfires would be ignited, preventing access to the area for a considerable time.

There is a reasonable likelihood of a landslide at one or more of the locations shown in Fig. 4 closing the UP track and a smaller probability that it would also affect the BNSF tracks. Once equipment reaches the site, clearing the debris should be a matter of several hours.

There are 13 overpasses over the BNSF in regions with a PGA>0.4g. Five of these and two over the UP, shown in Fig. 4, are likely to be exposed to a PGA>0.8g. An additional seven are in the San Bernardino Basin, primarily on city streets, and could have an unexpected response to basin-induced amplification and oscillation at a critical period. It seems likely that, in spite of seismic retrofits, one or more overpasses would fall on the track. Clearing debris from a span collapsed on a track would probably require about 24 hours.

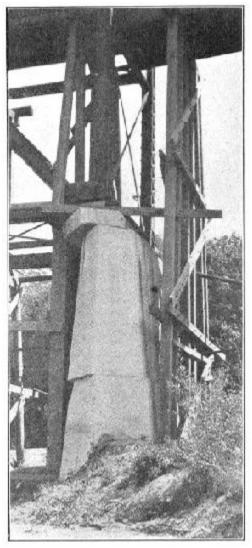
Fig. 5 Pier 5 – Pajaro River Bridge [Fig. 2 of Wallace *et al*]

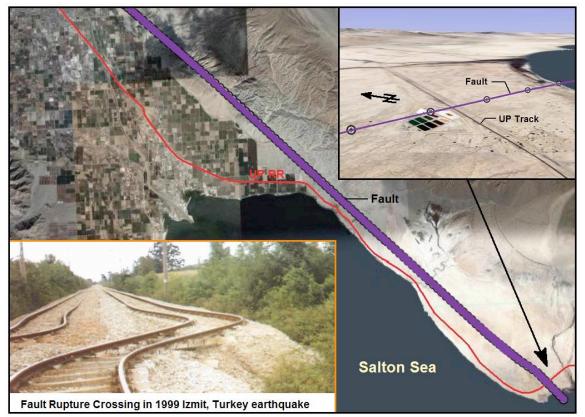
Fig. 6 Fault crossing and alignment along Salton Sea of UP line to Yuma

The most certain damage from the scenario earthquake is bending of rails and an impassable alignment due to the offset at the fault. The insert in Fig. 6 illustrates this type of damage, but on a low fill which did not require significant grading to provide a roadbed. Because of the topography, establishment of useable alignments through this area will be relatively time-consuming and the amount of equipment that can be utilized will be limited by congestion. Although possibly not realistic for permanent alignments because of interference with flow in the creek, it appears that the quickest way to reestablish rail connections would be to build new embankment on the southwest side of the fault between the BNSF and Cajon Creek to connect with the BNSF alignment to the northeast of the fault and build embankment on a similar plan for the UP. A retaining wall along the creek might be required to alleviate adverse effects on creek hydraulics. Some type of stabilization of the fault gouge to a considerable depth, possibly by injection grouting, either before constructing embankment over the fault or as soon as possible after it is completed, should be part of the construction. Considering the damage to railroads in the 2001 Atico earthquake in southern Peru, and the related recovery time, tracks should be in service on the new alignment in no more than a week.

About sixty miles of the Union Pacific line from San Bernardino to Yuma runs roughly parallel to and, for about half of its length, between five and ten miles from, the San Andreas Fault. The line runs along the east side of the Salton Sea, within one or two miles of the fault for about 20 miles, as shown in Fig. 6, until it turns east and crosses the fault. If there is a train in this area at the time of the earthquake – a realistic assumption considering the traffic density, there is a considerable risk of its derailment. For most of the rest of its length, it is far enough from the fault that, although possible, derailments caused by ground acceleration are unlikely. The location of the line does not make landslides a hazard and major bridge damage is unlikely.

The line crosses the fault rupture on a low embankment, as is evident from the insert in Fig. 6, at a location where the offset will be about 12 feet. Unless a high water table from the Salton Sea results in liquefaction, this situation will be very similar to one of the fault crossings in the 1999 Izmit earthquake where one of two tracks was returned to service within 45 hours after the earthquake. A photo furnished by the State Railways of Turkey, showing this damage, is an insert in Fig. 6. After the Izmit earthquake, a new alignment was constructed to connect the offset tracks within a few days but over a month after they were placed in operation it was still impossible to maintain track surface over the fault as an arch of compacted material had not yet formed over the loose gouge. (Operating speed was severely limited and the track was inspected after every train.) Some type of stabilization of the fault gouge to a considerable depth, possibly by injection grouting, should be part of the reconstruction at the fault crossing.

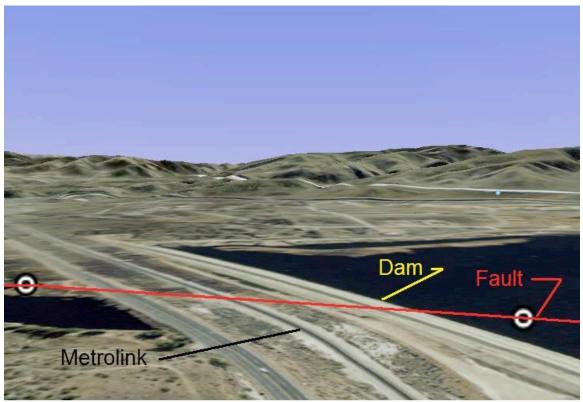
Fig. 7 Fault rupture, Lake Palmdale. Dam and Metrolink track

The Metrolink line carries little freight traffic and will be out of service due to crossing the fault rupture where the offset is about nine feet. The line is about 100 yards downstream from the dam for Lake Palmdale which also crosses the rupture as shown in Fig. 7. If the dam is breached – which is probable, the track and embankment will be washed out for the length of the breach. If this happens, the flood water may be rapidly dissipated allowing repairs to begin. A longer period out of service could result from precautions related to a damaged dam with a full reservoir. Any train, including commuter trains, operating in the vicinity of the breached dam could be exposed to the flash flood. Other, less significant damage to the line, including slides in cuts or embankments and minor damage to tunnels, is possible. If the dam is not breached, repairs at the fault rupture may be complicated by a high water table which may result in liquefaction and generalized instability of soils at the location. Stabilization of fault gouge under the embankment will be required. If the dam is breached, the line would probably be back in service in about a week. If it is not, the line would be out of service until the Lake Palmdale reservoir is drained and repairs taking an additional three or four days are completed.
