TRANSPORTATION PROBLEMS AND NEEDS IN THE AFTERMATH OF THE
1985 MEXICO CITY EARTHQUAKE

Antoine Hobeika
Siamak Ardekani
Alejandro Martinez-Marquez

1987

Quick Response Research Report #10

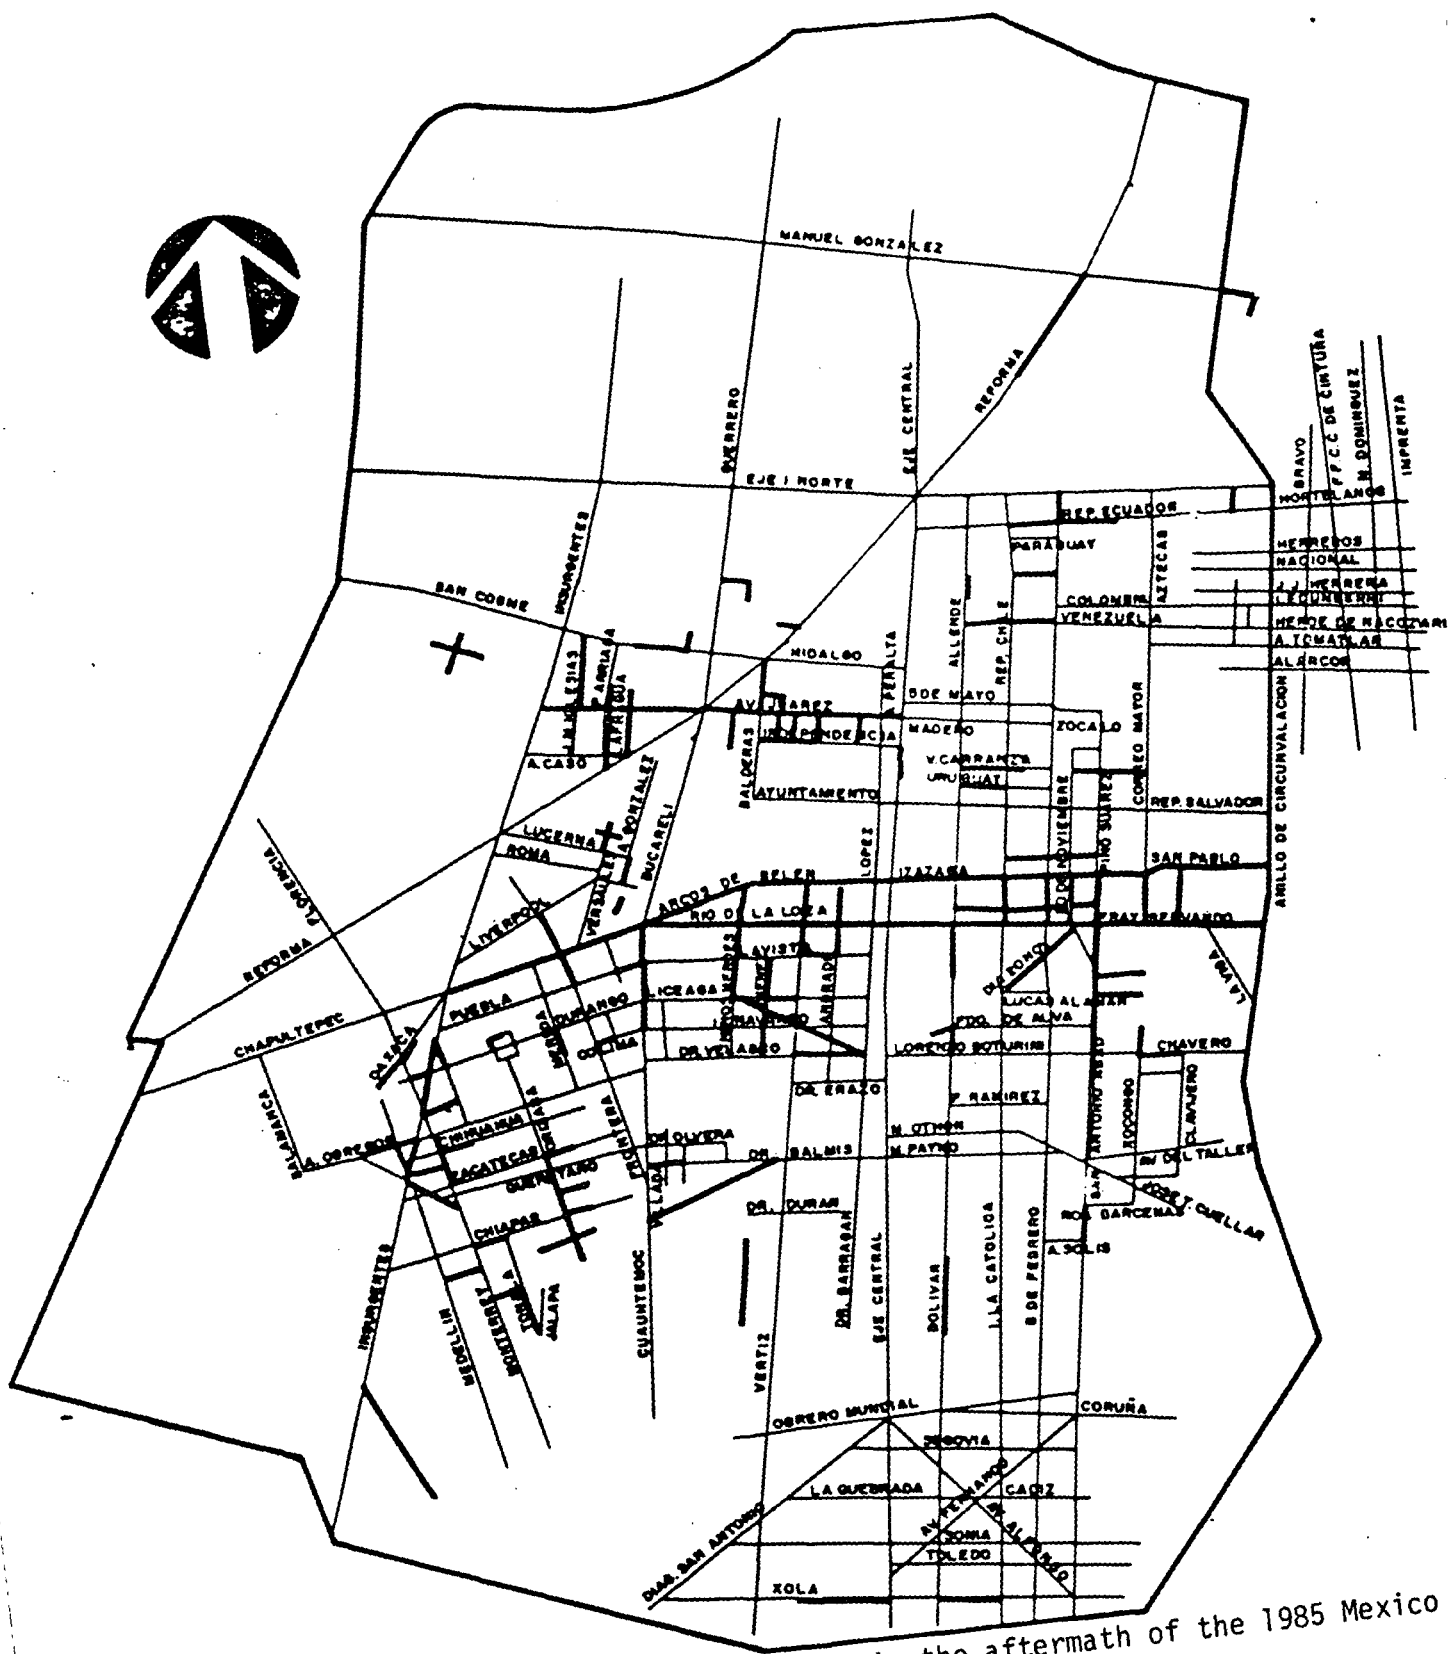
Figure 1. The map of severely damaged regions in the aftermath of the 1985 Mexico City earthquakes.

Most of these problems were concentrated in the central region of Mexico City shown in Figure 1. This is a zone whose primary streets are under the control and monitor of the Mexico City computerized traffic control system since 1982. Figure 2 also shows the distribution of the capacity reductions on a street-by-street basis within the affected network shown. The extent of disturbances within the area shown includes:

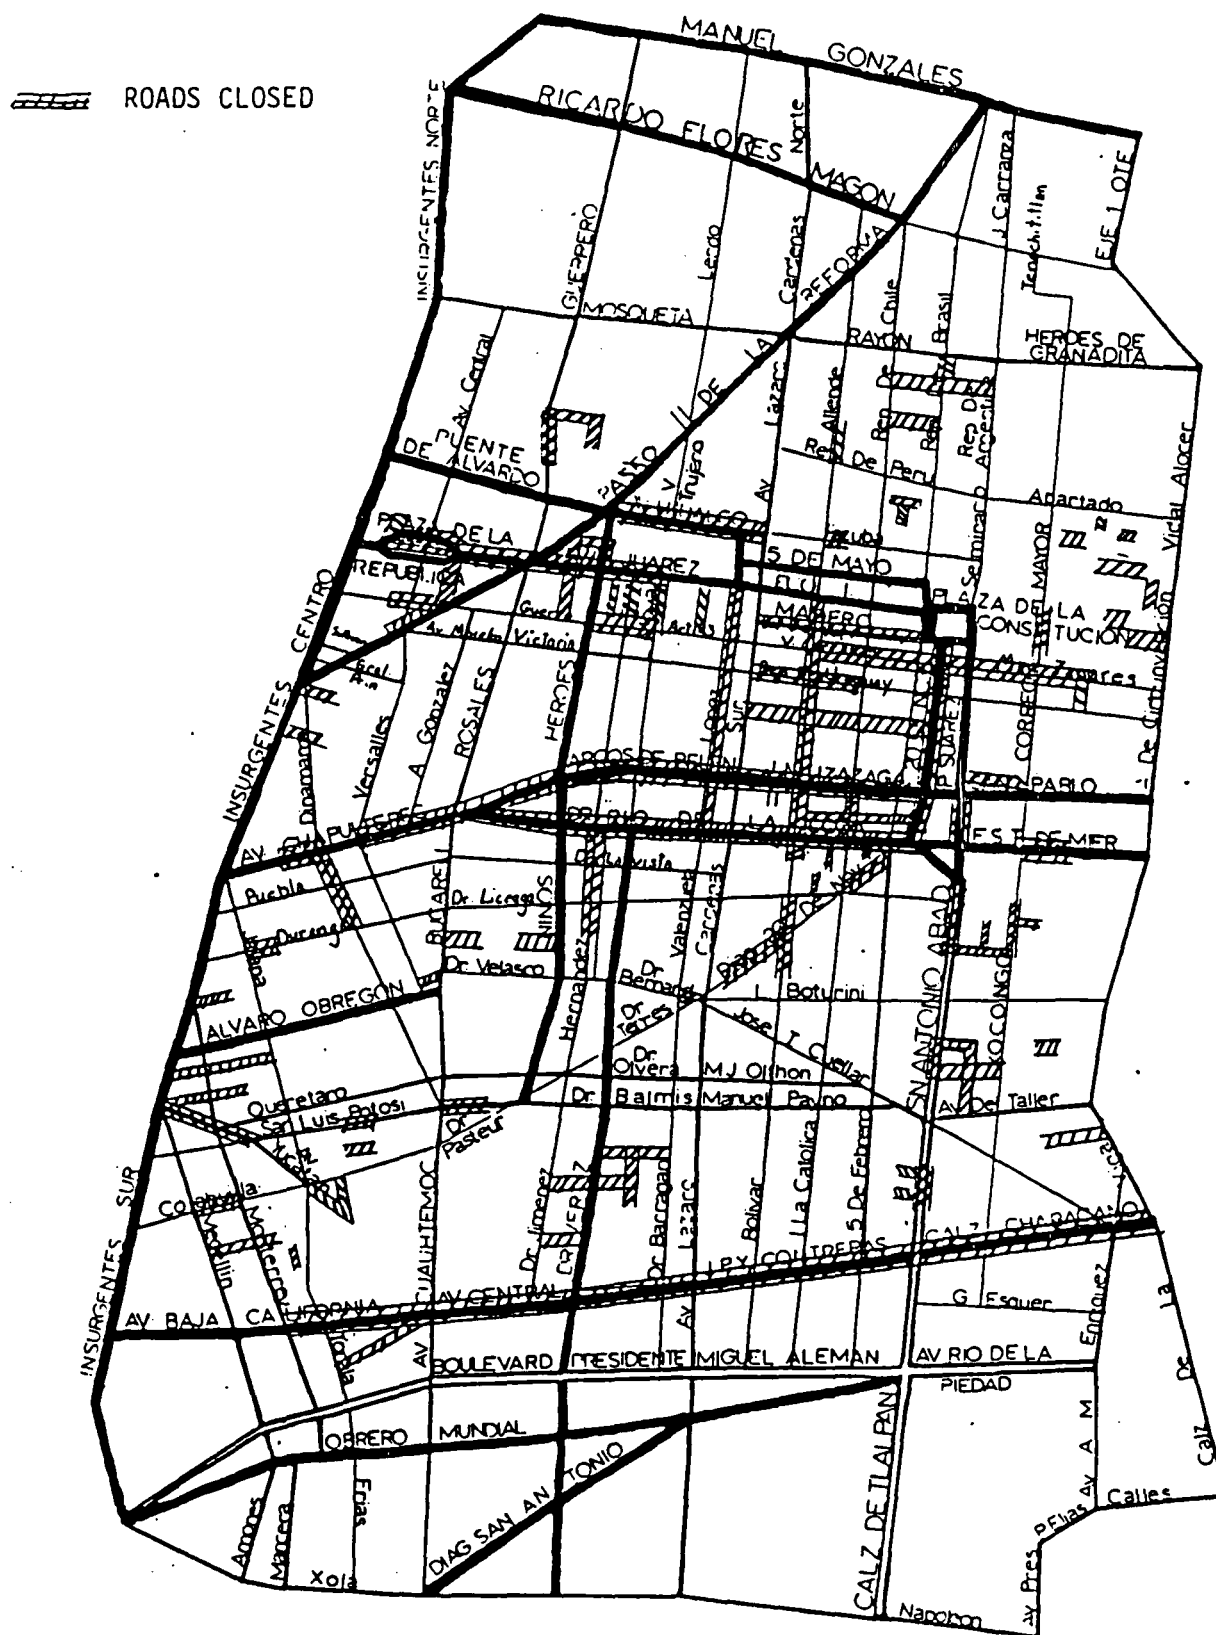
Figure 2. Location of streets closed to through traffic in the aftermath of the September 1985 Mexico City earthquake.

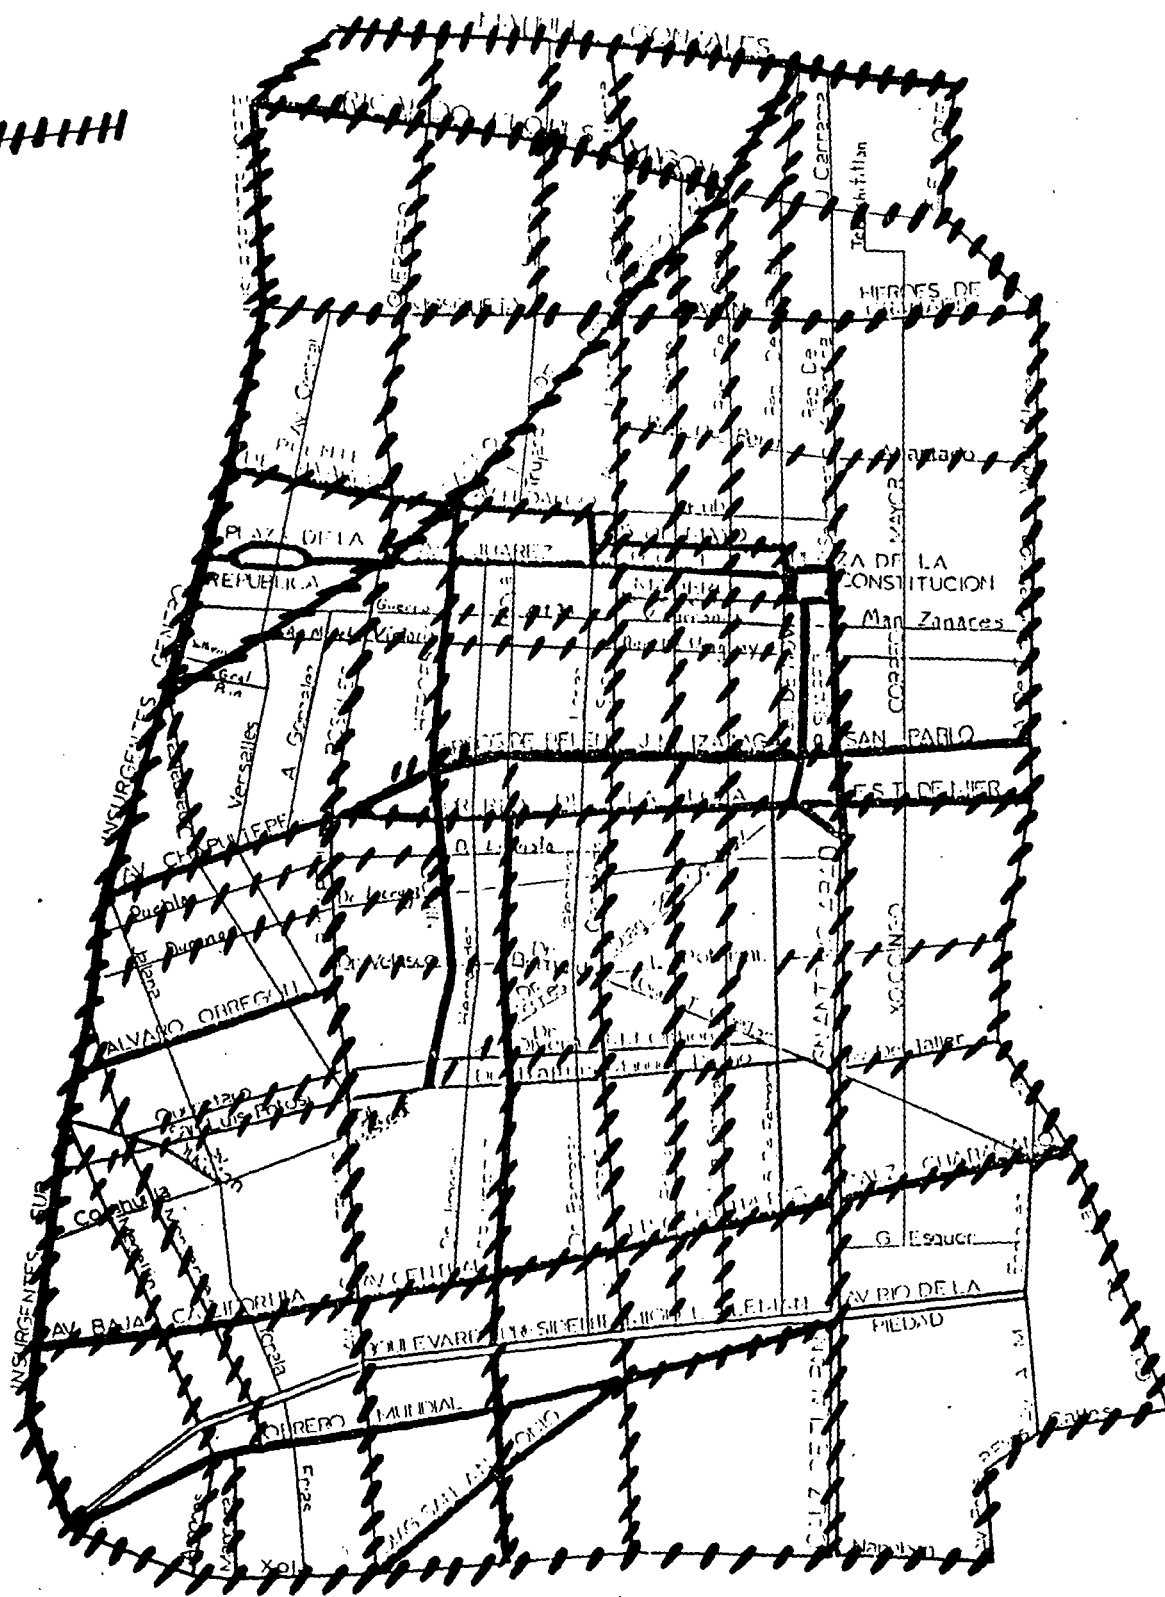
Figure 3a. Bus routes in the Mexico City study network.

As expected, the streets in the city center are heavily utilized as transit and para-transit routes. Figures 3a and 3b show the concentration of bus and trolley routes within the city center. In addition, all metro lines also converge at the city center (Fig. 3c). Consequently,

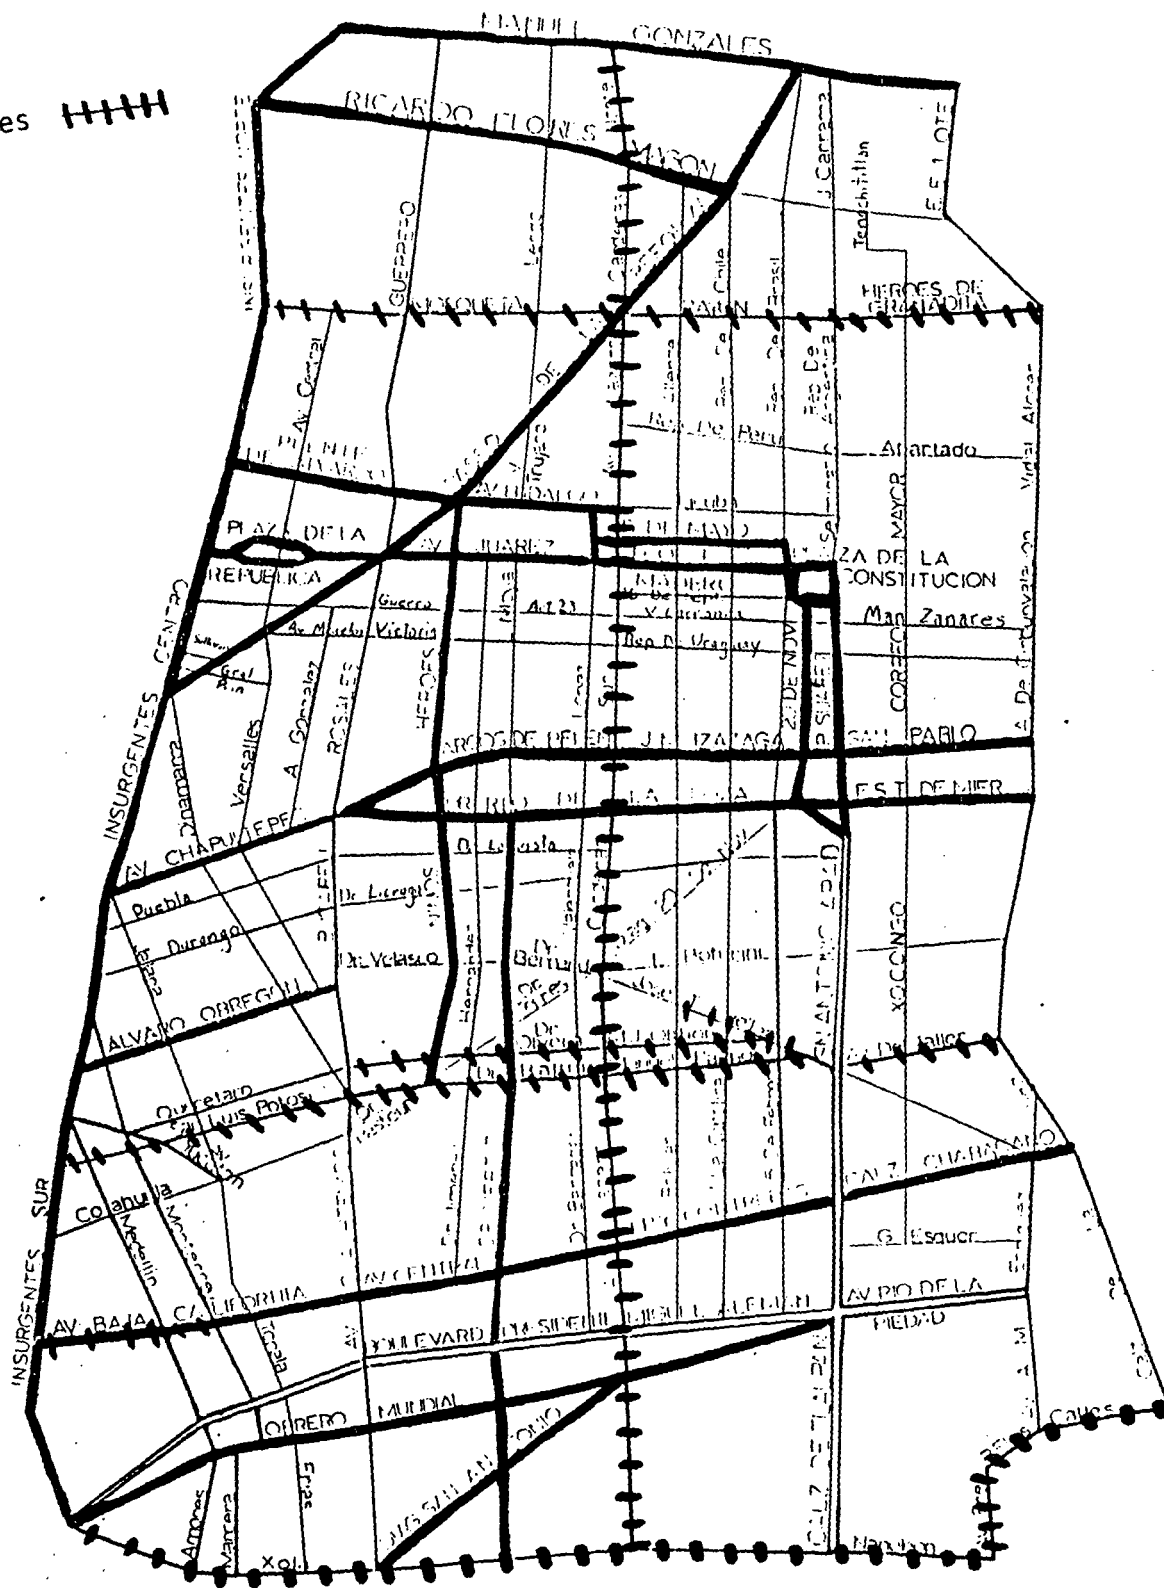
Figure 3b. Trolley lines in the Mexico City study network.

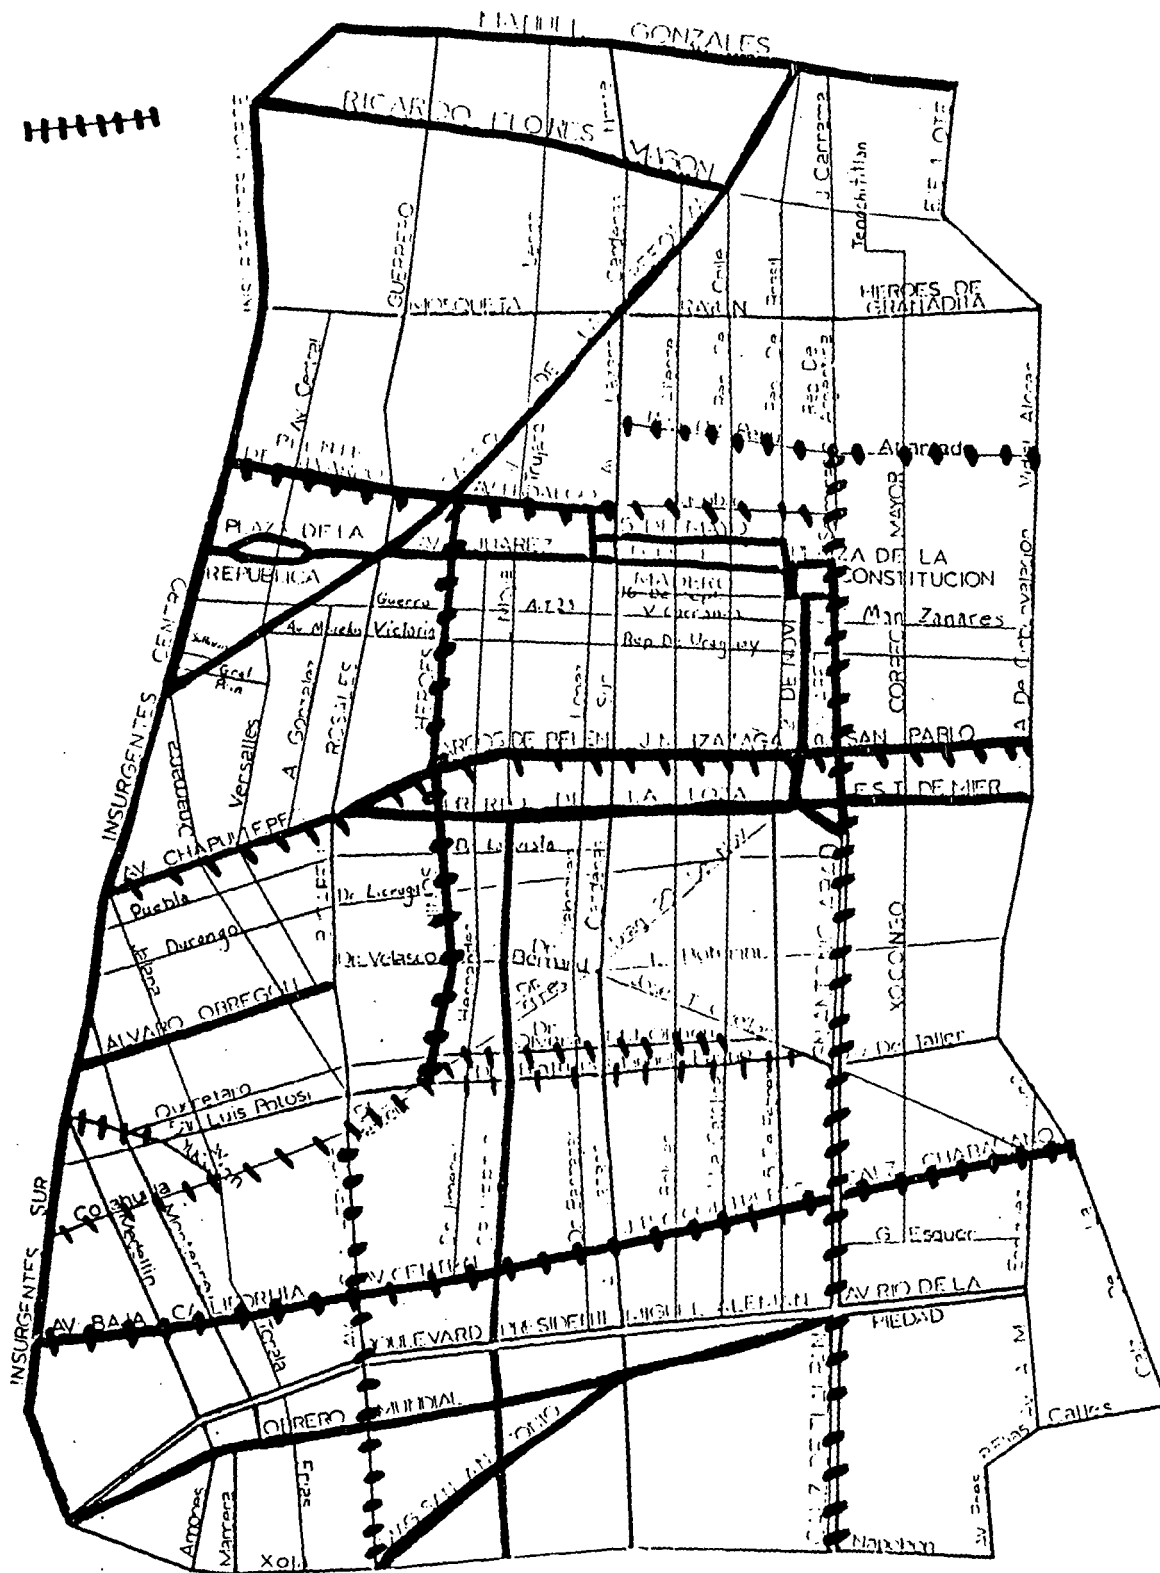
Metro Lines

Figure 3c. Metro lines through the Mexico City study area.

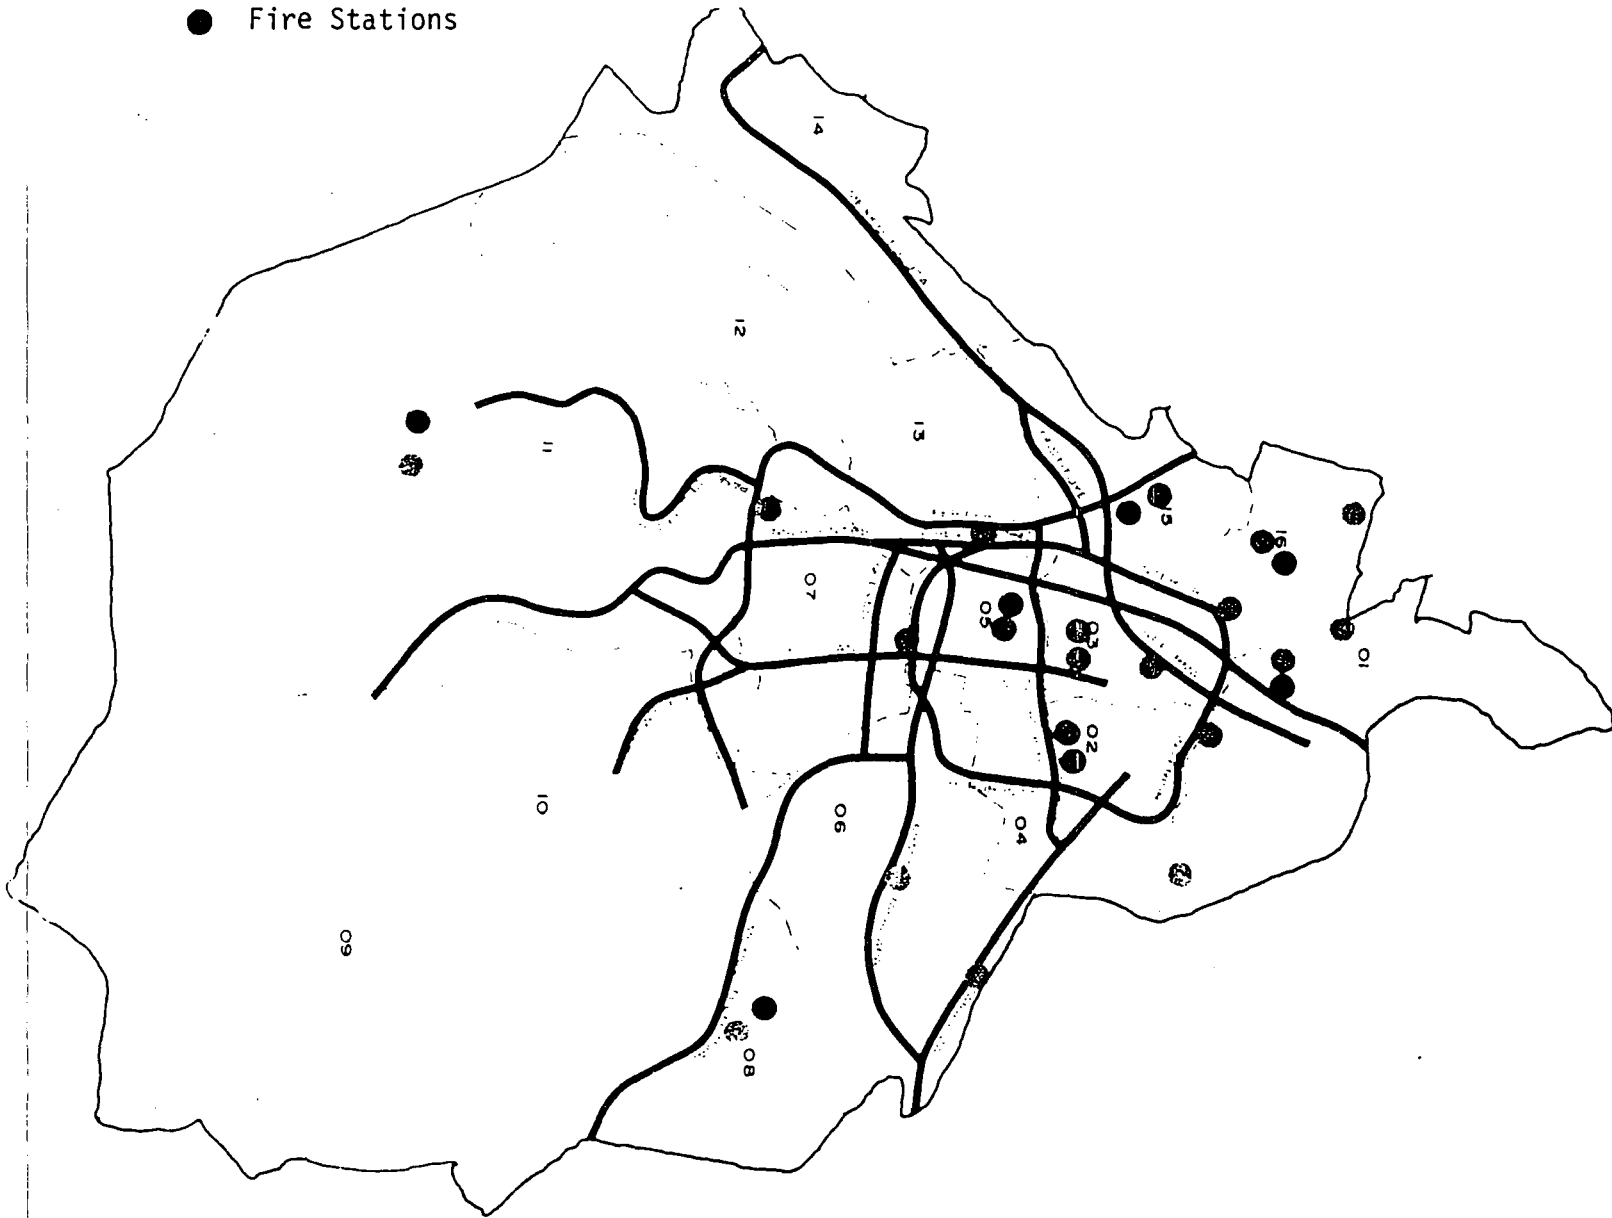
- Ambulances
- Fire Stations

Figure 4. Location of fire stations and ambulances in Mexico City.

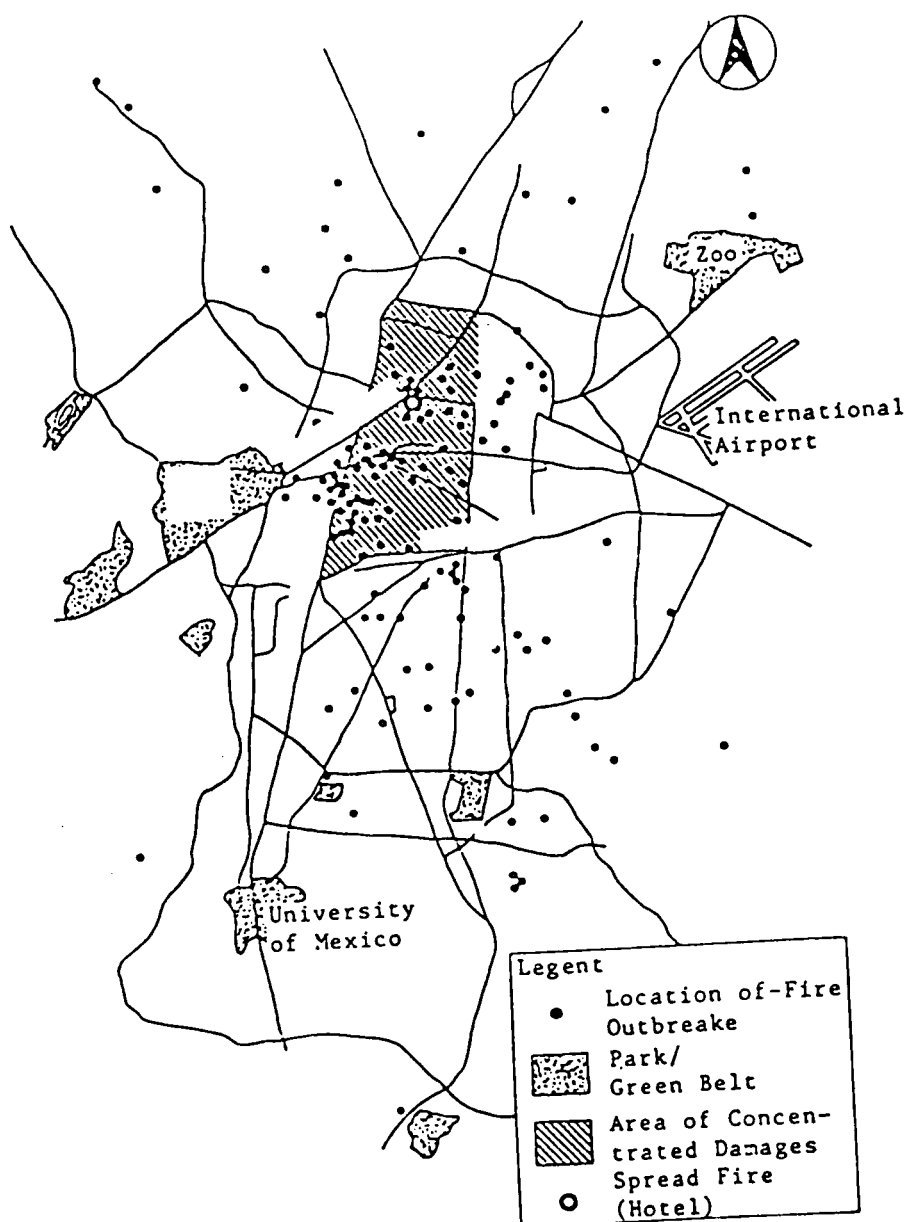
Figure 5. Location of fire outbreaks in the three days following the September 19, 1985 Mexico City earthquake (Ref.2).

Despite such limited resources, following the 1985 earthquake, the Mexico City fire brigade was forced to engage in activities as diverse as removing crushed walls, quenching fires, preventing gas leakages, and supplying water to medical facilities. Within the first 24-hour period after the earthquake, the fire brigade responded to 193 cases of fire and 236 cases of gas leakage (Ref. 2). In the three days after the earthquake, 351 cases of fire were reported; Figure 5 shows the loca-

In the aftermath of the earthquake, it was necessary to mobilize scarce medical resources to widely scattered location in the city. Sporadic fires had also broken out in many locations (Fig. 5). Emergency response agencies, generally understaffed and underequipped, had to make the most efficient use of their resources.

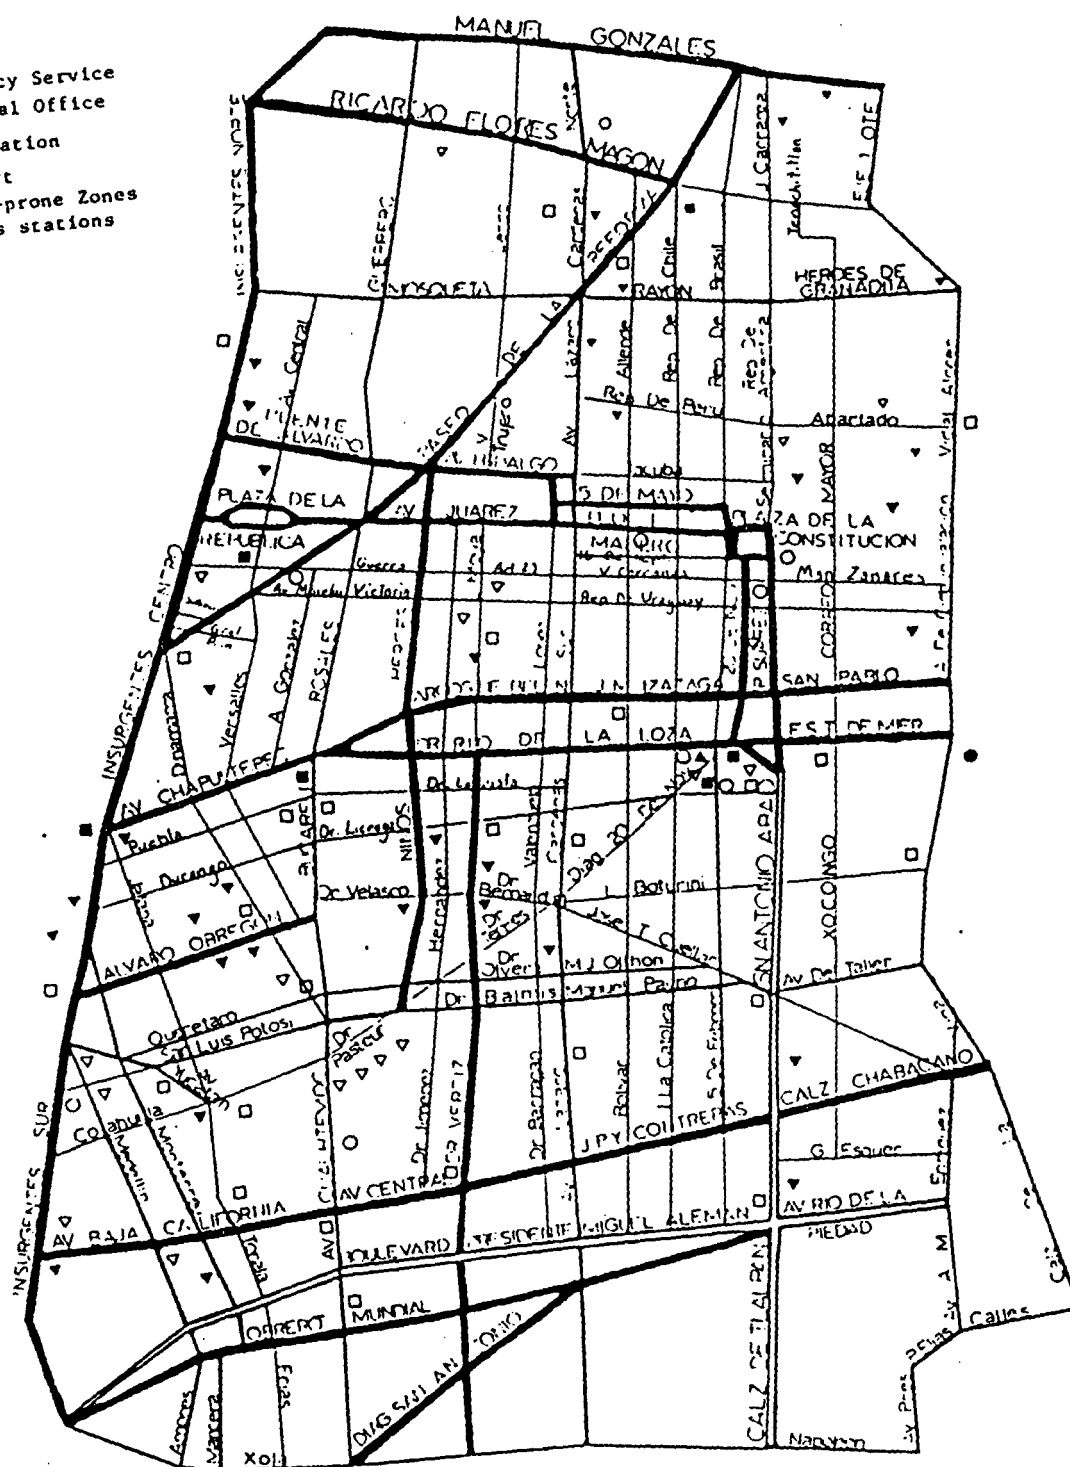
- ▽ Hospital
- ▼ Clinic
- ▲ Emergency Service
- Political Office
- Fire Station
- Heliport
- Danger-prone Zones
- ex: gas stations

Figure 6. Location of critical buildings in the Mexico City study area.

A second problem was in dispatching emergency vehicles under unknown route conditions. Emergency units such as ambulances, rescue teams, and fire vehicles had to make numerous attempts and diversions, usually by trial and error, in order to access areas where secondary and local streets were closed. This was particularly the case within the "Colonia Juarez" and "Colonia Roma" zones. Figure 6 exemplifies the vehicle dispatch problem through showing the spatial distribution of the critical facilities which were potential origins or destinations of emergency vehicles.

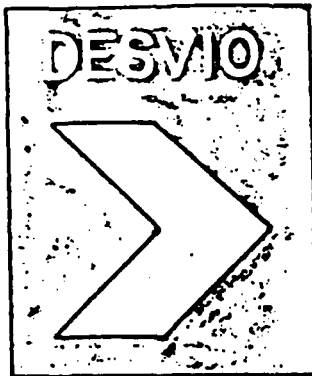
- ① Chevron sign to indicate Detour

Figure 7. Special signs used in Mexico City after the September 1985 earthquake (Ref. 4).

The implementation of these plans on Saturday, September 21 required design and manufacturing of a number of special signs (Fig. 7).

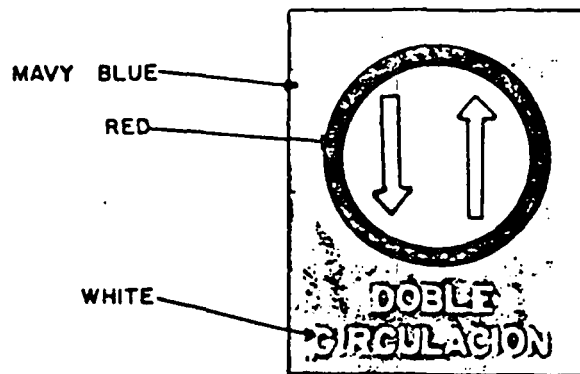
- ② One-way Street converted into two-way

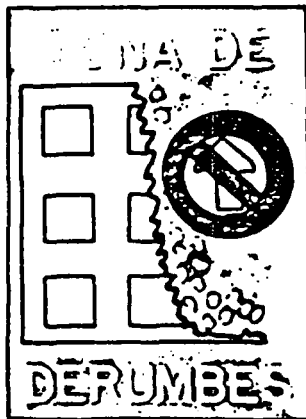
- ③ Sign for collapsed buildings or being demolished combined with do-not-enter sign

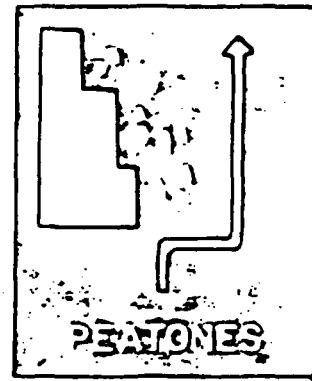
- ④ Sign for pedestrians to walk around the zone affected by a damaged building.

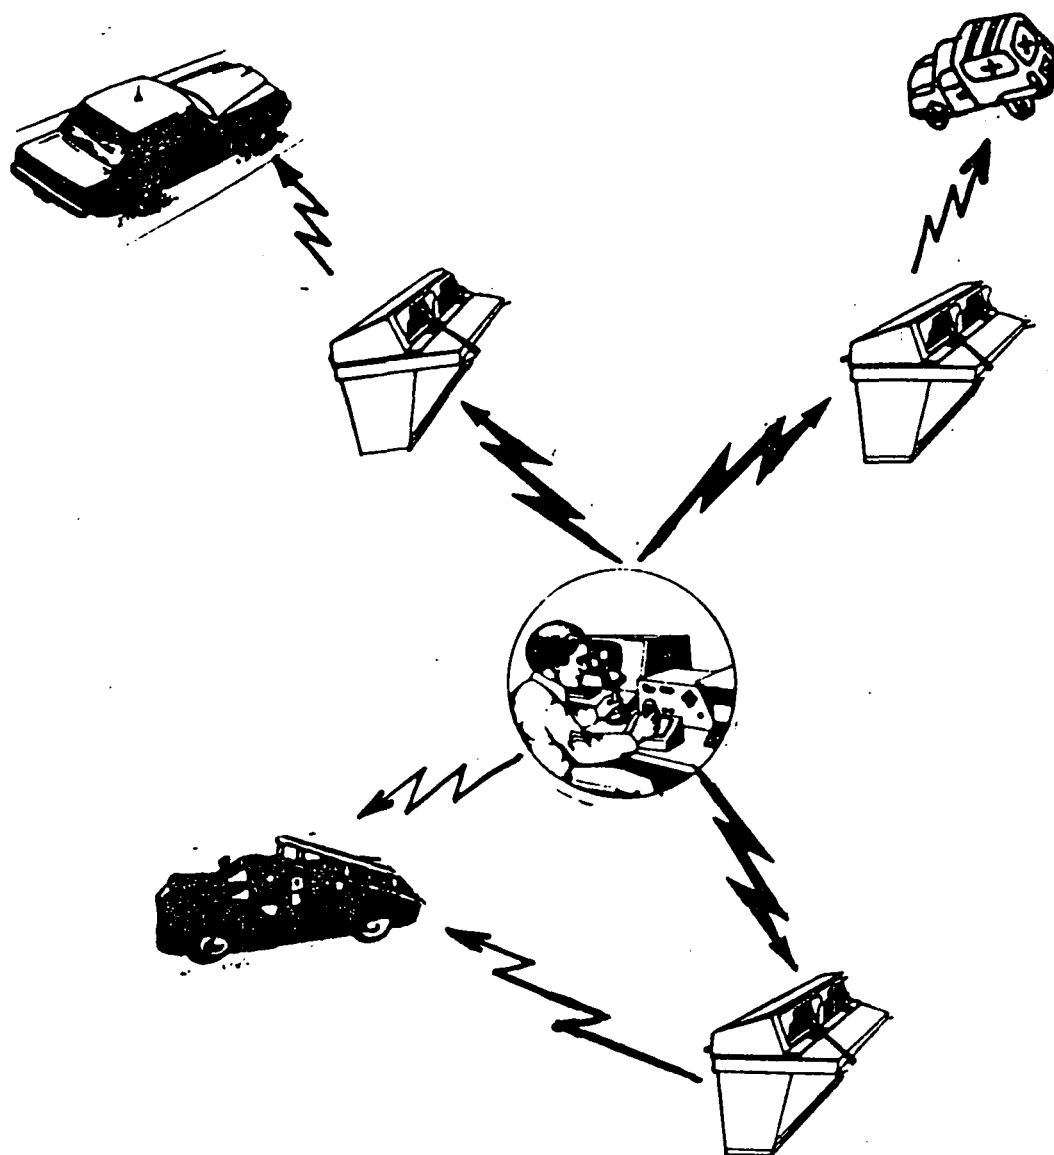
Figure 8. A schematic diagram of the proposed transportation emergency management headquarters.

Such capabilities would, of course, be more feasible with a main-frame computer facility. Since main-frame facilities were not available for 72 hours following the September 19 earthquake, a battery-operated micro-computer is therefore recommended. The micro-computer facility would have graphical network editing capabilities and be stationed at a central command post. All information regarding the conditions of the street networks would be communicated to the command center. The computerized map of the network could then be modified based on incoming data. The latest graphical documentation of the network conditions can then be made available to all interested parties in the form of a hard-copy map or by telecommunication links. Figure 8 shows a schematic diagram of the proposed command center.
