Comparative Reliability Analysis of Tornado Pressure

A case study of Matador tornado

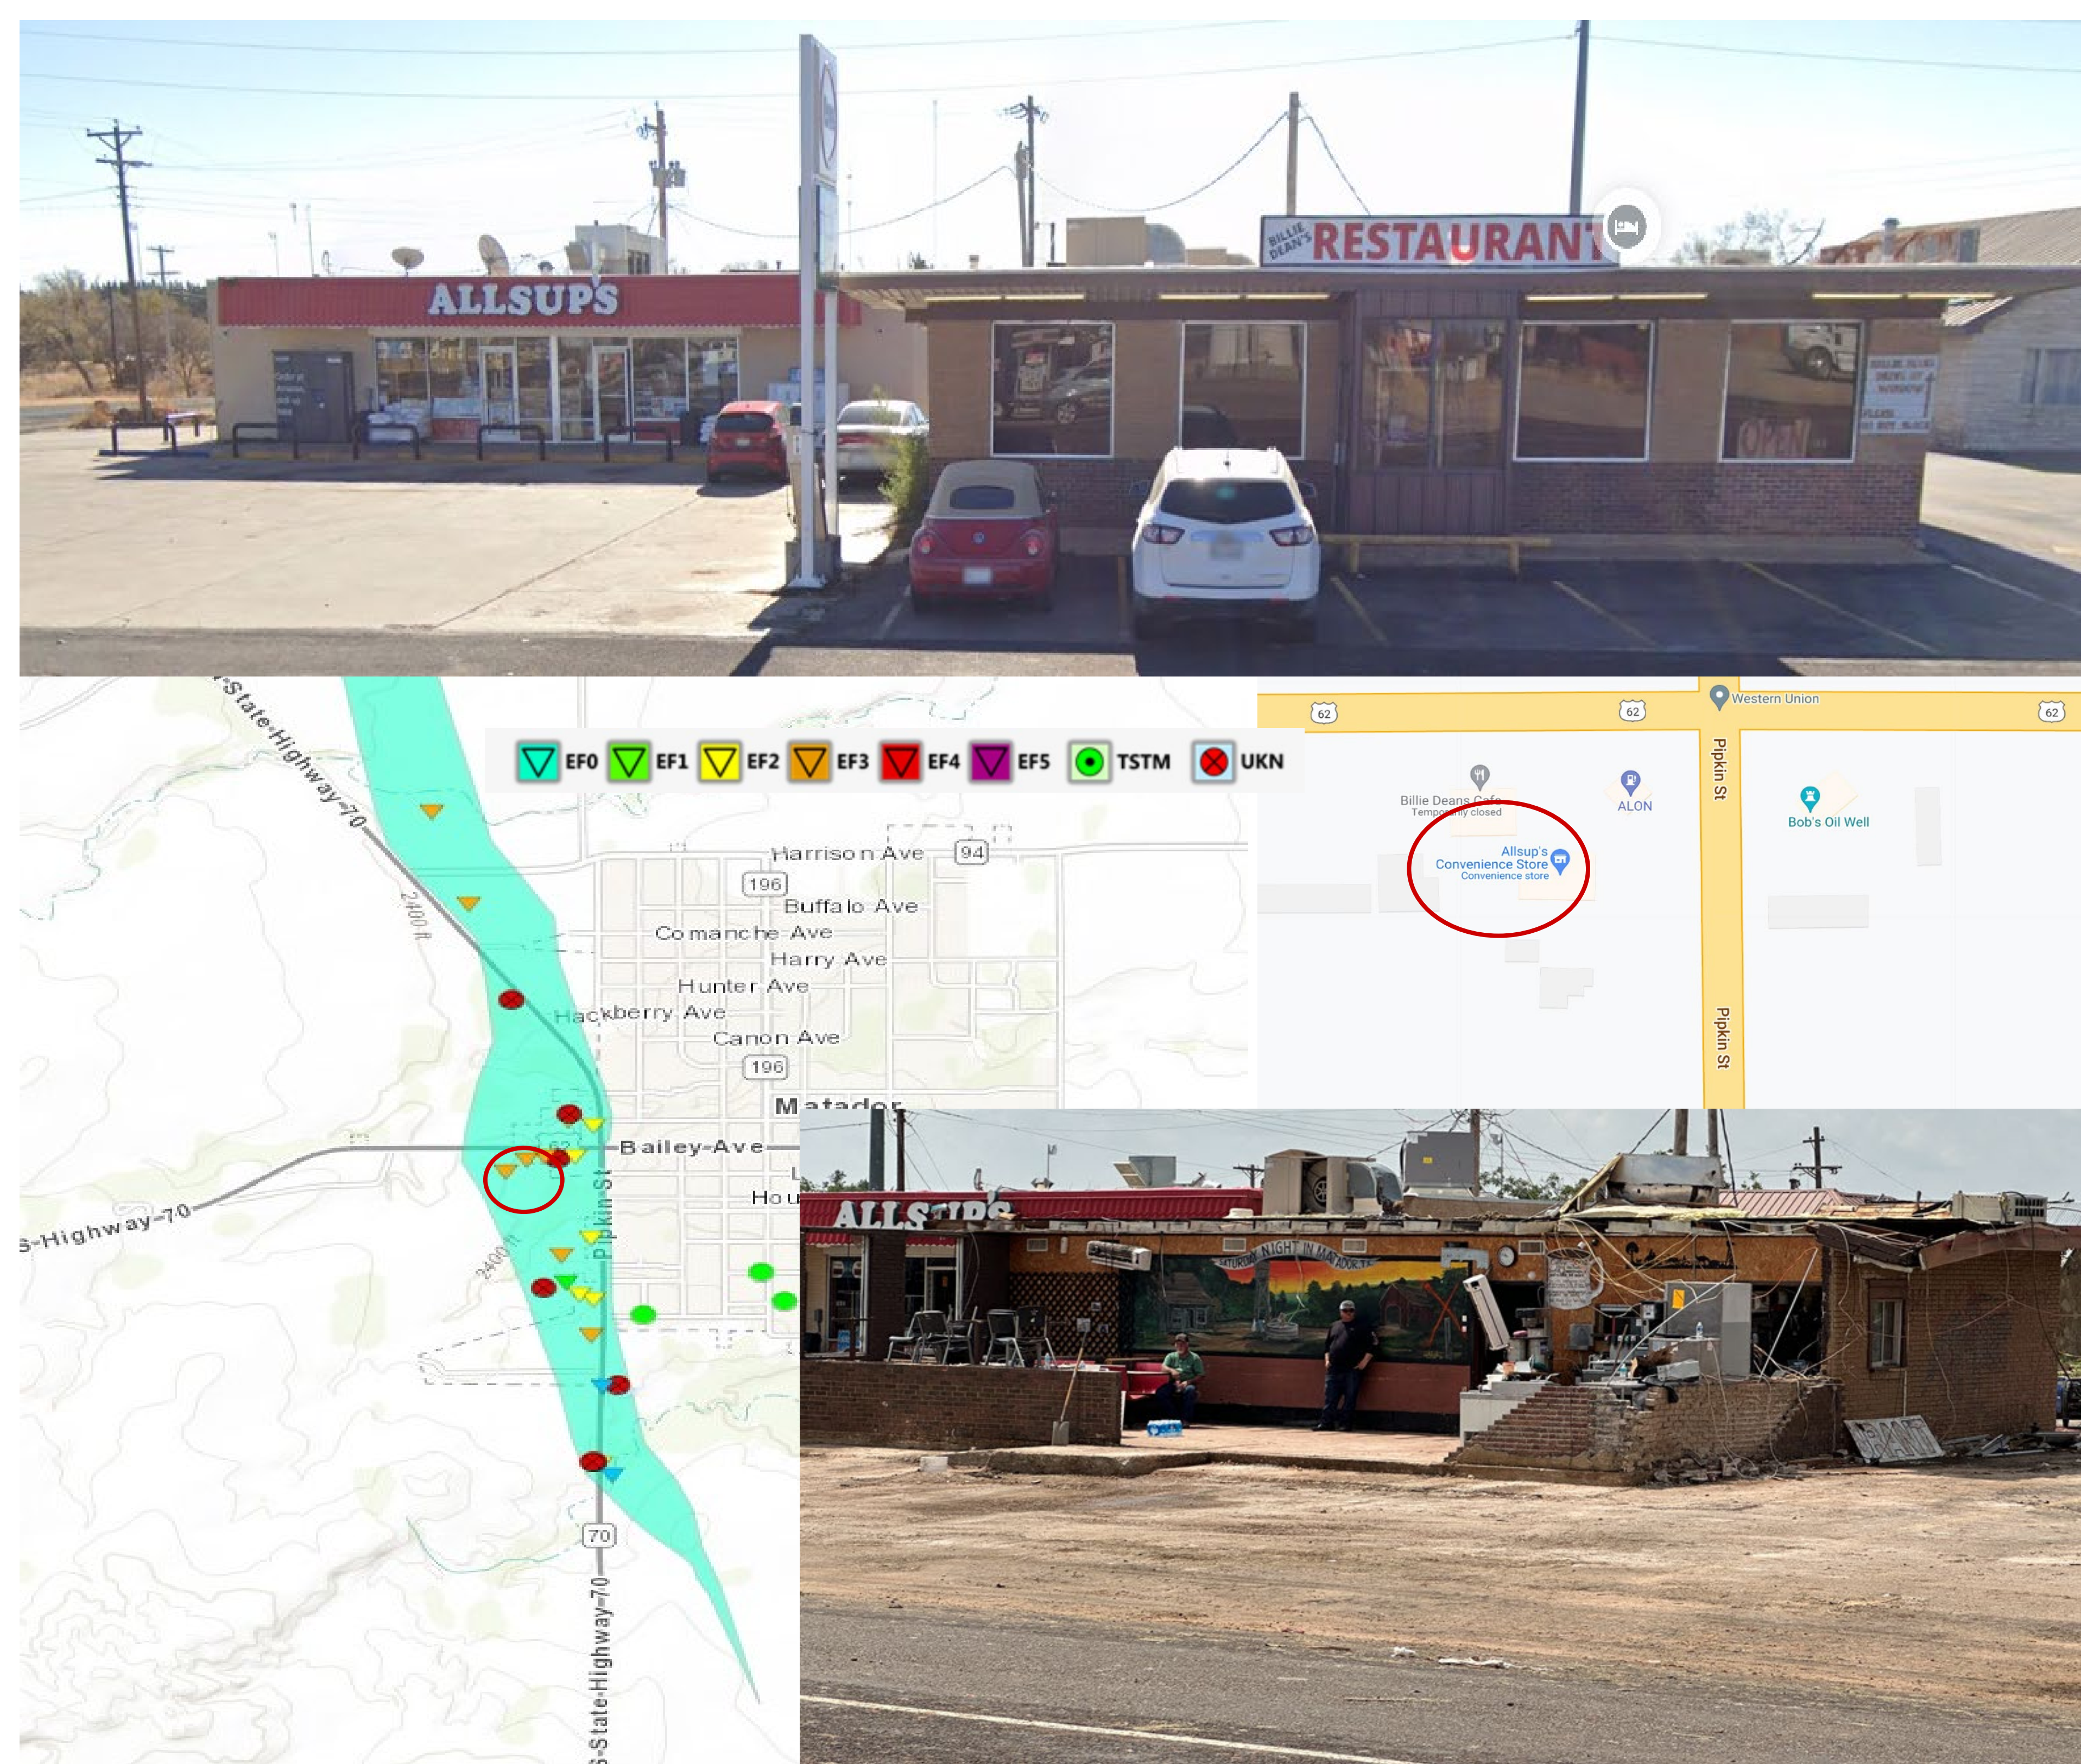
Figure 2 : Track Map of Tornado - Matador, Texas (June 21, 2023)[2](bottom left), Building destroyed in Matador tornado(bottom right)(Bruce Haynie)[2], Google street view of building before Matador tornado (top).

The Matador tornado developed in the southern Texas Panhandle and moved south-southeastward reaching Matador around 8pm on June 21, 2023 [2]. The tornado was classified as an EF-3, with consultation from Dr. Kishor Mehta and Dr. Delong Zuo from the Texas Tech University National Wind Institute. Figure 2 displays the low-rise flat roof building that was destroyed in the tornado located at the intersection of Bailey Avenue and Pipkin Street in Matador, Texas. The building resembles a typical one-story light-weight low-rise building in Texas, US.

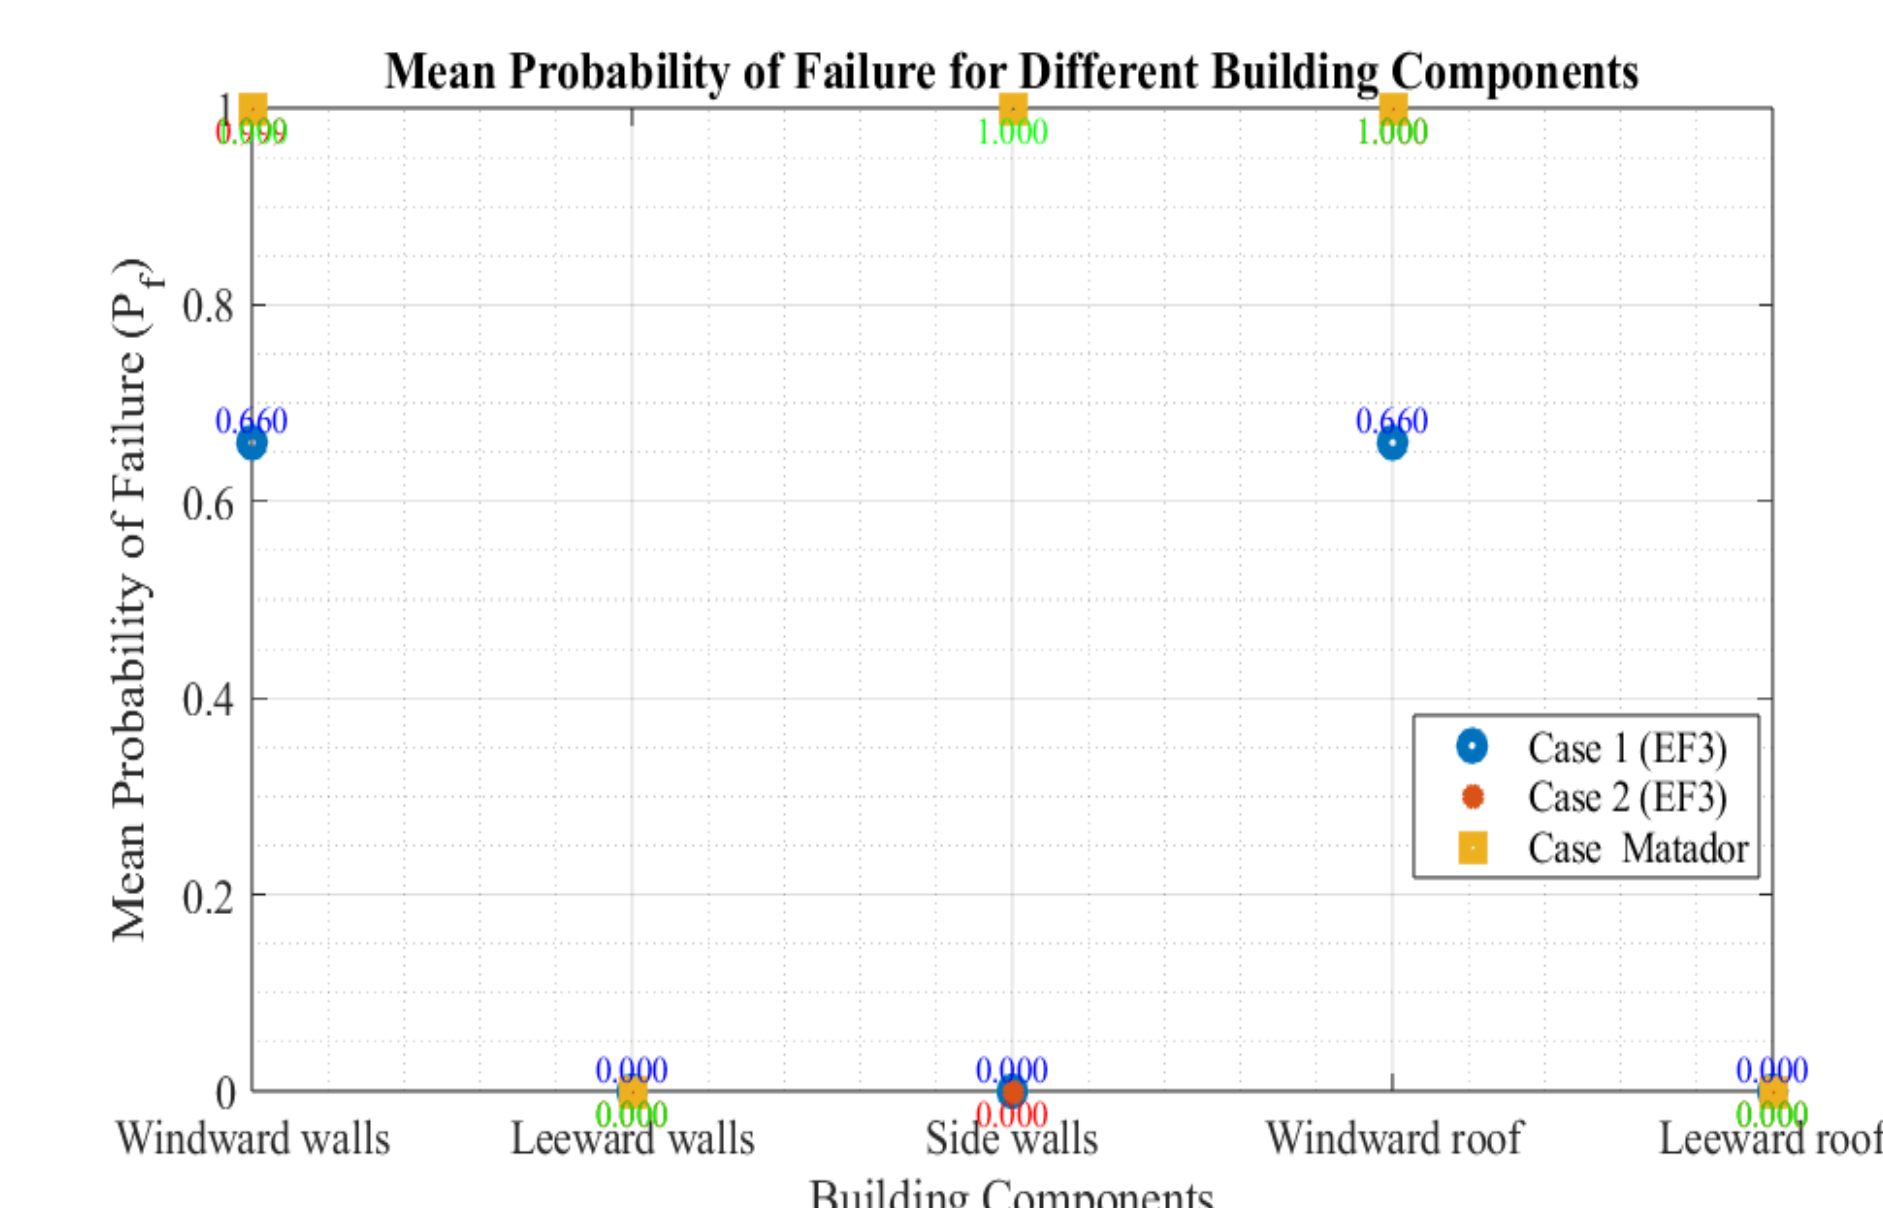
A distinct limitation is the high probability of failure observed even at low tornado scales. Figure 3 plots the probability of failure of the model against Matador values. Leeward walls and Leeward roof have shown 0% probability of failure for all the cases, whereas the windward walls and windward roof have 100% probability of failure for Load Case II. The side walls shows 0% probability of failure for both cases however, the wall was damaged in the Matador tornado.

Figure 3 : Comparison of mean probability for Model and Matador values.
